# **A Review of Structural Failures in Ireland**

Trinity College Dublin  
Department of Civil, Structural and Environmental  
Engineering

A Thesis submitted for the degree of Master of Science  
by

Ian James Duckenfield

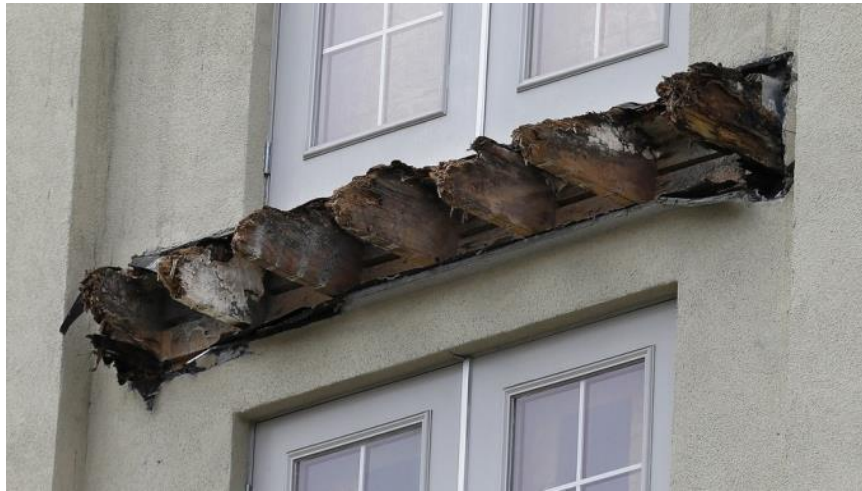
This section was written a month after the balcony collapse in Berkeley, California which took the lives of 6 young people, 5 of them Irish (Mayton, 2015). The preliminary indications suggest dry rot in the timber (refer to Fig 1.2.1).

Fig 1.2.1 Fatal balcony collapse at Berkeley (TheJournal.ie, 2015)

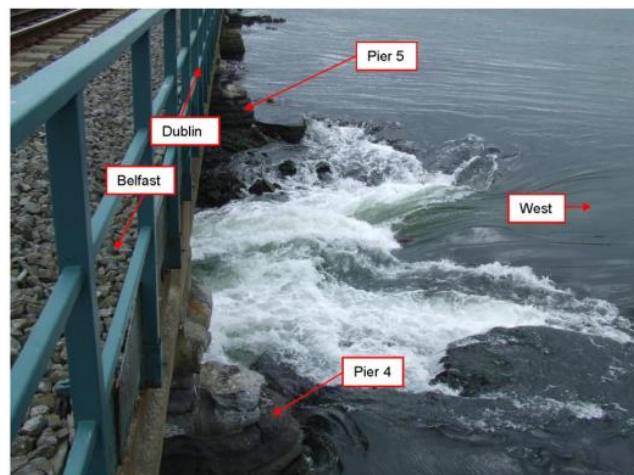
Fig 2.2.4.a Photograph taken of piers 4 and 5 taken 3 days before the collapse. (Railway Accident Investigation Unit, 2010)

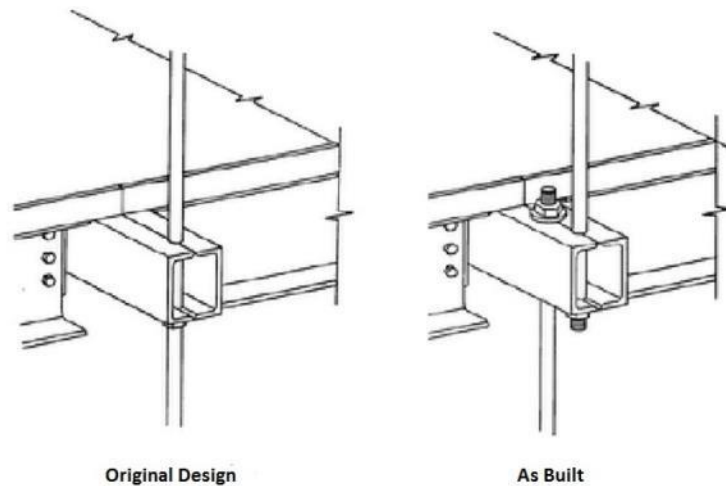
Fig 2.3.6.a The original design and the “as built” detail. (WordPress.com, 2011)

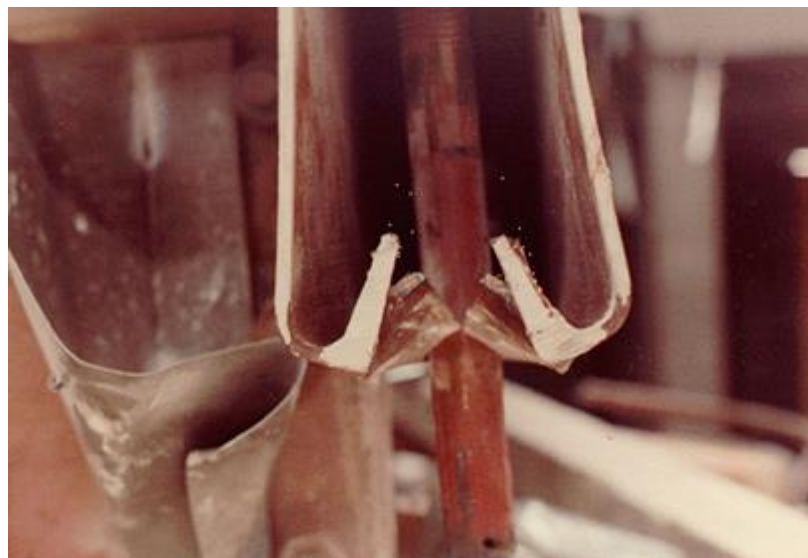
Fig 2.3.6.b Failed connection at transverse beam (Kansas City Star, 1981)

(note the weld connecting the toes of the channels has failed)

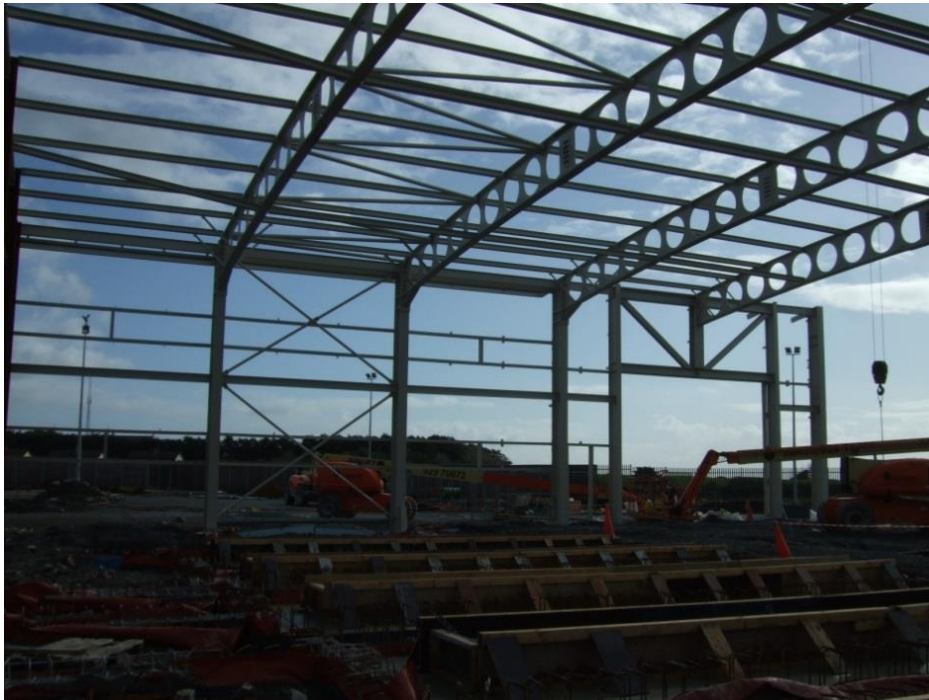
An industrial type single span portal framed building was designed with a curved rafter. The span was 38 metres with a height to ridge of 10 metres. A castellated rafter was selected for aesthetic reasons and also for service runs. Refer to Fig 3.5.1.a.

Fig 3.5.1.a. Photograph taken during steel erection showing the roller shutter door ope.  
(Confidential Source, 2015).

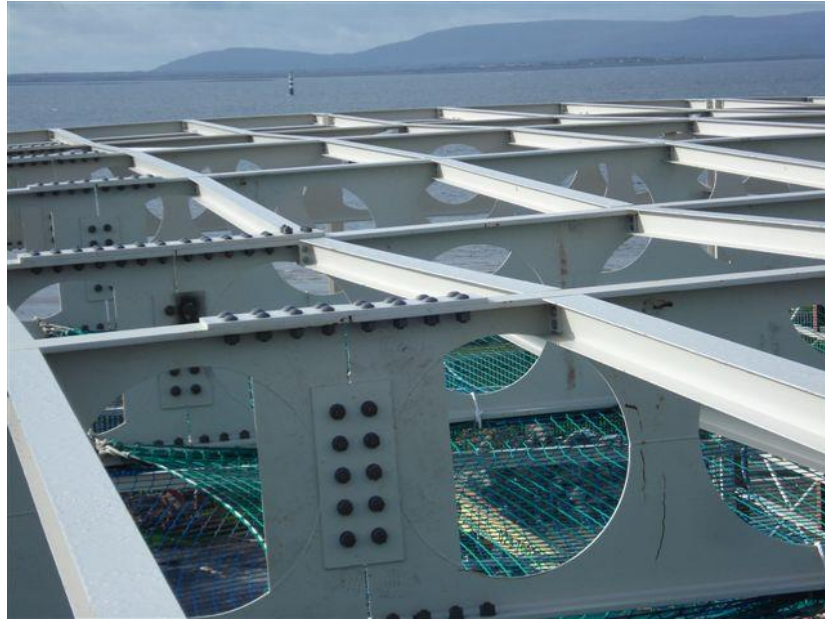
Fig 3.5.1.b. Photograph showing the sag in the castellated rafter. (Confidential Source, 2015).

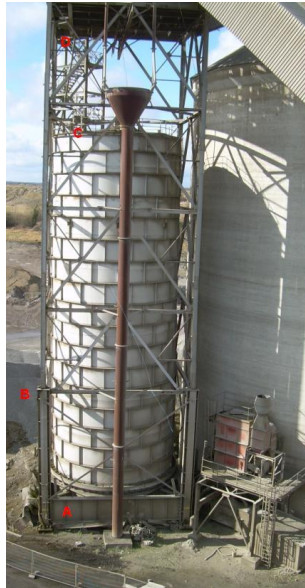
Fig 3.5.3.a. View of silo after failure (Confidential Source, 2015).

Note the large plate girder A should be connected to the top of the heavy column section at B. Note also that the top of the silo C should be near the top of the framework at D. The aftermath of the failure can be seen in the 2 photographs below – Figs 3.5.3.b and c.

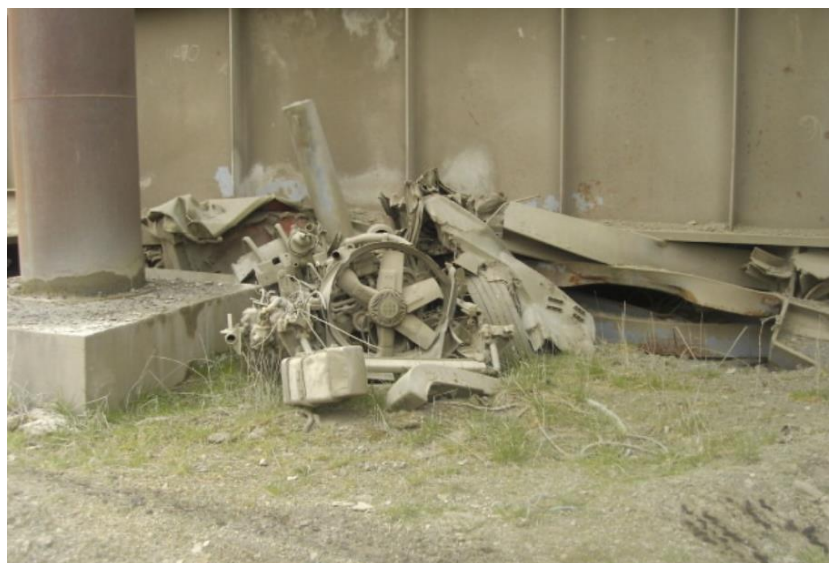
Fig 3.5.3.b. The remains of the truck under the silo (Confidential Source, 2015).

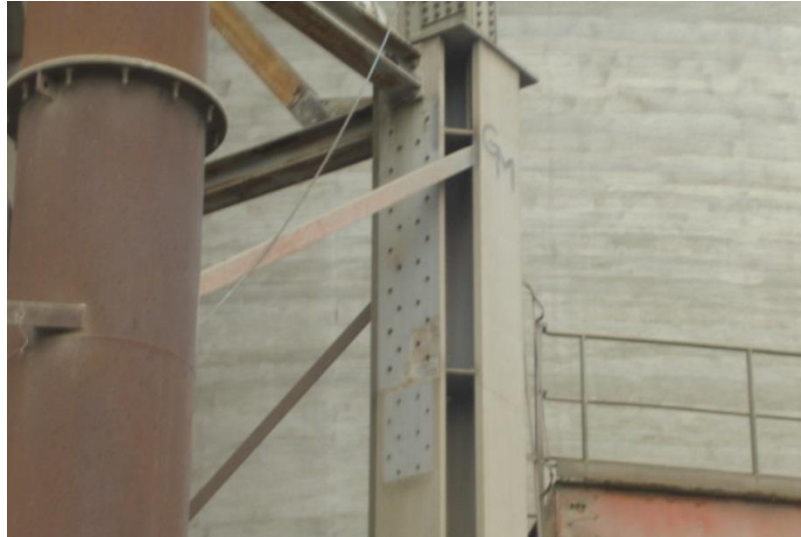
Fig 3.5.3.c. Failed bolted connection (Confidential Source, 2015).

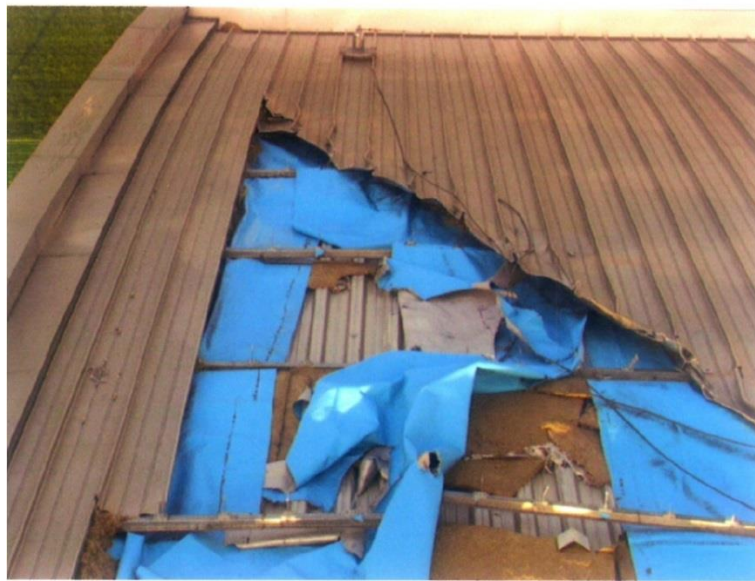
Fig 3.5.8.d. Damage to roof (Confidential Source, 2015).

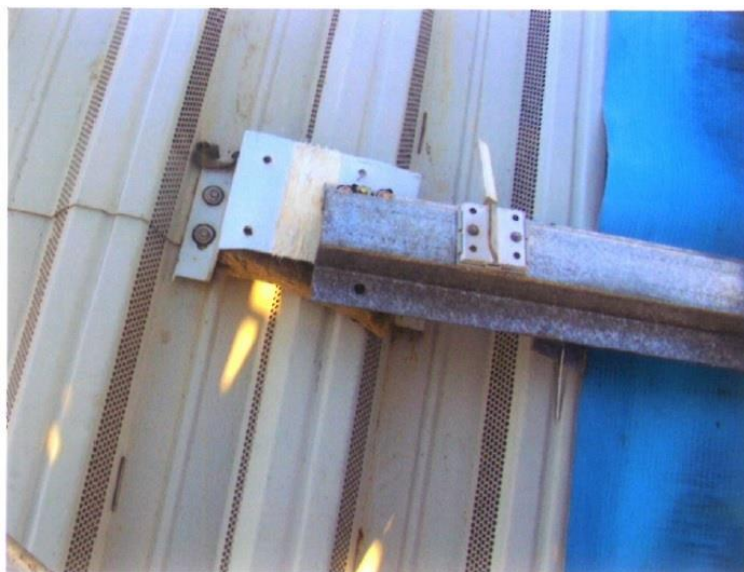
Fig 3.5.8.e. Damage to two top hat sections (Confidential Source, 2015).

(note the continuous upper top hat section and the lower top hat section as 130 mm long)

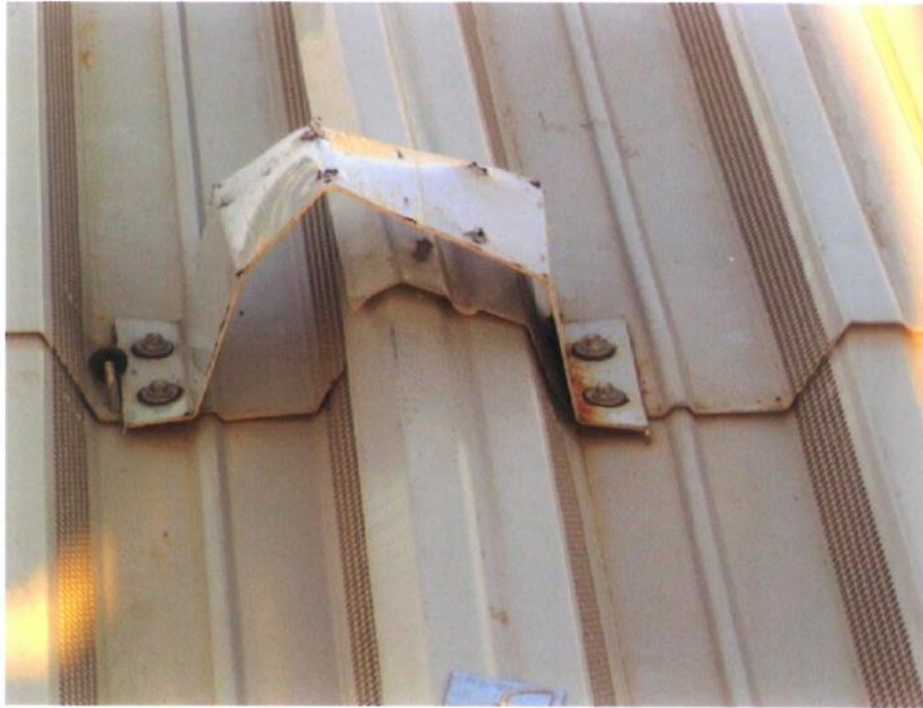
Fig 3.5.8.f. Damage to lower top hat section. (Confidential Source, 2015).

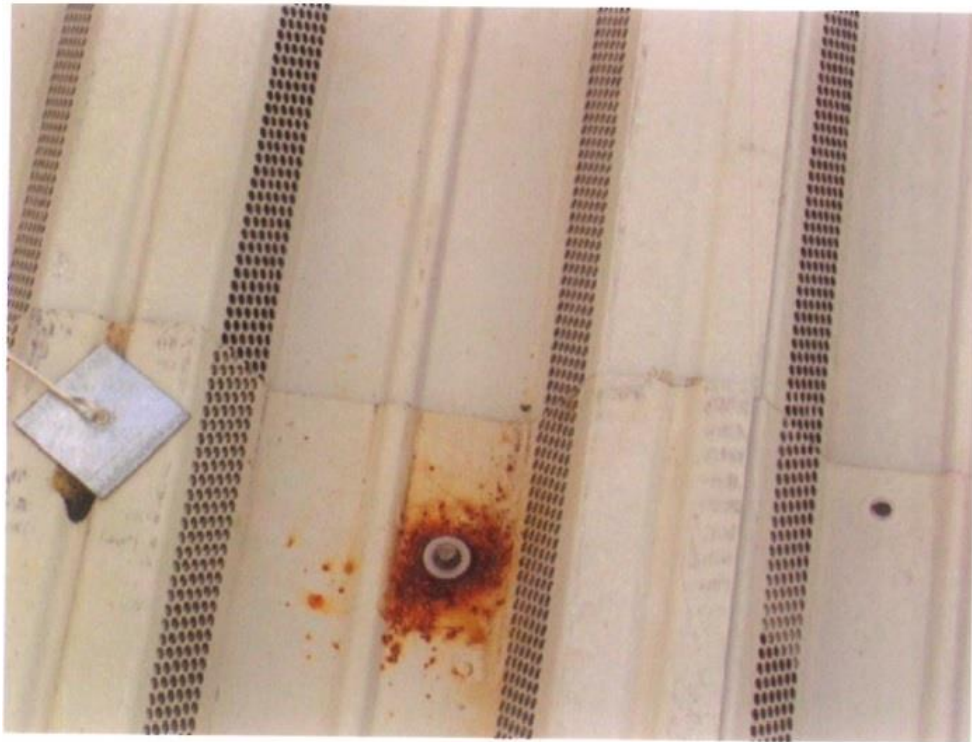
A cause for significant concern is that the photograph (Fig 3.5.8.g below) was taken only 2 years after the official opening of the building.

Fig 3.5.8.g. View of lower sheet. (Confidential Source, 2015).

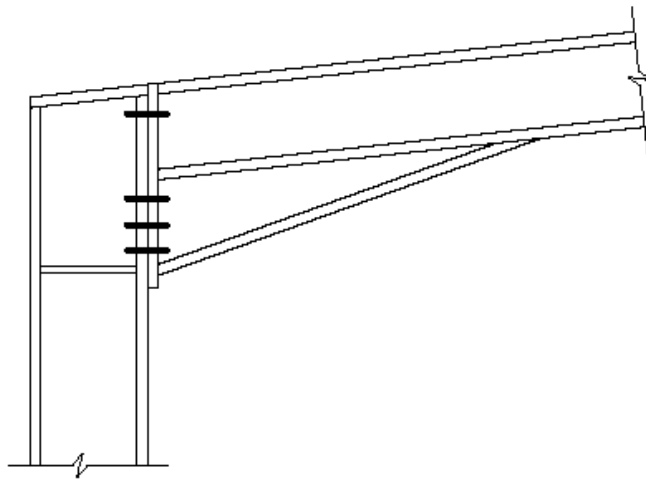
The steel erector decided to carry out an on-site modification and to drill new holes in the column section. The frame was erected with only a single pair of bolts at the top of the rafter – ie in the tension zone – refer to Fig 3.5.9.a below.

Fig 3.5.9.a. Detail of the portal haunch with the bolts in the incorrect configuration.

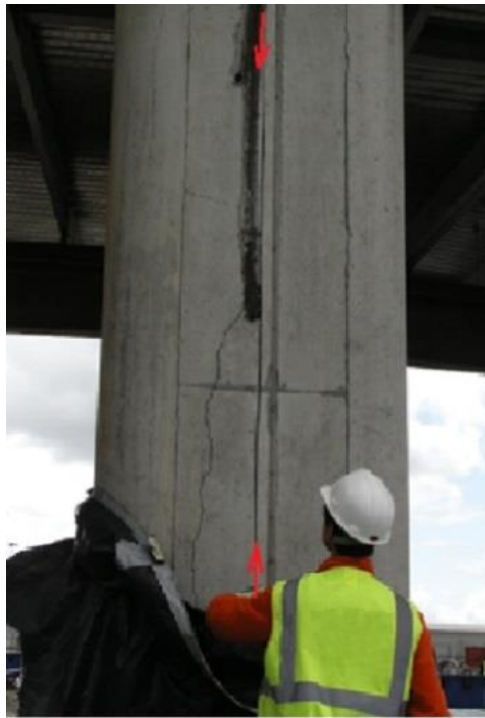
A sawn joint was made as shown in the Fig 3.5.12.a and b below, but this was not a solution. How the column was left on site is not known.

Fig 3.5.12.a. Photograph showing dislodged soft board and crack in concrete. (Confidential Source, 2015). (Sawn joint highlighted)

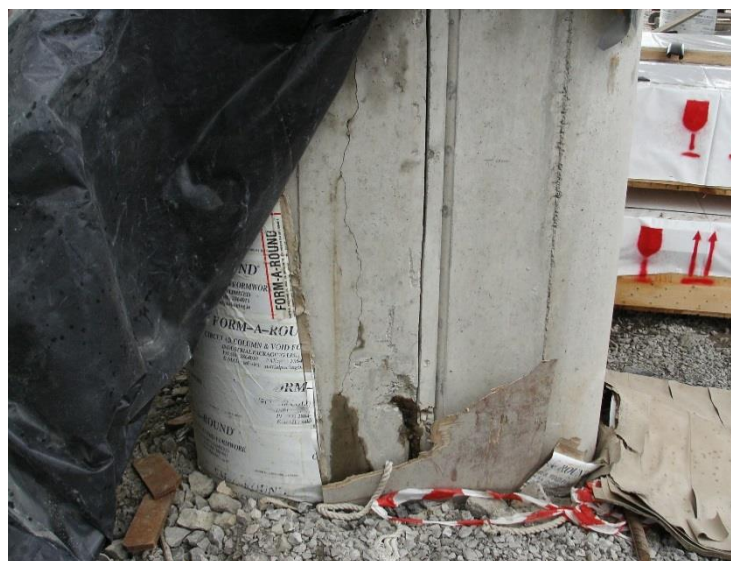
Fig 3.5.12.b. Photograph showing base of column and sawn cut. (Confidential Source, 2015).

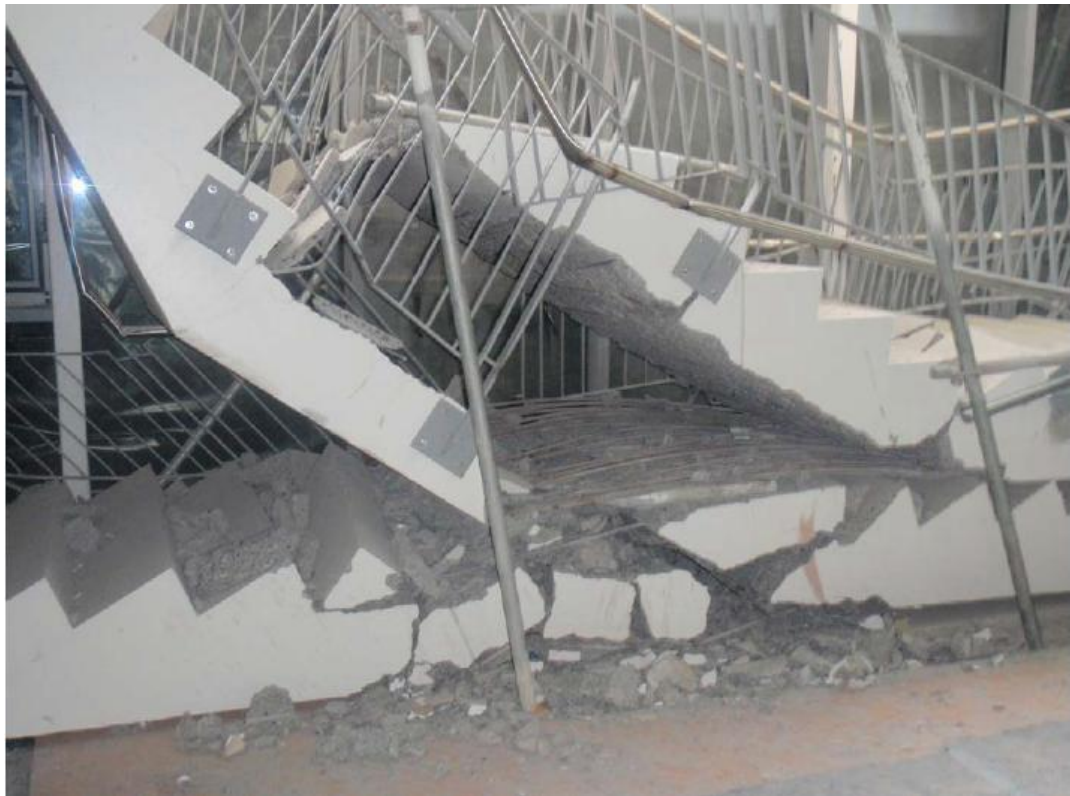
The upper stairs failed, collapsed onto a lower, similar flight which in turn collapsed onto the ground floor. Photographs of the collapse are shown in Figs 3.5.14 c and d below.

Fig 3.5.14.c. Collapsed stairs. (Confidential Source, 2015).

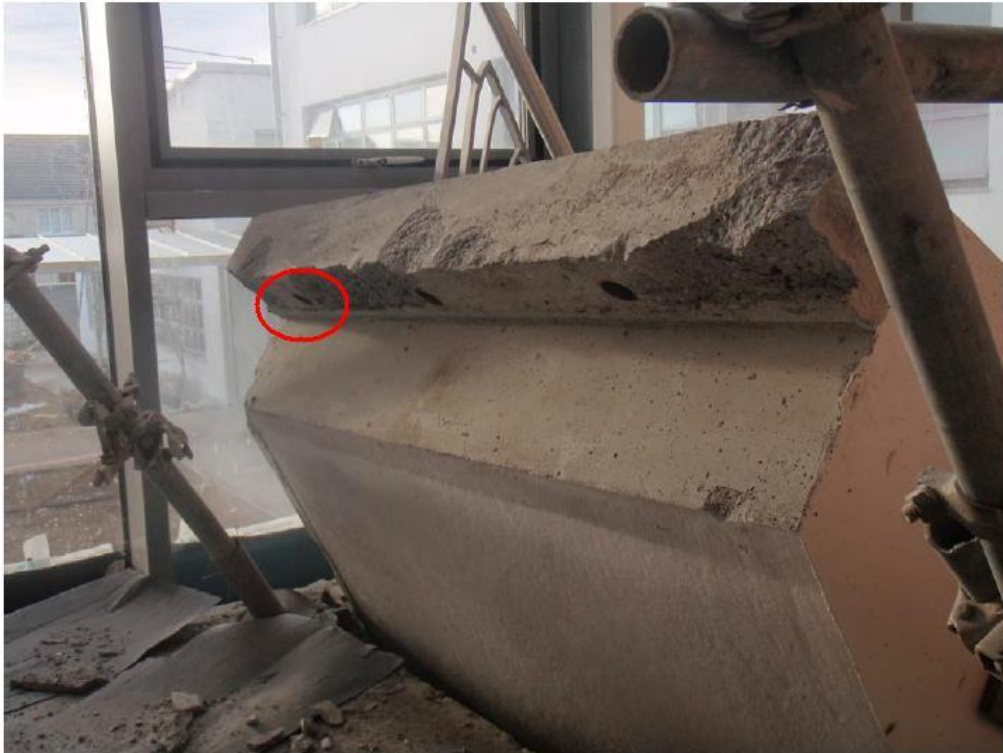
Fig 3.5.14.d. Detail at top halving joint (note: dowel hole). (Confidential Source, 2015).

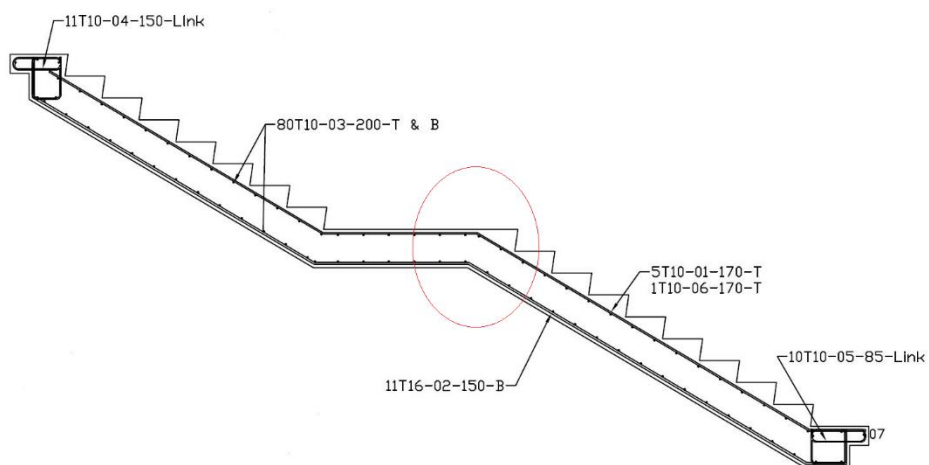
The primary cause of the collapse was the incorrect detailing of the reinforcement at the junction of the lower flight and the half landing – see Fig 3.5.14.e. The bottom steel is in tension and tries to straighten out. The correct detailing is shown below – see Fig 3.5.14.f.

Fig 3.5.14.e. Reinforced concrete details.

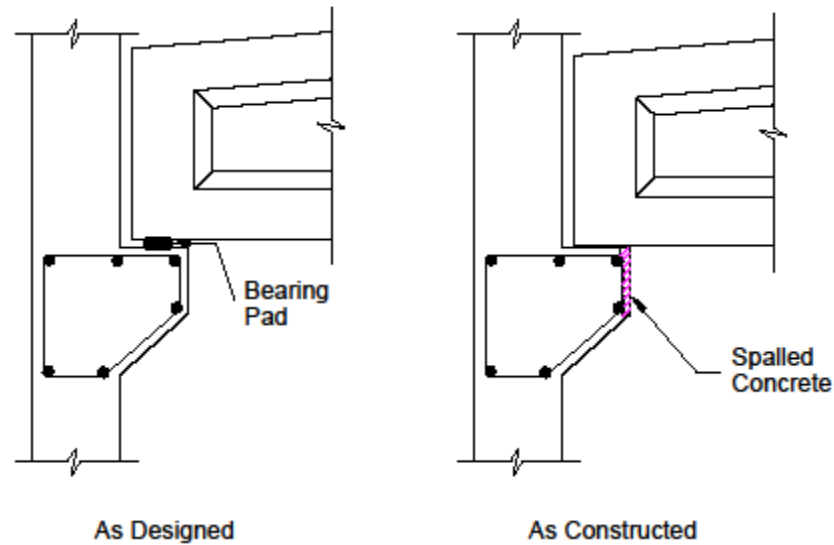
Fig 3.5.18.a. Design detail with the “as constructed” detail. (Confidential Source, 2015).

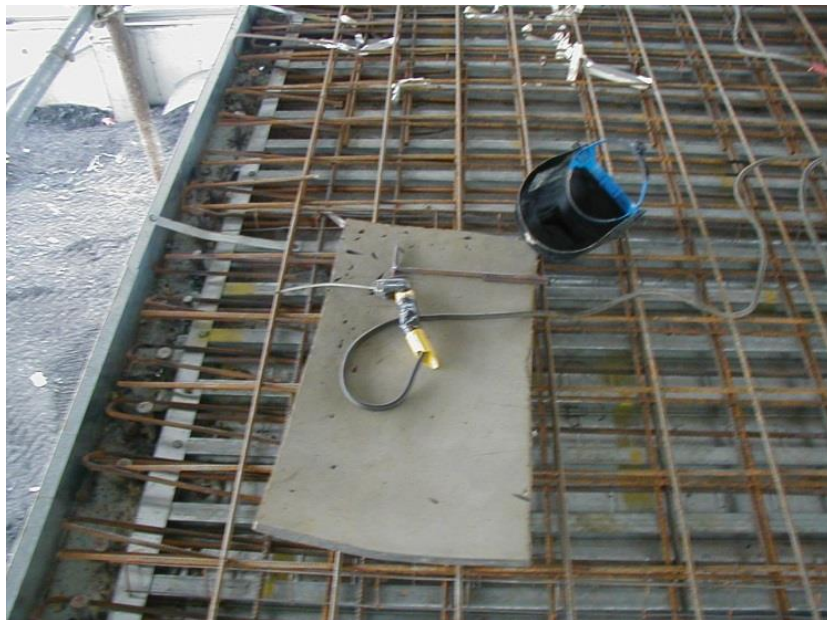
Fig 3.5.19.a. Photograph showing evidence of studs welded with sticks. The studs can be seen to the left of the photograph. (Confidential Source, 2015).

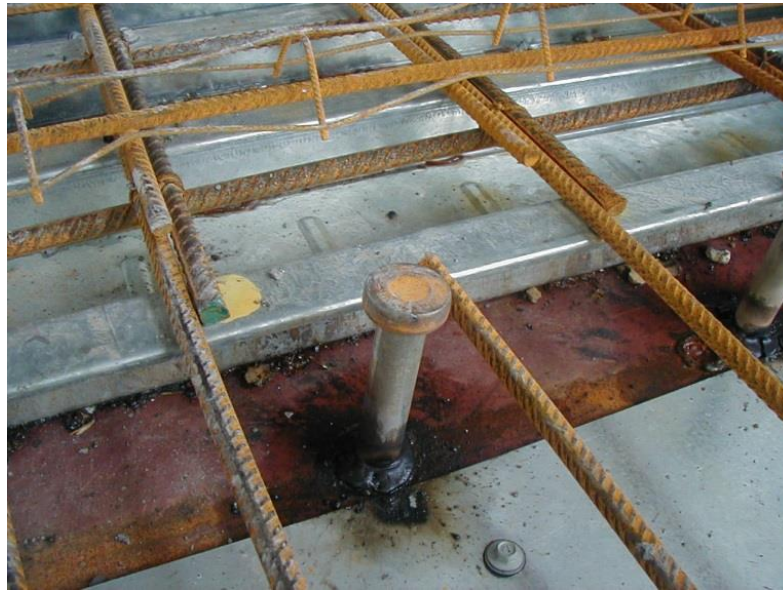
Fig 3.5.19.b. Photograph showing the stud welded to the steel beam using stick welding procedures. (Confidential Source, 2015).

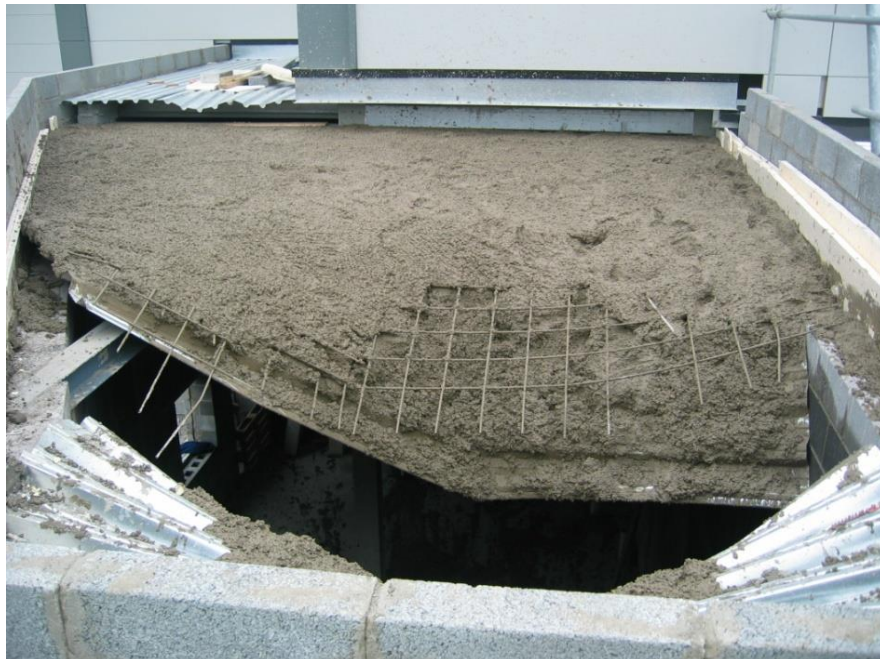
Fig 3.5.20.a. Deck failure during construction. (Confidential Source, 2015).

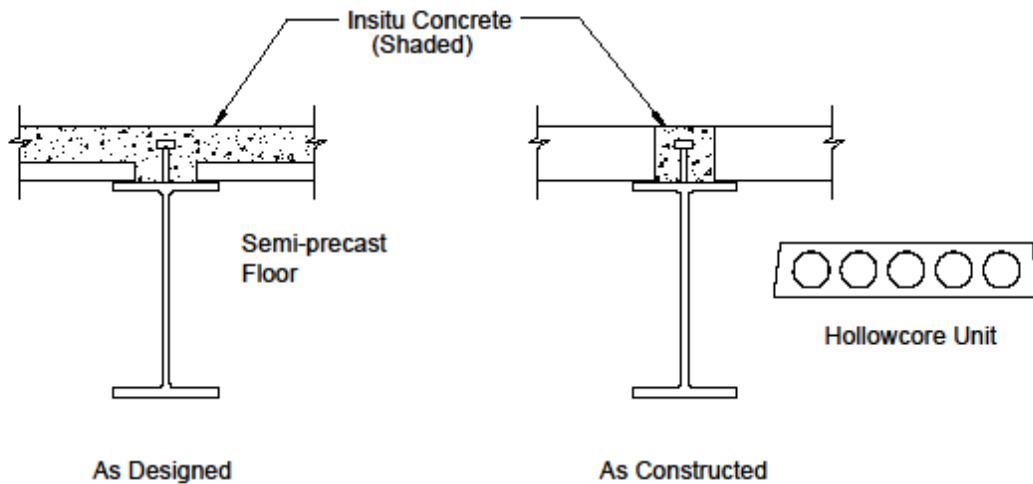
Fig 3.5.21.a. The structural engineer's design intent and the "as-constructed" beam detail.

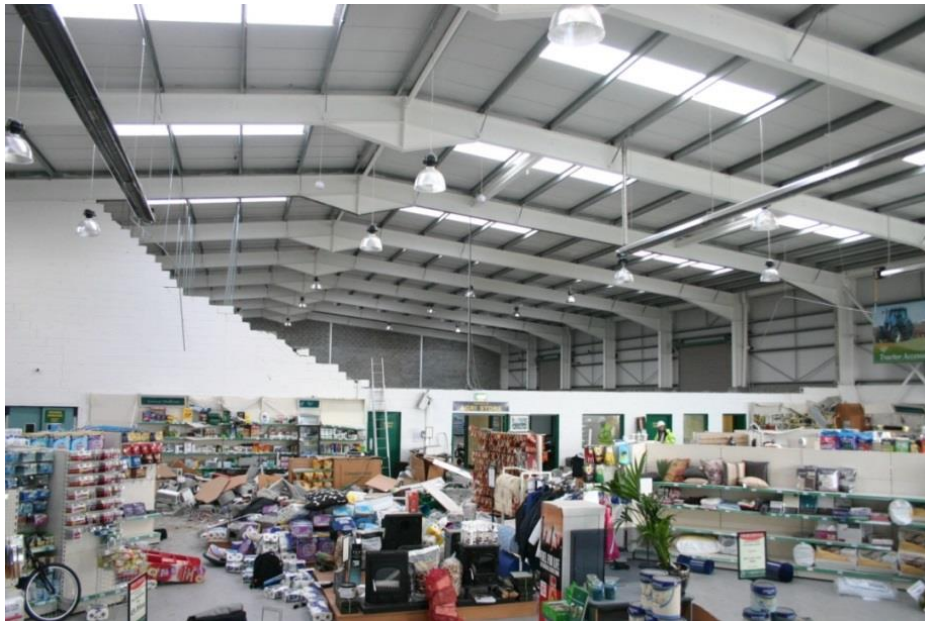
Fig 3.5.22.a. Internal view after the collapse. (Confidential Source, 2015).

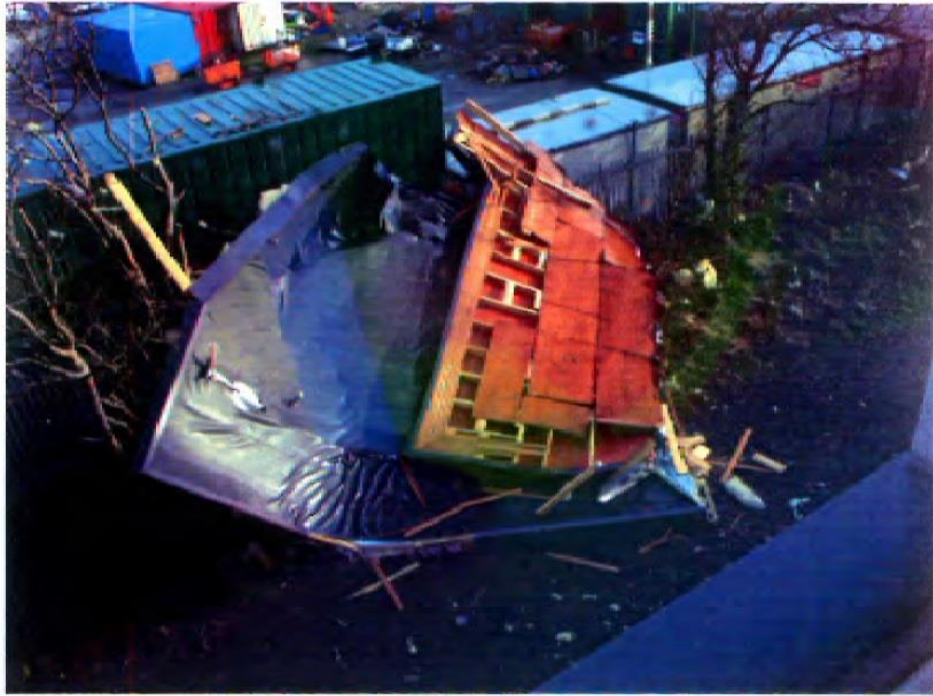
Fig 3.5.24.b. A section of roof landed in the car park. (Confidential Source, 2015).  
(note sections of lower plywood attached to upper joists.)

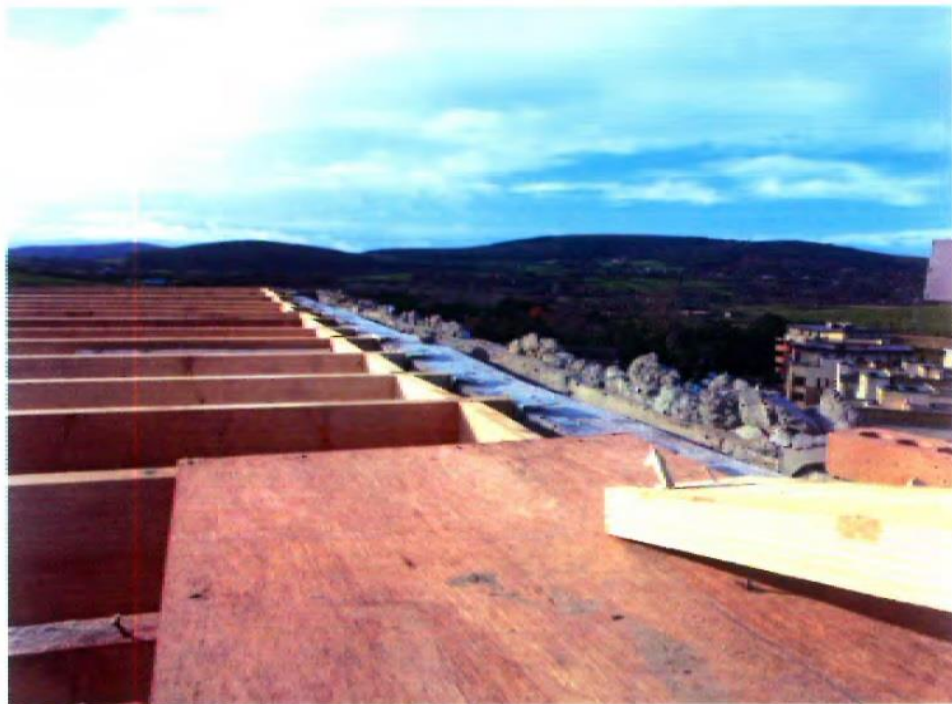
Fig 3.5.24.c. View of damaged roof. (Confidential Source, 2015).

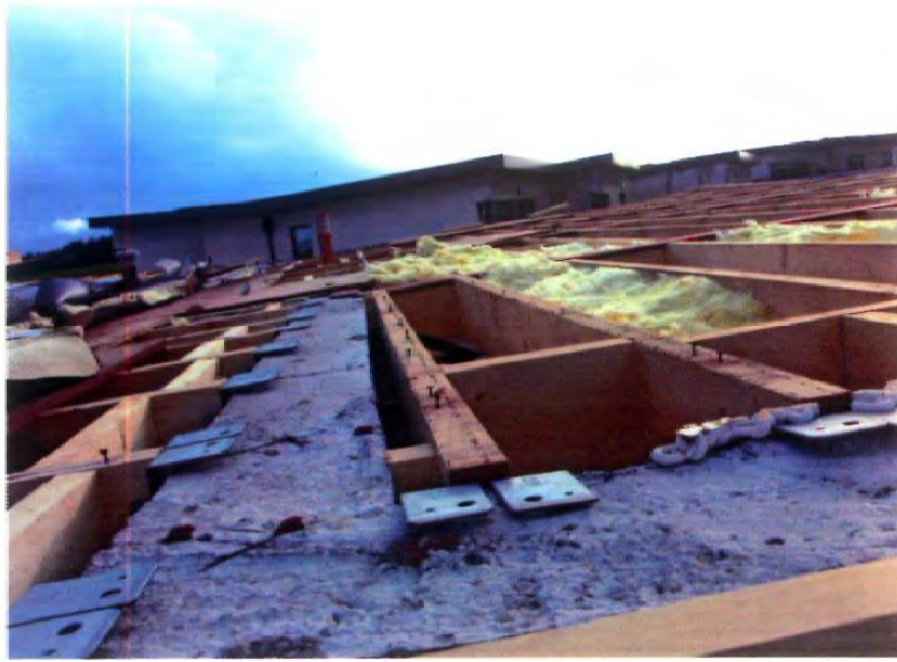
Fig 3.5.24.d. Additional view of damaged roof. (Confidential Source, 2015).

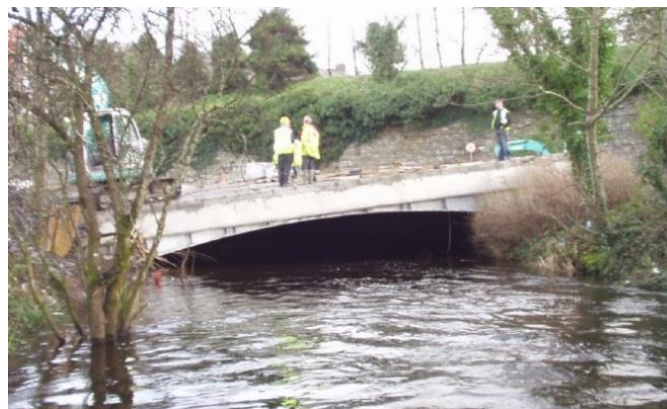
Fig 3.5.28.c. View after pile failure. (Confidential Source, 2015).

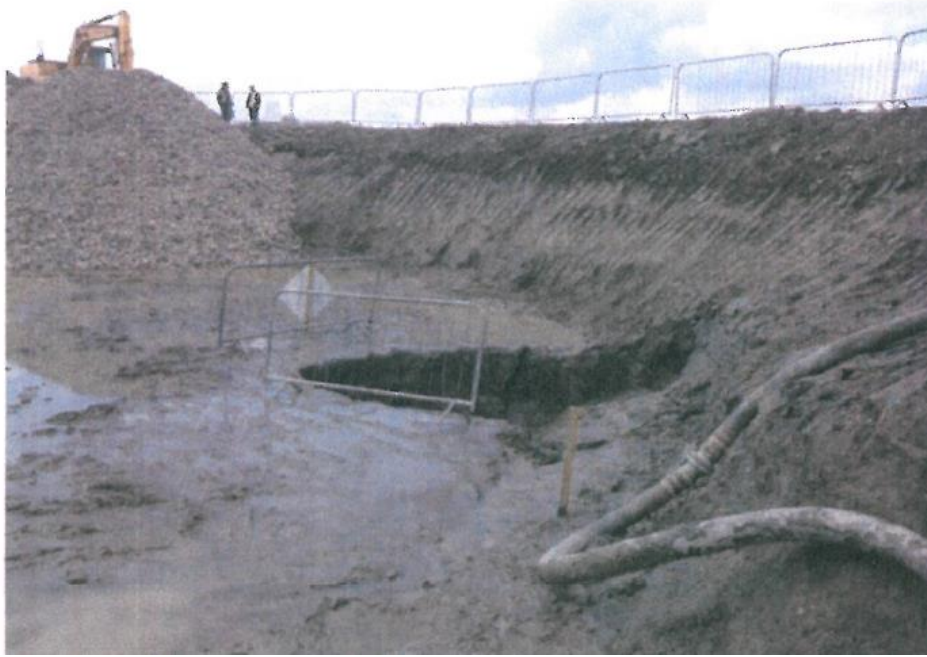
Fig 3.5.31.a. Photograph showing sinkhole during excavation work (Confidential Source, 2015).

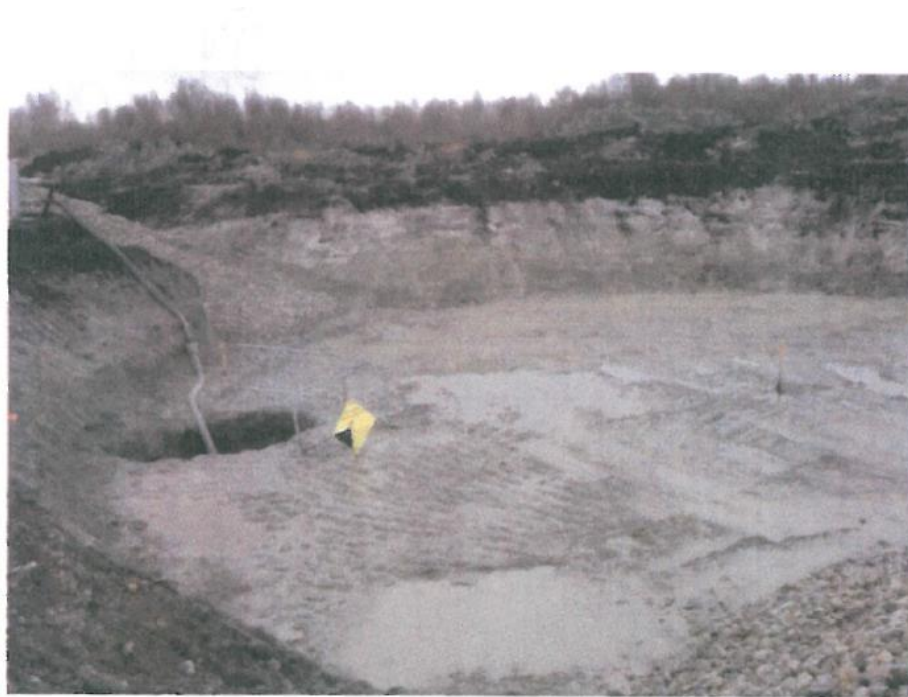
Fig 3.5.31.b. View of sinkhole – note water pump (Confidential Source, 2015).

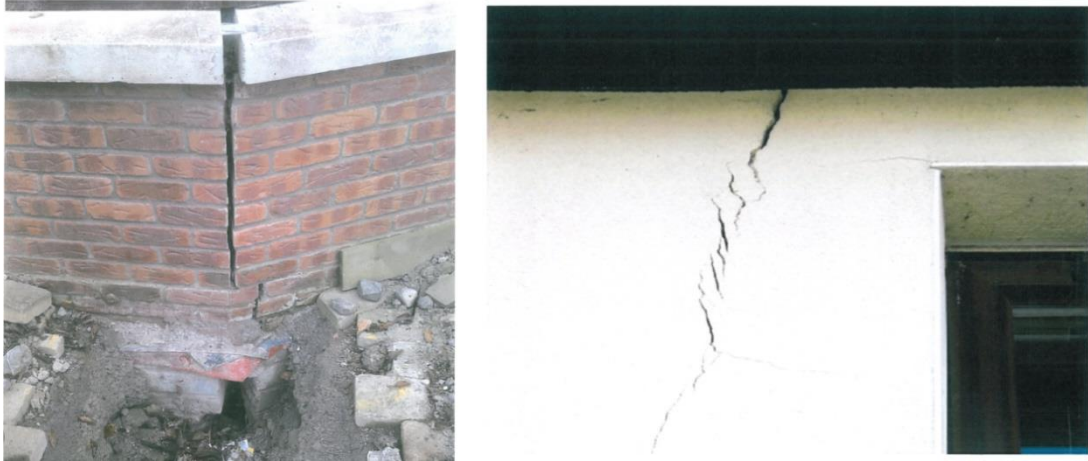
Fig 3.5.32.b. Cracks in front and rear elevations. (Confidential Source, 2015).

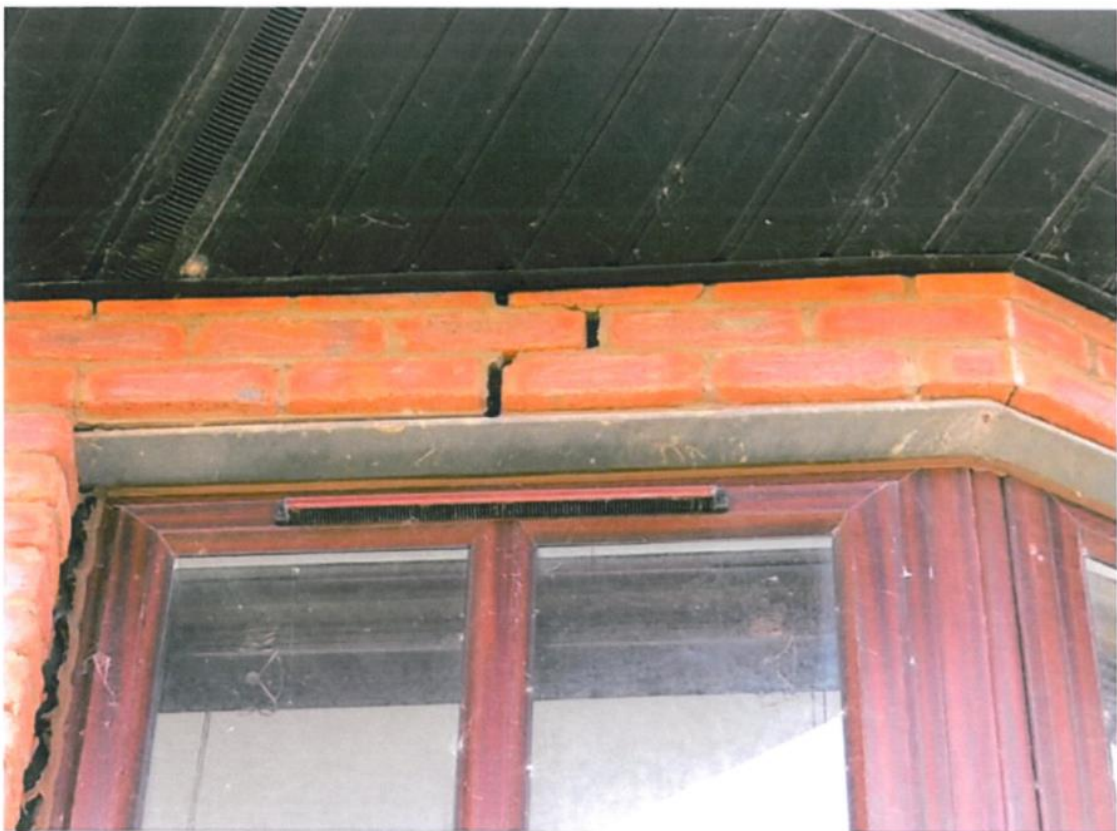
Fig 3.5.32.c. Front elevation – cracking over upper floor window. (Confidential Source, 2015).
