O'Kelly B.C., Ward P.N. and Raybould M.J. 2008. Slope stabilization of an embankment on the West Coast Main Line, UK. *Proceedings, First International Conference on Transportation Geotechnics, 25th–27th August, Nottingham, UK*. Vol. 1, pp. 335 – 341.

## Slope stabilization of an embankment on the West Coast Main Line, UK

**ABSTRACT:** A site inspection of an embankment on the West Coast Main Line (UK) revealed a general deterioration of the embankment, significant movement of the trackside services and waterlogging and bulging along the embankment toe. The medium-height embankment, with side slopes at about 30 degrees to the horizontal, was constructed on natural sidelong ground and the site had been an area of previous instability (former ash and slag tip). Site investigation, ground monitoring and analytical modelling indicated that the embankment was at limiting equilibrium and that recent progressive movement was occurring along a rotational slip surface located within the embankment core (ash and slag materials overlying reworked glacial till). The upgrade works comprised the installation of a row of stabilizing piles along the mid-height of the embankment side slope (facil

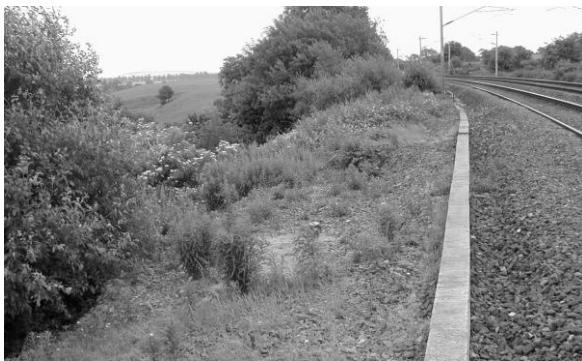
The embankment has an overall length of about 300 m and had been constructed on natural sidelong ground, which generally sloped in a north eastward direction. The embankment slope on the Up-line side was up to 13 m in height whereas the side slope on the Down-line side was less than 4 m in height (typically between 2 and 3 m). The side slopes were densely vegetated with grass, shrubs and mixed wood (Figure 3).

Figure 3. View southwards along Up-line slope.

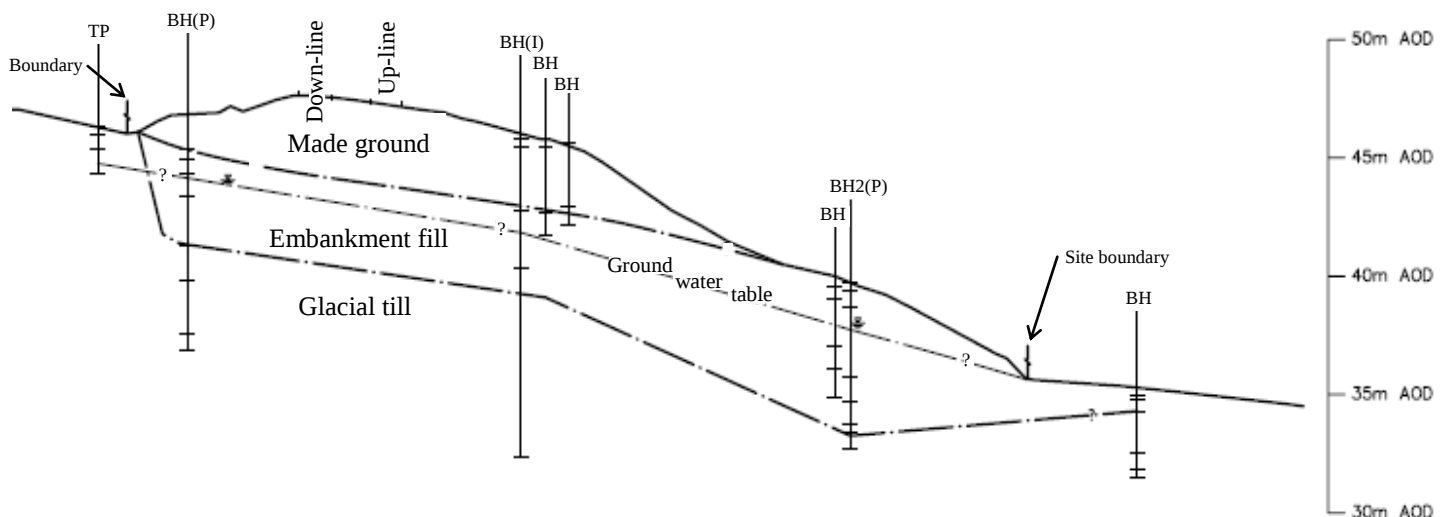
Figure 4. Geological profile at section AA in Figure 1. Note: BH, borehole; TP, trial pit; (P), includes piezometer.

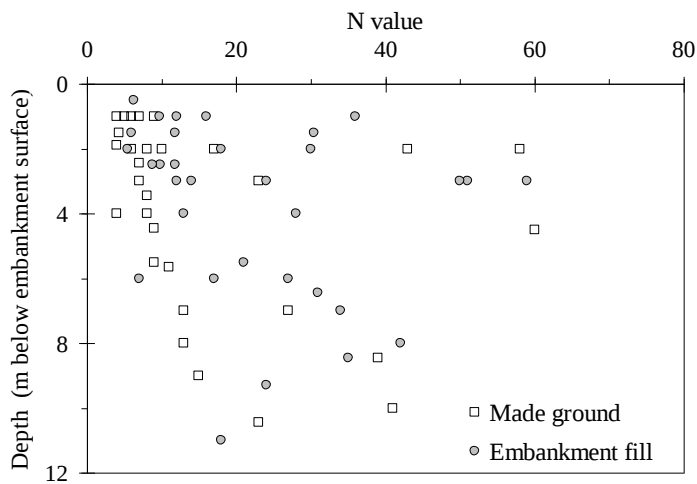
Figure 5. Standard Penetration test data.

The lower section of the embankment was most likely constructed using locally-sourced glacial till material. The soils are generally of low plasticity and the SPT N-blow values (Figure 5) indicated frequent loose zones present.

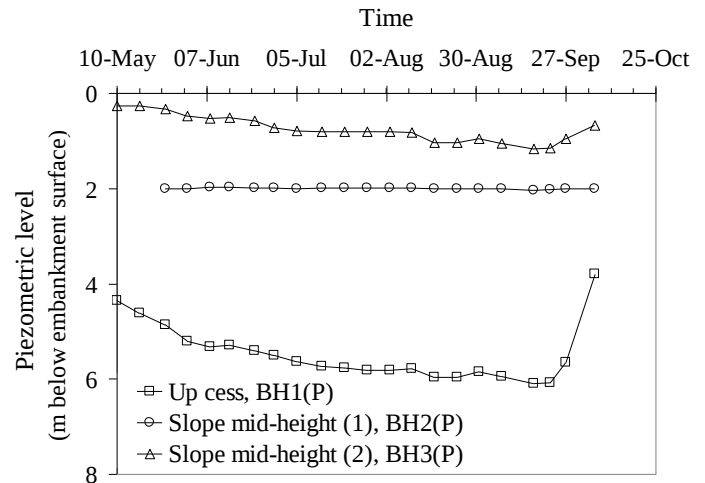
The data shown in Figure 6 indicated a relatively high groundwater table that fluctuated seasonally

(substantial rise in groundwater levels between September and October 2001). The groundwater table was generally located between 3.7 and 6.0 m below the embankment crest level (within the reworked glacial till material) and between 0.3 and 2.0 m below the mid-height of the slope face. The groundwater table was almost coincident with the ground surface at the embankment toe. However, no seepage had been observed from the slope face itself.

Figure 6. Groundwater levels within the embankment core.

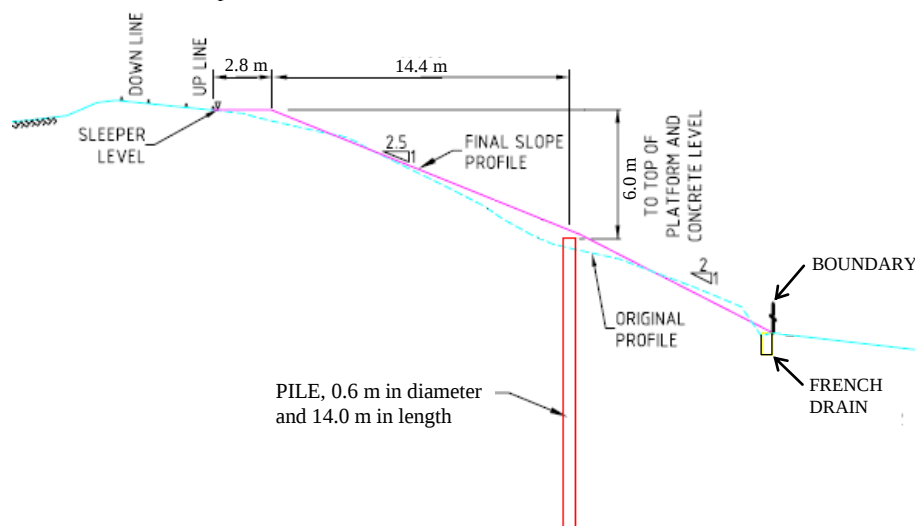
Figure 7. Upgraded embankment.

The upgrade works comprised the construction of an embedded pile retaining wall (shear dowels) along the mid-height of the Up-line embankment slope, the re-grading of the slope face and the construction of a toe drain (Figure 7). The embankment slope was regraded to one vertical in 2.5 horizontal above the new retaining wall and to one vertical in 2.0 horizontal below. In addition, a 2.8 m wide cess walkway and shoulder were constructed along the Up-line. The upgrade works used best practice measures, through a process of value engineering, to reduce the hazard of further slope movement that would affect the rail track.

A row of reinforced-concrete piles (46 number in total) were installed through the full depth of the embankment and penetrated the underlying stable ground, thereby preventing further lateral slope movement and reducing future movements at the track-bed level. The location of the piles at the slope mid-height was the most efficient and caused the least disruption to rail operations (clear spacing of 17.2 m between the pile row and the nearest Up-line rail). The re-grading of the upper slope reduced the

risk of shallower rotational slips, which had occurred near the embankment crest, and the possibility of lateral spreading of the track-bed material. The construction of the toe drain with outfall to Gill Beck stream reduced the high groundwater table/water-logging near the embankment toe.

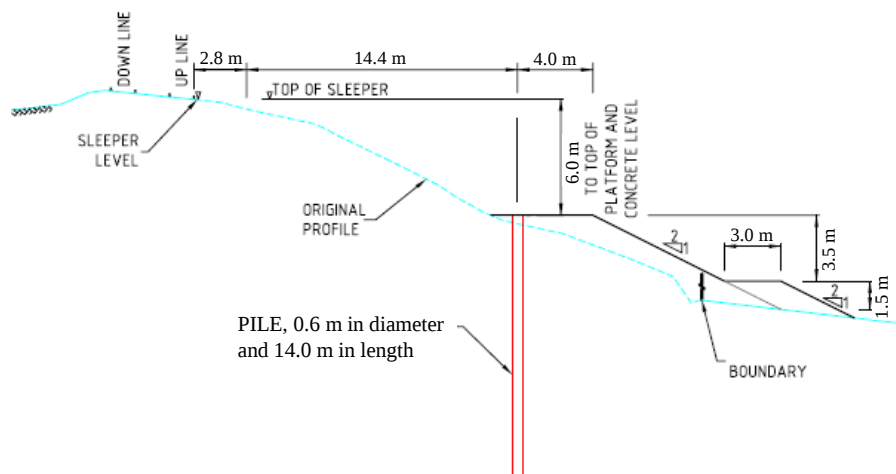
Figure 8. Temporary works.

A temporary haul road was constructed to access the base of the slope, which had been cleared of all vegetation. Then a piling platform up to 5.0 m in width was constructed along the length of the upgrade works (70 m in overall length between 63 mls 1534 yds and 63 mls 1610 yds) at the mid-height of the embankment slope (Figure 8). The platform was constructed using granular fill, progressively benching into the lower embankment slope to reach a distance of 1.3 m above the pile cut-off level. The benches were excavated in bays (typically 5.0 m in length, 600 mm in height and with a slope angle of about 60° to the horizontal) parallel to the track.
