# **Stabilisation of Stanton Lees Landslip using Pile Retaining Wall Solution**

## **Abstract**

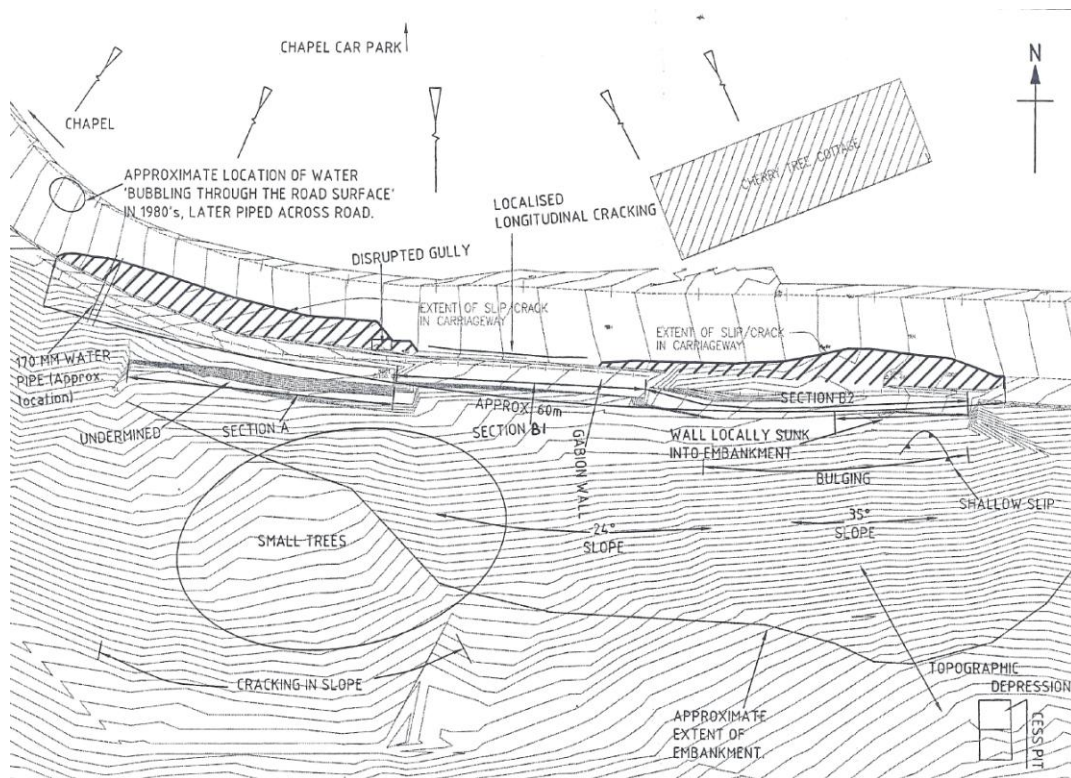
**Fig. 1. Main Features of the Landslip**

The embankment, constructed between 1955 and 1962, is located in front of Cherry Tree cottage and, in plan, is about 90 m in length (Fig. 1). The hillside is characterised by pronounced undulations extending from the foot of the gritstone crags behind Stanton Lees village (Stanton Moor Edge) to Hillcarr Farm at an elevation of about 120 mAOD. Springs discharge off the hillside to the relatively level ground behind Lees Road to the north of the landslide before percolating underground as groundwater flow.

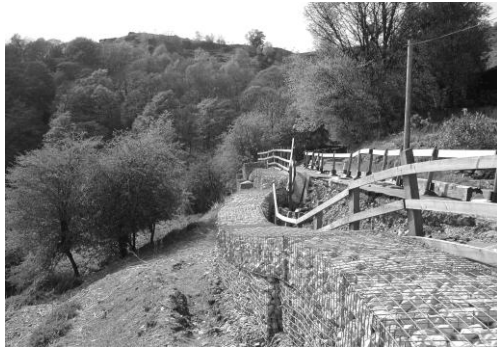
The landslip occurred on the down-slope side of the single-carriageway road located between Cherry Tree cottage and the chapel. The road, which falls in elevation by about 4 m between the chapel and the cottage, had a longstanding problem of instability. The slip was reactivated in November 2002, and over the following period of 14 months, the southern half of the road had settled locally by up to 1.5 m along an affected length of about 60 m and had caused outward destabilising movement of the gabion wall by as much as 1.0 m, Fig. 2.

(a) Down-slope movement of existing gabion wall

The embankment slope supporting the existing gabion wall probably slipped under conditions of elevated groundwater following heavy and prolonged rainfall. The movement of the slope undermined the wall resulting in its outward and downward movements. The slip surface daylighted immediately beneath or behind the gabion wall, with the subsequent forward movement of the wall resulting in the collapse of the soft and loose backfill behind the wall and the consequent collapse of the road. The forward movement of this fill further contributed to the loading of the head of the slip. It is likely that the forward movement of the wall exaggerated the eccentricity of the loading conditions on the wall resulting in bearing capacity failure.

The remedial works involved replacing the existing gabion wall with a cantilevered bored pile retaining wall. Variations on the retaining wall theme that involved the construction of a retaining wall at mid-height or at the toe of the embankment slope were also considered but practical difficulties in establishing plant on or at the foot of the slope were considered too difficult to overcome. All construction was required to occur from road level to avoid placing plant or temporary works on the slope that could lead to its further destabilisation. An anchored bored pile wall solution was ruled out due to issues surrounding the placement of anchors beneath property adjacent to the site (required anchor lengths of 8–10 m would have reached beneath Cherry Tree cottage and its garden).

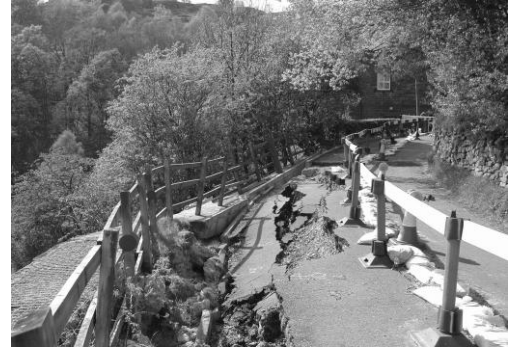
(b) Collapse of road pavement

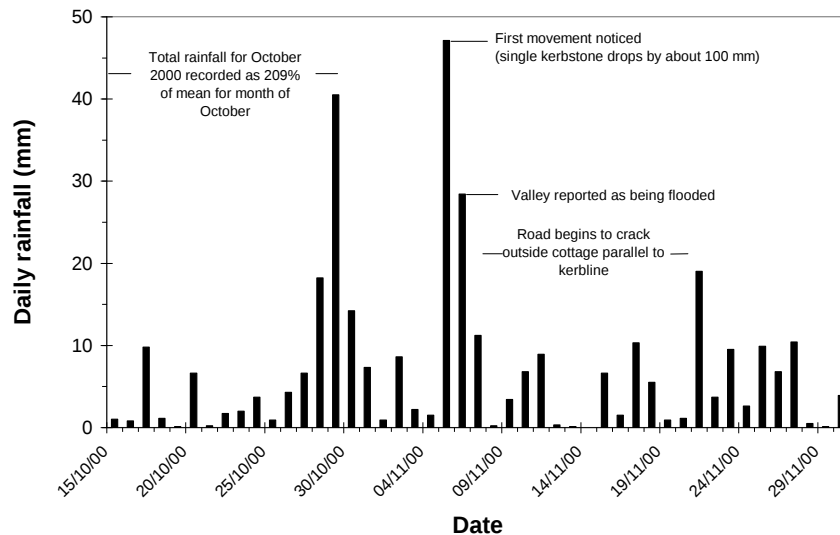
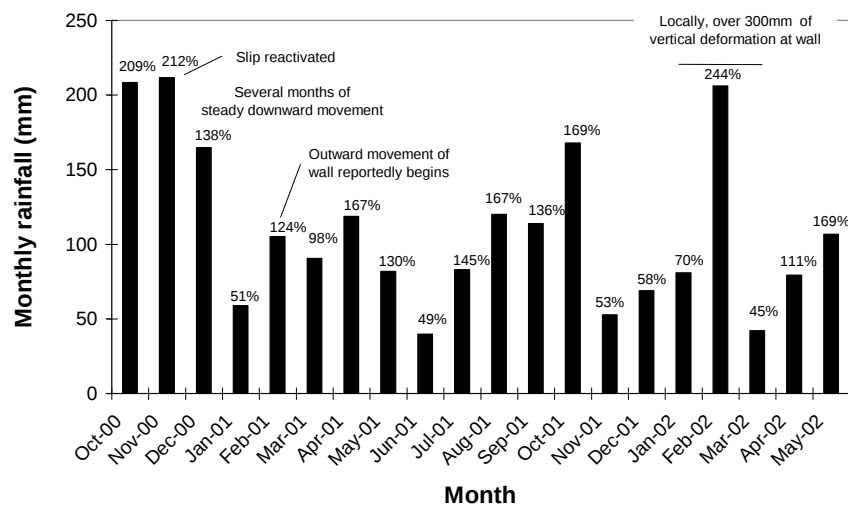
(a) Daily data (15th October–30th November 2000)

(b) Monthly data (Oct. 2000–May 2002). Note: figures relate to percent typical monthly rainfall  
**Fig. 3. Rainfall Intensity Recorded at Middleton, Derbyshire, UK**

On 5<sup>th</sup> November 2000, 47 mm of rainfall was recorded at Middleton with a further 28 mm recorded the following day. Heavy rainfall preceded the 5<sup>th</sup> November event with October 2000 yielding 209% of the mean monthly rainfall for that month (as recorded over the preceding 30 years). Rainfall for the month of October 2000 was the second wettest since 1870 (the wettest being in 1998), while November 2000 was the wettest since 1951. Autumn 2000 was the wettest season since local records began in 1870, as reported by the Met Office.

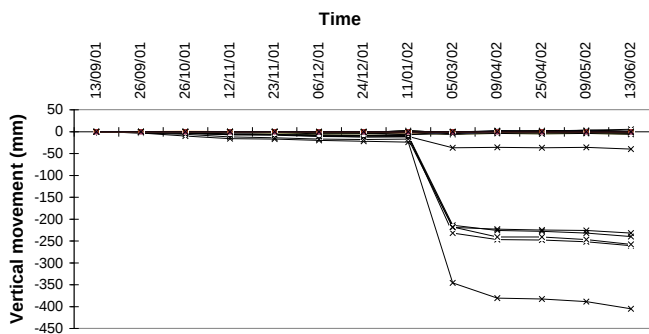
**Fig. 4. Vertical Movements for Survey Points at Road Level**

Figure 4 shows the most substantial movement was recorded in front of Cherry Tree cottage and at points located on the retaining wall, and within the sunken road at the western part of the slip. Half of the movement took place between 1<sup>st</sup> January and 5<sup>th</sup> March 2002, which coincides with the high total rainfall figures recorded at Middleton (i.e. 200 mm for the month of February alone). The survey points located on the northern side of the road showed no significant signs of either vertical or horizontal movements with any recorded movements well within the survey error of  $\pm 4$ –5 mm.

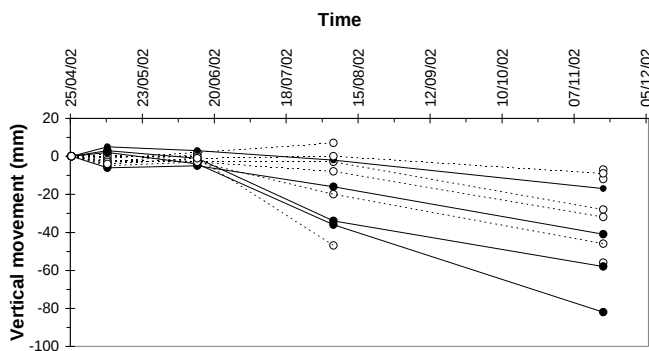
Several pegs located on the embankment moved down-slope by up to 80 mm indicating an underlying trend related to a developing landslide. The most significant down-slope movements were recorded at the embankment crest, Fig. 5.

**Fig. 5. Vertical Movement for Survey Pegs Below Slip.** Note: solid lines and symbols indicate points located along the embankment crest.

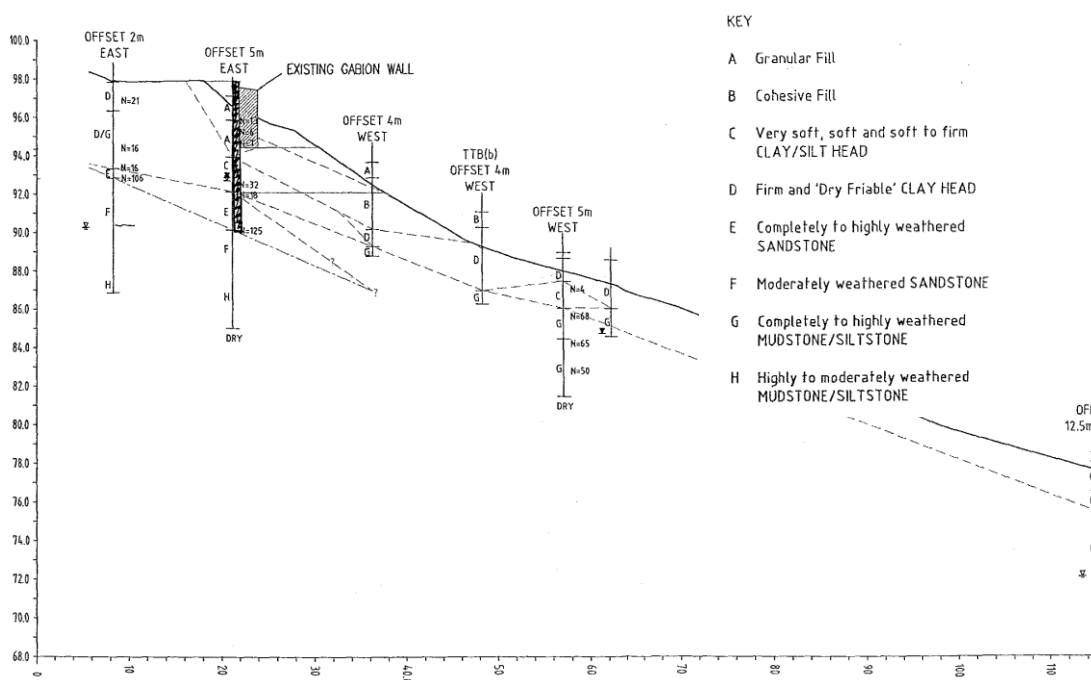
Fig. 6. Geological Cross-Section through the Site

The most adverse ground conditions with respect to slope stability were identified passing through the embankment slope in front of Cherry Tree cottage (Fig. 6). This section had the steepest embankment profile, the greatest thickness of superficial deposits overlying bedrock and the maximum wall deformation, with the slope at the limiting equilibrium condition. Very soft to firm Head and embankment fill materials were present beneath the site. Localised softening occurred due to seepage from the underlying sandstone and mudstone or possibly seepage from redundant water mains beneath the road. Minor shear surfaces of limited persistence were recorded in some of the trial pits immediately below the interface between the Head material and the completely weathered mudstone.

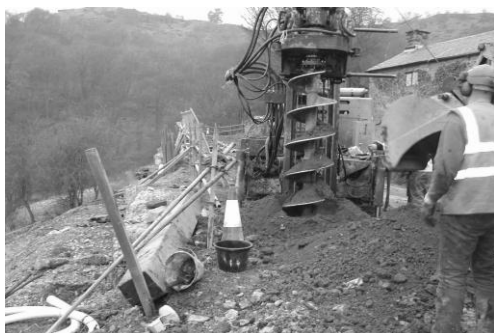
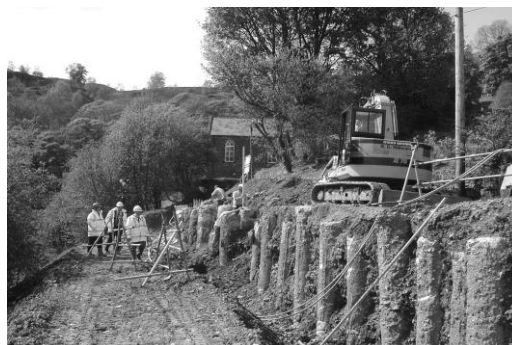
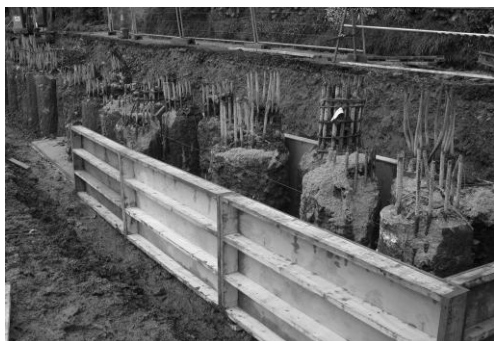
**Fig. 7. Construction of Bored Pile Retaining Wall**

(a) Lightweight auguring rig

(b) Outermost row of piles

(c) Placement of formwork for construction of capping beam

The design required two rows of 600-mm diameter bored piles (86 in total) installed along the southern verge of the road. The locations of the piles were staggered in plan arrangement with a clear spacing of 1.0–1.7 pile diameters between the individual piles (Fig. 7) which had the added benefit of allowing the free passage of groundwater, as compared against a contiguous wall solution. The piles, ranging from 8.0–13.5 m in length, were founded within the underlying mudstone and sandstone bedrock. At these embedment depths, the full active and net available passive earth pressures reach equilibrium so that overturning of the wall was prevented. To allow for the adverse combination of sub-vertical and sub-horizontal fracturing in the bedrock, the embedment depths were increased above the values calculated from the *WALLAP* analysis.
