## **Weathering and consolidation trials on sandstones used in Irish monuments**

**Dr. Paul KISSANE<sup>1</sup>, Dr. Sara PAVÍA<sup>2</sup>**

### **Abstract**

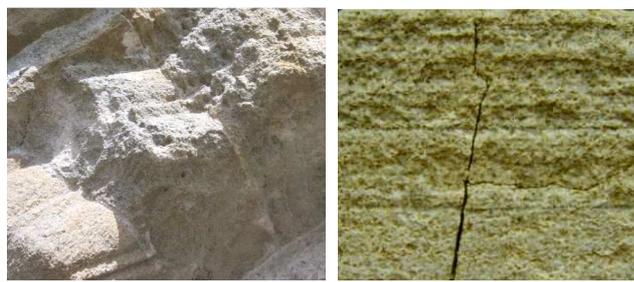
The Drumbane sandstone in the west side of Cormac's Chapel is exposed to the prevailing south-westerly wind and rain, resulting in differential erosion, as shown in Figure 1. The sheltered east side is damp, resulting in a blistered surface that is flaking, as shown in Figure 2.

Fig. 1 Differential erosion, Drumbane sandstone

The other decay types – flaking, granular disintegration and differential erosion – also reflect the response of combinations of cementation and constituent packing to weathering. In this instance, flaking is limited to the outermost surface and involves the loss of cohesion from grains that are coming away from the stone but remain connected to each other (more localised concentrated loss of cohesion), while granular disintegration can progress deeper because it is due to total loss of cohesion between individual grains. Differential erosion is evident where locally weaker material is removed from the surface (Pavía & Bolton 2002).

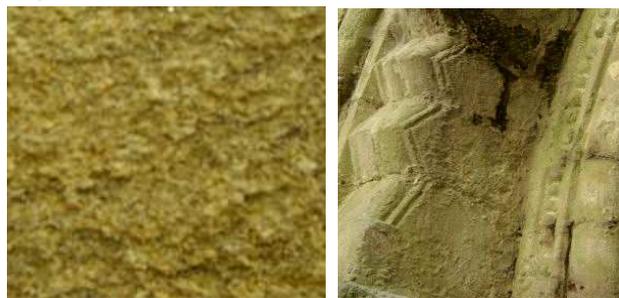
Fig. 2 Flaking, Drumbane sandstone

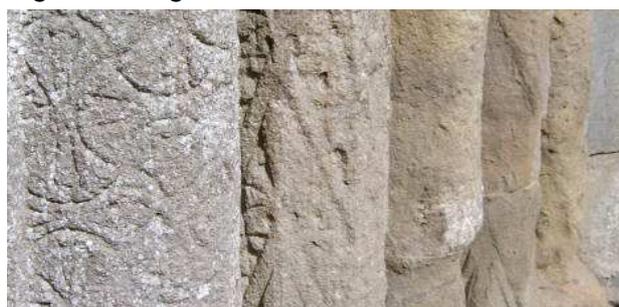
The Killaloe sandstone in the doorway of St. Brendan's cathedral has been exposed to high moisture and salt contents for so long that the highly strong and durable stone has become weak and friable. The granular disintegration responsible for the current appearance of the stone was only minutely evident in the samples weathered in the laboratory, as shown in Figure 3.

Fig. 3 Granular disintegration, Killaloe sandstone
