*In: 'Proceedings of International Seminar Theory and Practice in Conservation- a tribute to Cesare Brandi'. May 2006. Eds. J. Delgado Rodrigues and J. M. Mimoso. Laboratorio Nacional de Engenharia Civil, Lisboa, pp. 493-500.*

## **Lime mortars for masonry repair: Analytical science and laboratory testing versus practical experience.**

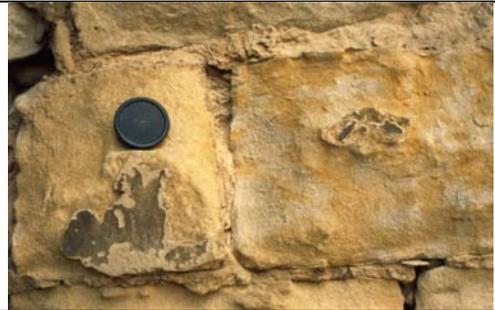
Figure 9- Masonry damage enhanced by mixing permeable sandstone with impermeable OPC mortar. Abalos Church, La Rioja, Spain.

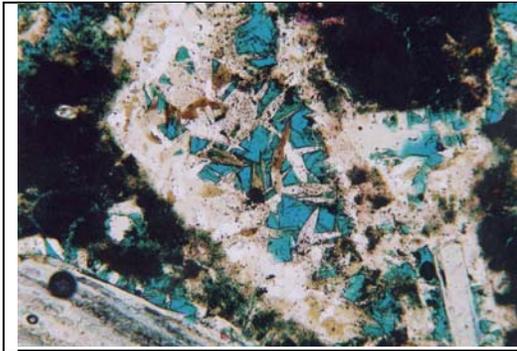
Figure 10- Gypsum originating from atmospheric pollution in a lime mortar pointing Dublin's Medieval City wall. 10X. Polarised light.

Mortar sulphation by atmospheric sulphur emissions also causes strong damage to lime mortars. An example of this is shown in Figure 10. However, this decay process is difficult to avoid in urban areas, as pollution due to atmospheric emissions is rising continuously.
