Compatibility test to find a mortar repair for Portland Limestone

Marwa Aly¹ and Sara Pavia²

Abstract This is part of a more comprehensive investigation which aimed at finding a suitable mortar to repair Portland limestone in historic Irish buildings. Mortars were designed using four binders which included natural hydraulic limes (NHL 2, NHL 3 and NHL5) and hydrated lime (CL90s); siliceous and limestone aggregate in different proportions and several additions (Portland stone dust-PSD-, ground granulated blastfurnace slag –GGBS-, Metakaolin and rice husk ash-RHA). Properties including compressive, flexural and bond strength, open porosity, water absorption, water vapour permeability, capillary suction and bulk density were investigated. According to the results, NHL5 mixes with GGBS and PSD were selected for the compatibility test, which is designed to determine the compatibility and durability of renders. This test was selected based on a preliminary investigation as the mortar would have to be applied as a render to repair the Portland stone weathered and lost over time. The compatibility test includes freeze thaw cycling, adhesion strength and water permeability. It was deemed

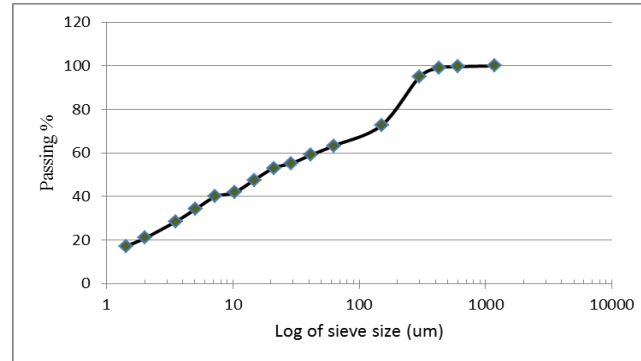
Fig. 3 Particle size distribution of Portland stone dust.

Portland stone dust (PSD) was obtained by grinding Portland stone aggregate. The PSD consists mainly of calcite ($CaCO_3$), with traces of silica in the form of quartz (SiO_2). The particle size distribution of the dust is included in figure 3. Base-bed Portland stone slabs (400x400x40 mm) quarried in the UK were used for the compatibility test. The mechanical and hygric properties of the stone as reported by the supplier and tested in our laboratories are included in Table 3.

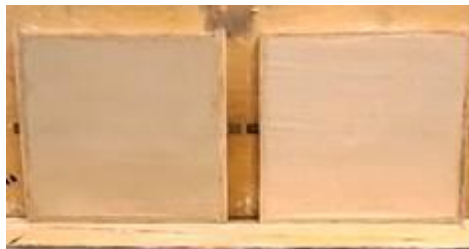
Fig. 4 Portland stone slabs rendered with 10 mm mortars in table 4.

The lime, additives and aggregate were dry mixed for 2 min. Water was added to achieve a 165 ± 5 mm initial flow diameter and mixed for 2 min at low speed and finally at high speed for 1 min. A 10mm thick mortar coat was applied on the Portland stone slabs ($400 \times 400 \times 40$ mm) (Fig. 6). The slabs were then covered with damp hessian and kept for 28 days at $20 \pm 2^\circ\text{C}$ temperature. The mortar were cured and stored according to EN 459-2.

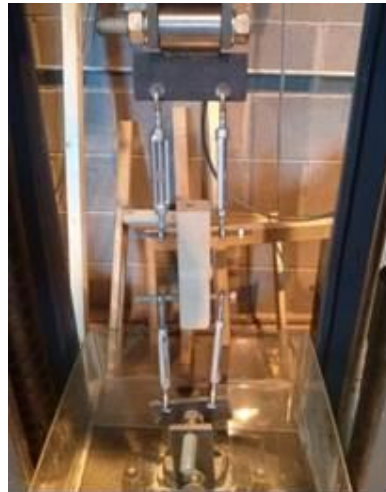
Fig. 5 Set up of pull-out test to measure bond strength between Portland stone and mortar.

Physical and mechanical properties of the mortars. The properties measured were compressive (EN 1015-11:1999), flexural strength (EN 1015-11:1999), water retention (EN 459-2: 2010), water absorption, porosity (RILEM 1980), bulk density (RILEM 1980), capillary suction (EN 1925) and vapour permeability (EN 1015-19). The mortar bond strength was measured in stone-mortar specimens using pull-out tests (Fig. 5) as described in (Maravelaki-Kalaitzaki et al., 2013). This test is designed to measure the direct tensile strength of the interface rather than the shear strength of the interface in conventional pull off tests. In order to avoid shear force, a hole was drilled in the stone pieces sandwiching the mortar and the sample pulled apart through pins inserted in the holes, Figure 5. The results reported are the arithmetic mean of 3-6 tests with their coefficients of variation.

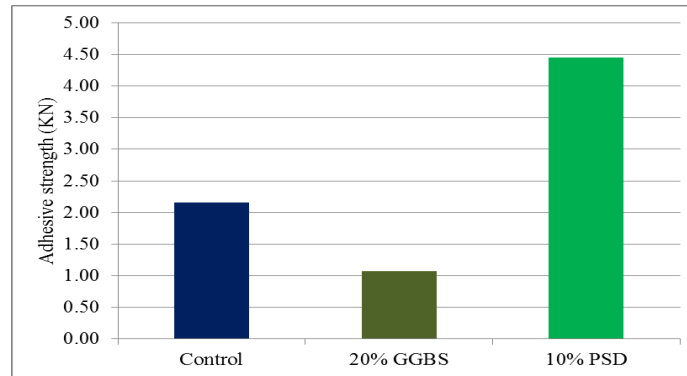
Fig. 16 Adhesive strength according to EN 1015-12.

The Portland stone dust greatly improves the adhesion of the NHL5 mortar to the Portland limestone substrate (more than doubles it)-Figure 14. This agrees with the SEM analysis which evidenced CaCO_3 and hydrates completely covering the dust and the aggregate thus providing internal cohesion to the material. The drastic change in the nature of hydrates brought about by the Portland stone dust (Figures 8-11) may have also contributed to the enhanced bond.

The NHL5 mortar with 20%GGBS shows c.50% decrease in adhesive strength compared to control mortar. This mortar showed the highest mechanical strength at all ages therefore the lower adhesion can be due to weathering during cycling or testing inconsistencies e.g when drilling the cores.
