Role of Geotechnics in Peatland Restoration and Management

Dr. Brendan C. O'Kelly

FIELD CASE STUDY — *Raheenmore raised bog, County Offaly, Ireland*

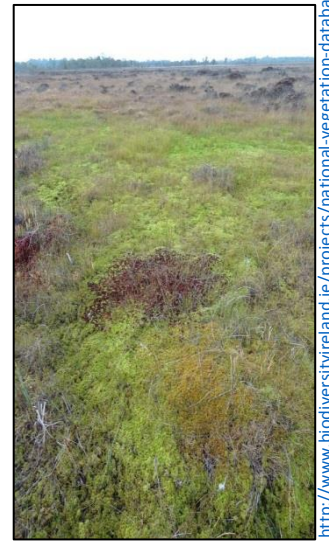
Sphagnum mosses, key species in *acrotelm* (upper) layer for active raised bogs

- health depends on availability of sufficient rainwater
- growth becomes stunted when mean groundwater level drops about 10cm below ground surface and/or surface gradient increases >1:30

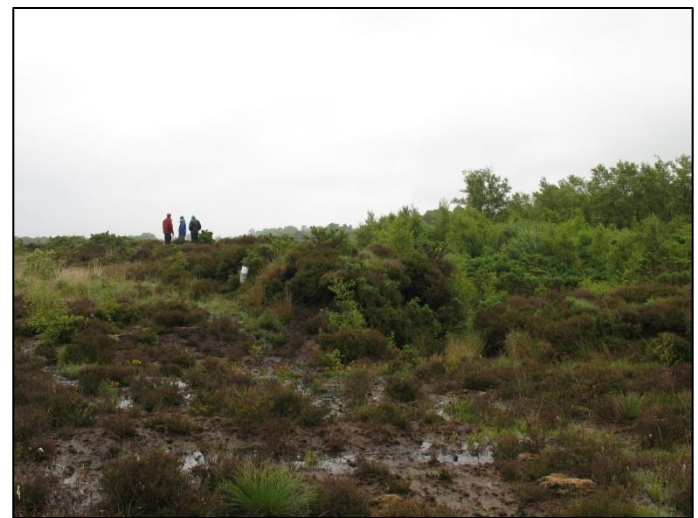
- Large-scale drainage and localized turf cutting for fuel, causes subsidence and ecological damage
- Oxidation of organic matter causes permanent material changes

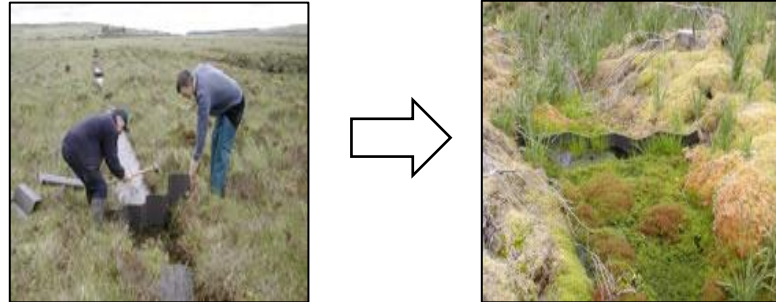
- Blocking existing drains

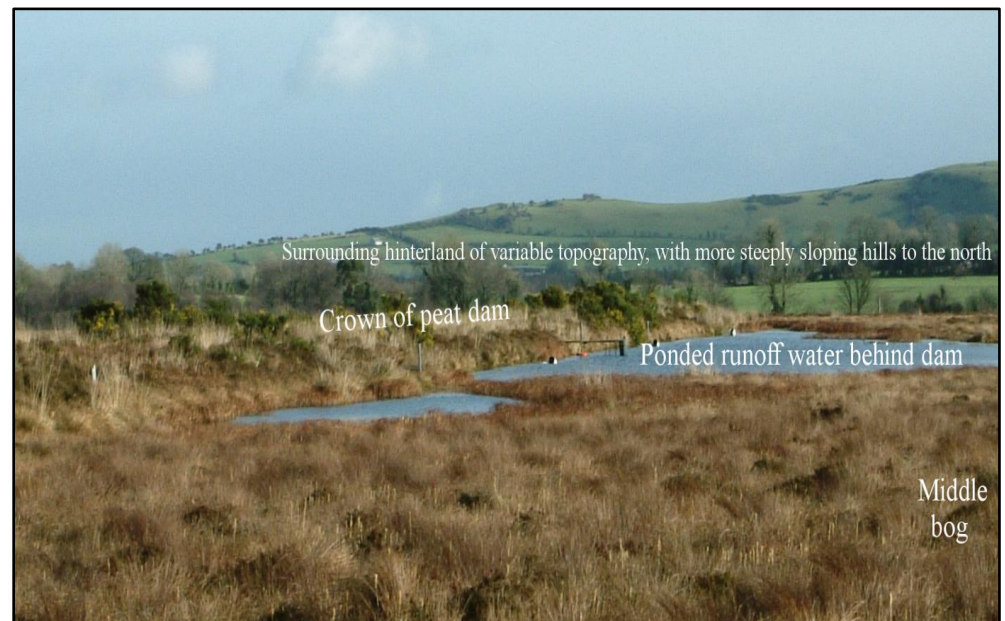
Photograph taken from high bog

3m-high peat dam constructed in 1997 retains 2.5m depth of ponded runoff water

Improved geotechnical design:

Reduced gradient of 1:4 for downside slope

High-density plastic membrane running from dam heel and keyed into underlying lacustrine clay layer

Shear key constructed between dam and underlying in-situ peat

— over six-year period following northern dam construction, affected bog surface had steadily risen by up to 1.0m and natural rejuvenation of indigenous *Sphagnum* mosses had begun to recolonize and infill along edges of ponded water
