M.Sc. in Geology, 2021.

Leona O'Connor

Development of a SEM-EDS method  
for quantifying free mica in  
building materials.

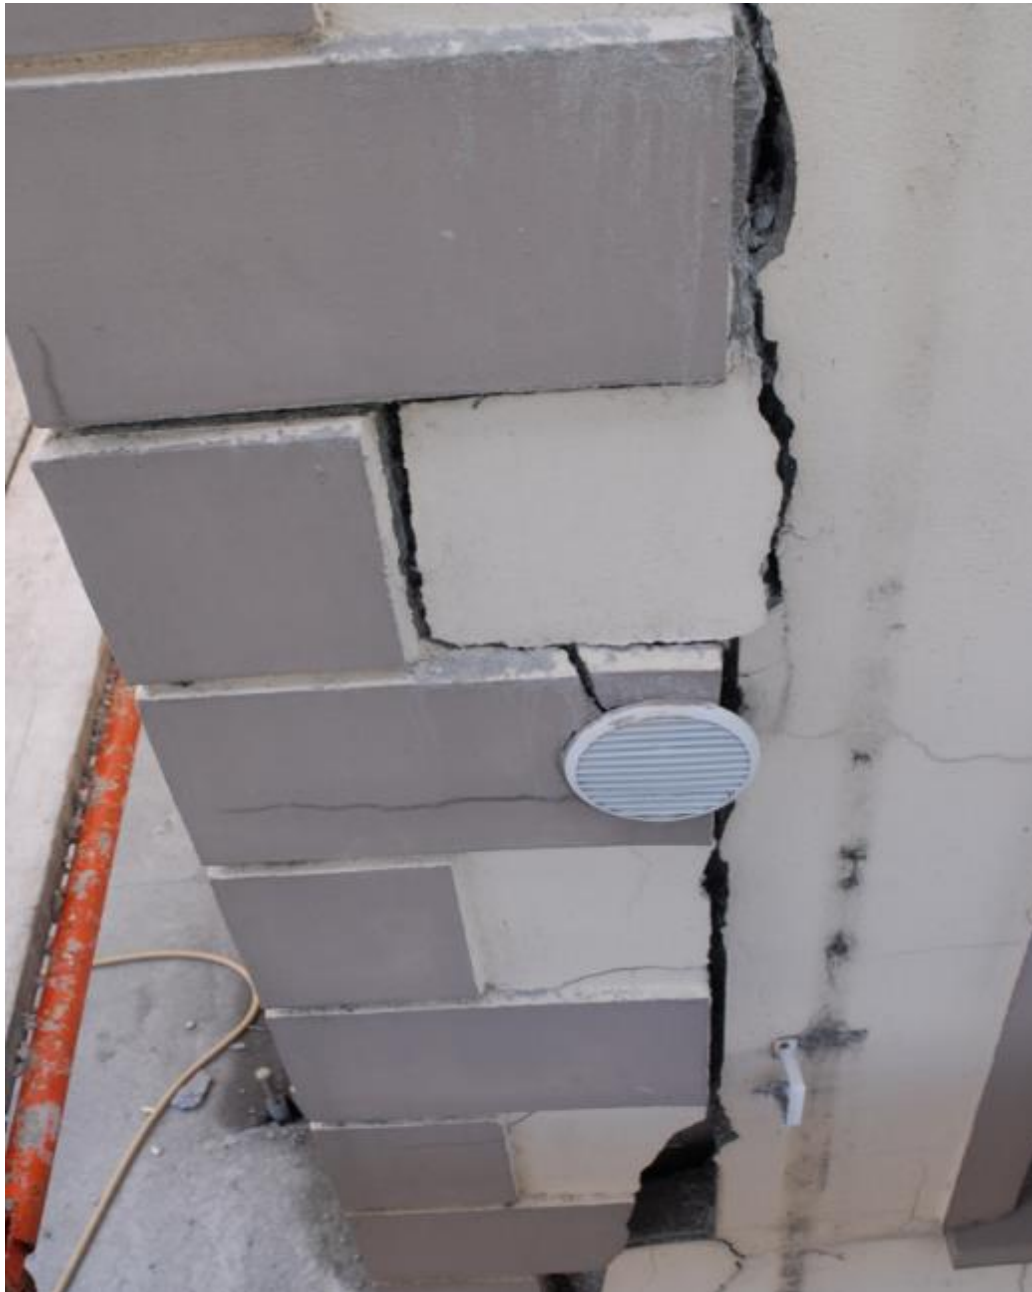
**Figure 2:** Severe vertical cracks in the gable end of a dwelling in County Donegal found to have high levels of mica in the concrete blocks used for its construction.

The Expert Panel observations, relating to the nature of the problem in Donegal, noted that dwellings exhibited a particular pattern of cracking of the outer render on the horizontal and vertical plane, with the most severe cracks appearing in the vertical axis near corners (see Fig. 2 & 3). Some dwellings experienced displaced window frames, limiting their use, related to the movement of the external outer leaf concrete blocks. The external walls directly exposed to the prevailing wind and rain were generally reported as having the worst structural distress and were where the problems were first noticed by some homeowners. In instances where the render had fallen off and the outer leaf concrete block was exposed, it was possible for the concrete blocks to be fragmented by hand. Other

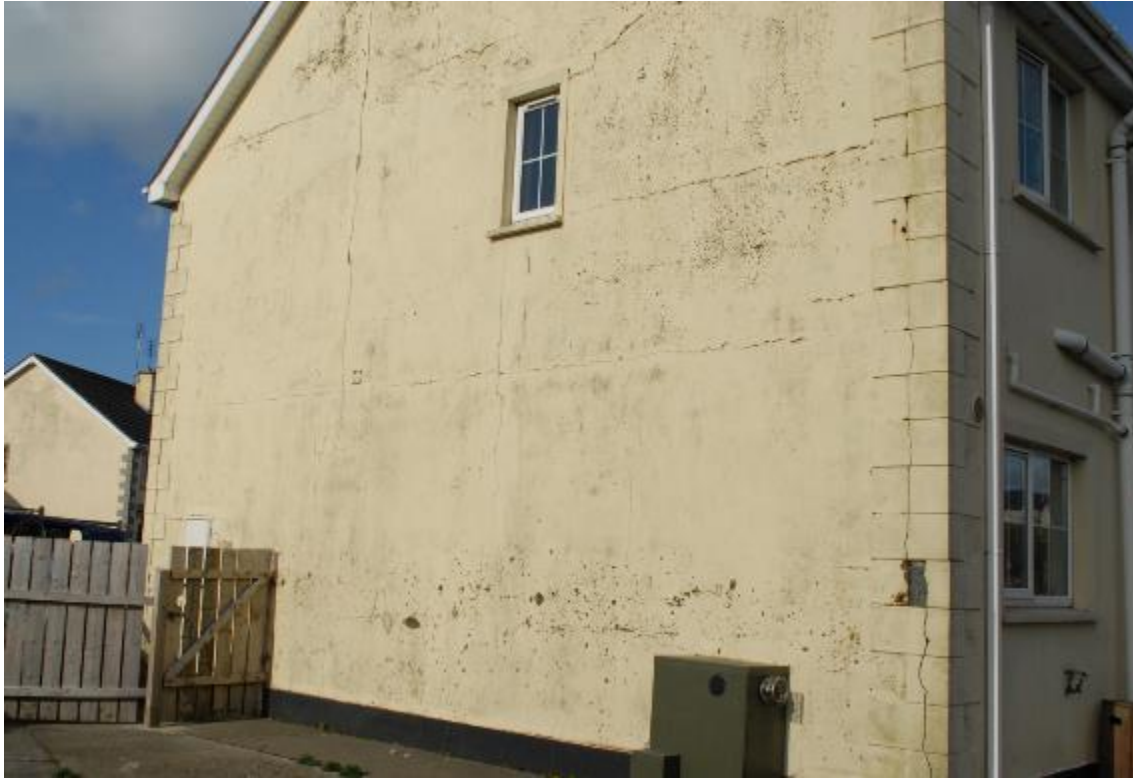
**Figure 3:** Gable end of a two storey semi-detached dwelling exhibiting the typical vertical and horizontal cracking pattern on the outer render, and a significant vertical crack through the quoin.
