# **Stabilisation of landslip using pile retaining wall solution**

Brendan O'Kelly (Trinity College Dublin)

BRI 2006  
12<sup>th</sup> October, Dublin

Stanton Lees, Derbyshire, UK

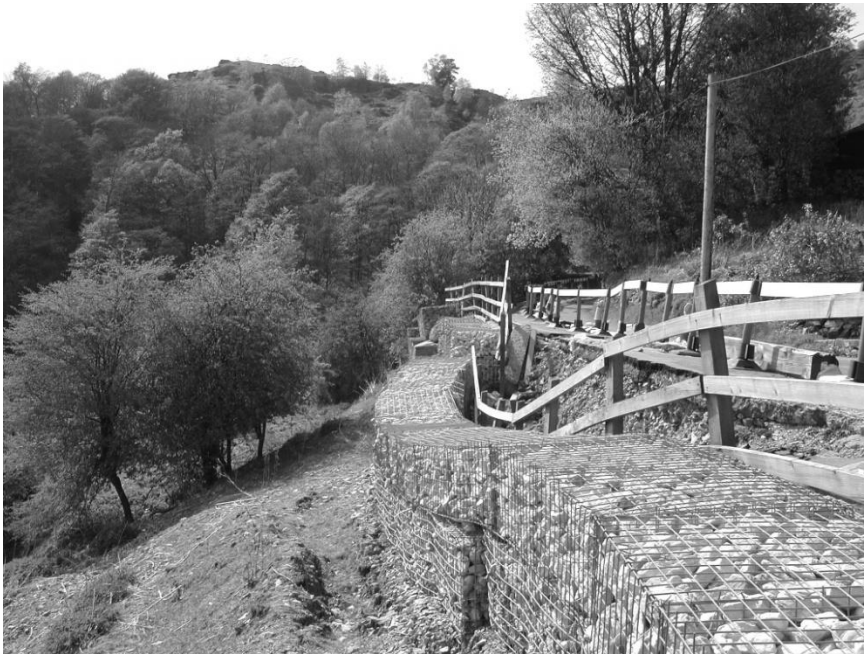
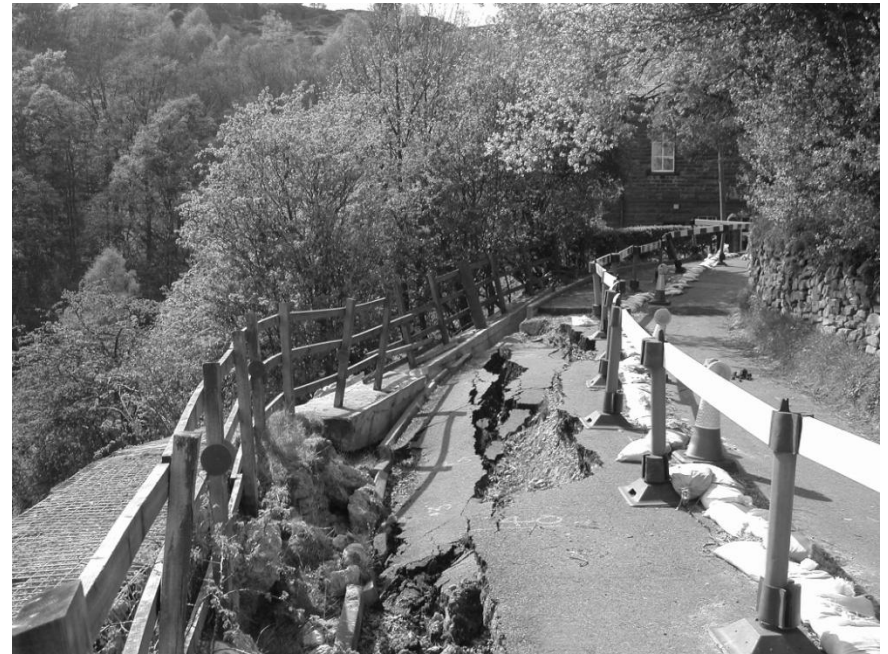
# Embankment supporting existing gabion retaining wall slipped 0.5–1.0 m

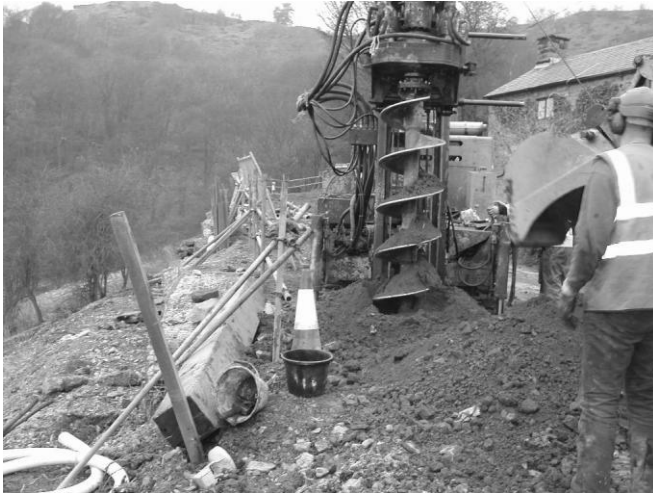
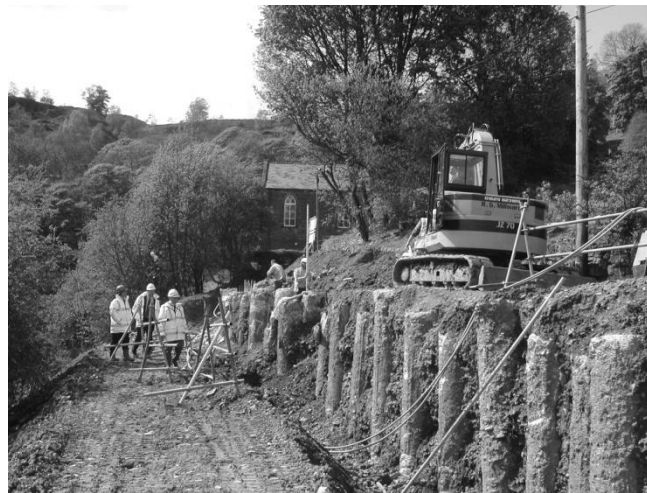
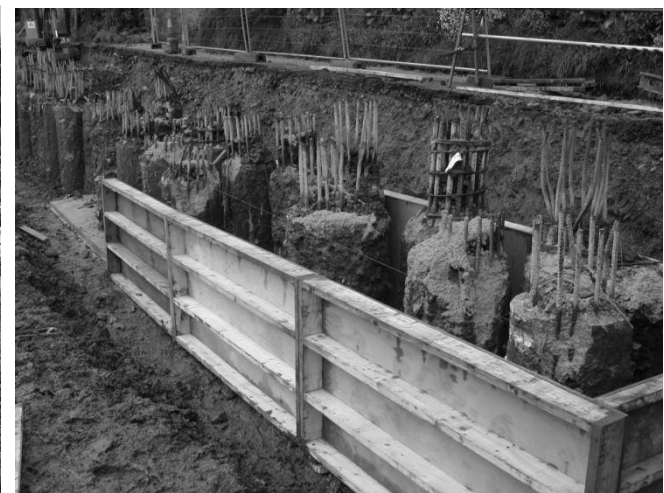
Two rows, 600-mm dia. bored piles (86 in total) installed along southern road verge  
staggered in plan, clear spacing 1.0–1.7 pile diameters, allows free passage of groundwater  
8.0–13.5 m in length, founded within underlying mudstone and sandstone bedrock  
reinforced-concrete capping beam connecting pile heads

25-tonne compact Bauer rig
