# **A Review of Structural Failures in Ireland**

Trinity College Dublin  
Department of Civil, Structural and Environmental  
Engineering

A Thesis submitted for the degree of Master of Science  
by

Ian James Duckenfield

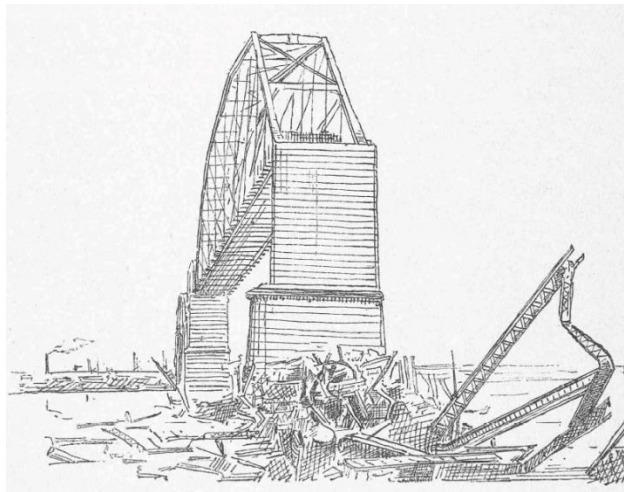
Fig 1.4.1 Collapse of Louisville Bridge (Elskes, 1894)

The analysis of each case is extremely perfunctory. For example, the collapse at Louisville gets a few lines in the text and only one word in the summary table – ouraga (or hurricane in English).

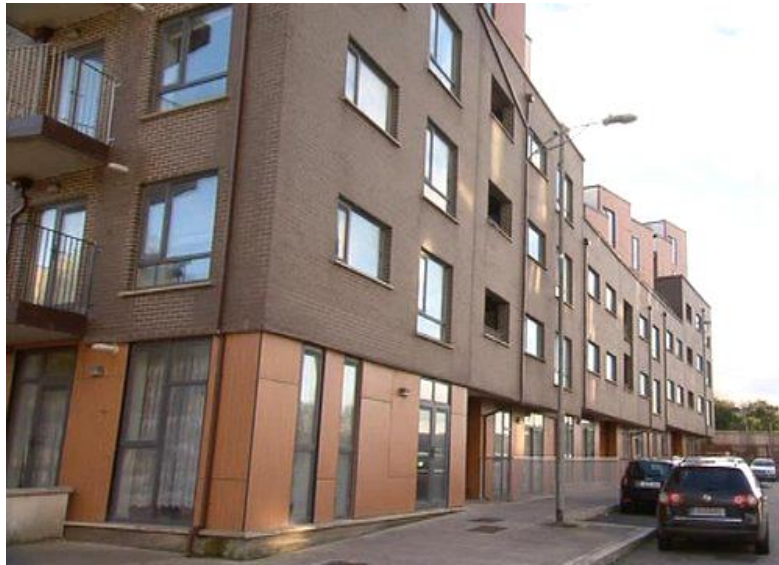
- problems with the gas installations
- problems with the electrical installations
- pyrite was found in the basement car park
- problems with the lifts
- problems with external wall panels

It transpired that around 80% of the owners were not covered by their insurance and that Local Authority inspections were grossly inadequate. This high profile case ended up in the Supreme Court. A deal was struck and ownership of the complex was transferred to the Local Authority (Dublin City Council) and residents no longer had mortgages for those properties. The human cost on the residents was appalling. Political pressure increased with the unfortunate suicide of a resident who was unable to handle his mounting debt together with living in a property described as unsafe. The Priory Hall story was seen as the worst example of Celtic Tiger construction with dreadful quality control (Irish Times, 2014).

Fig 2.2.2.a Priory Hall (completed 2007) (Northern Sound, 2013)

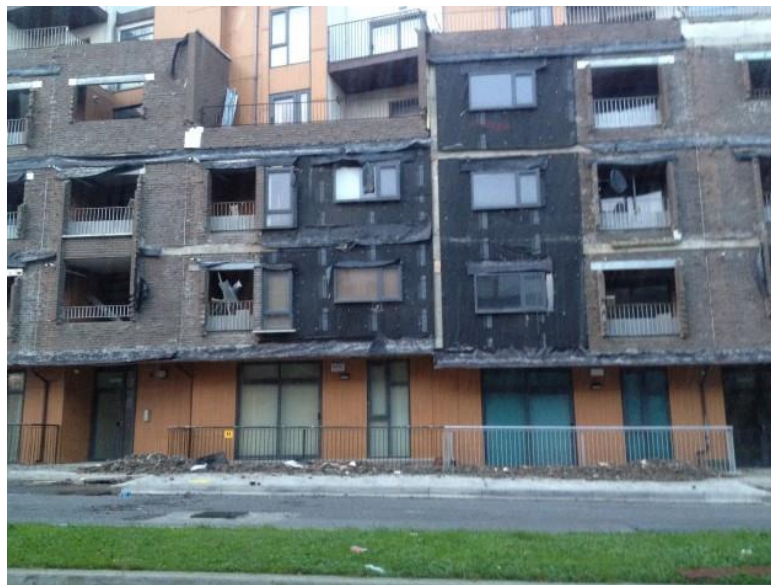
Fig 2.2.2.b Priory Hall (after investigation work) (TheJournal.ie, 2011)

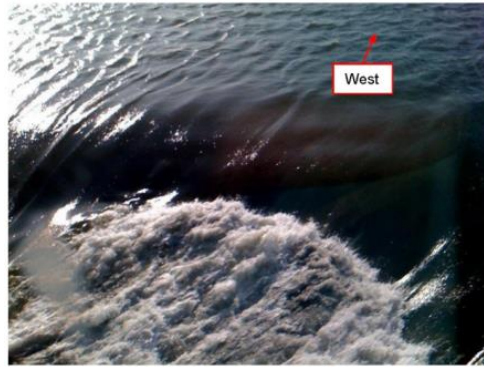
Early on the day of the collapse, a passenger on a train travelling over the viaduct noticed what he described as a whirlpool on one side of the viaduct. Returning over the viaduct later in the day and only 30 minutes before the collapse he again saw this whirlpool and photographed it. This photograph is reproduced in Figure 2.2.4.b.

Fig 2.2.4.b Photograph taken by a passenger only 30 minutes before the collapse. (Railway Accident Investigation Unit, 2010)

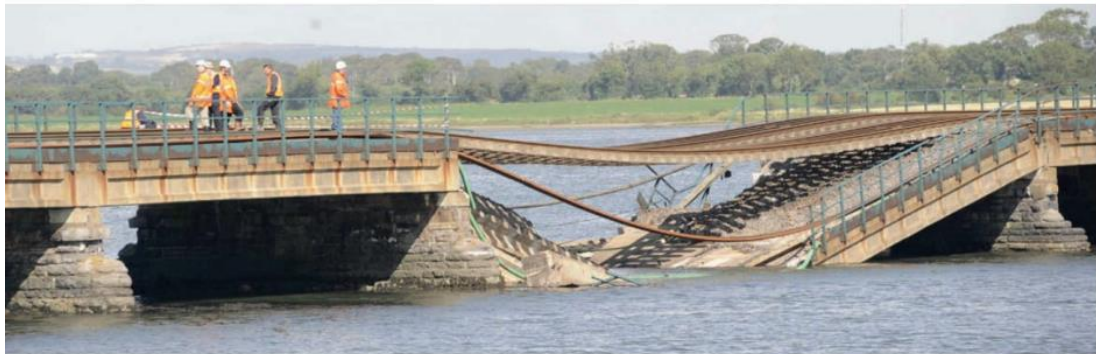
Only two minutes later, a train passed over the viaduct in the other direction. The driver noticed the viaduct beginning to collapse. The driver put his train into a “coast setting” and managed to reach the far side of the viaduct where he radioed the signalman who stopped all rail traffic. The collapsed section of the viaduct is shown on the two Figures below 2.2.4.c and d.

Fig 2.2.4.c The Viaduct after collapse (Institution of Structural Engineers 2012)

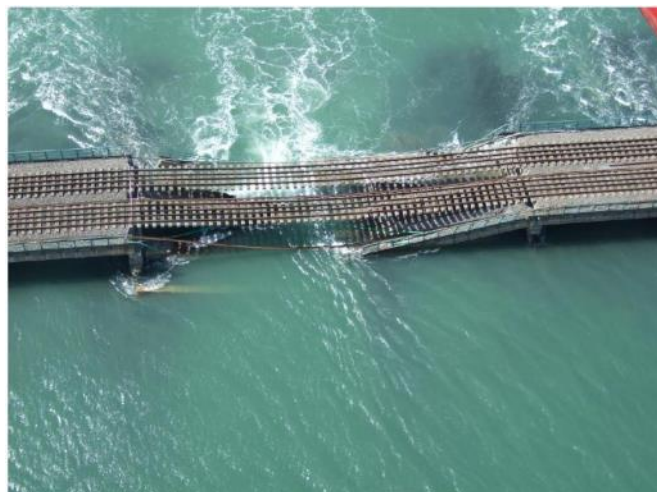
Fig 2.2.4.d Aerial view of the collapsed viaduct (Railway Accident Investigation Unit, 2010)

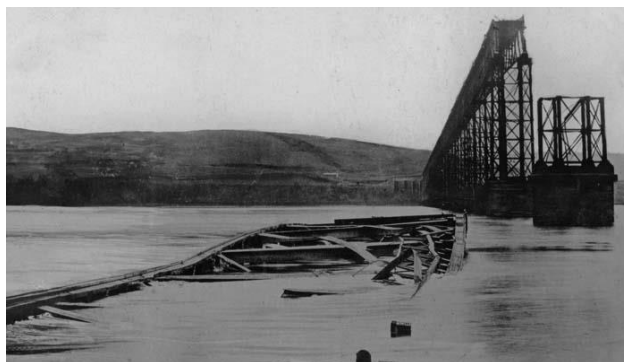
An express train travelling north to Aberdeen passed over the bridge and the bridge collapsed causing the train to fall into the water below. It was believed that there were around 74 or 75 people on the train. There were no survivors (HMSO, 1881). A Court of Inquiry was set up involving some of the leading bridge engineers of the day.

Fig 2.3.2.a Tay Bridge after collapse in 1879 (North British Railway Study Group 2016)

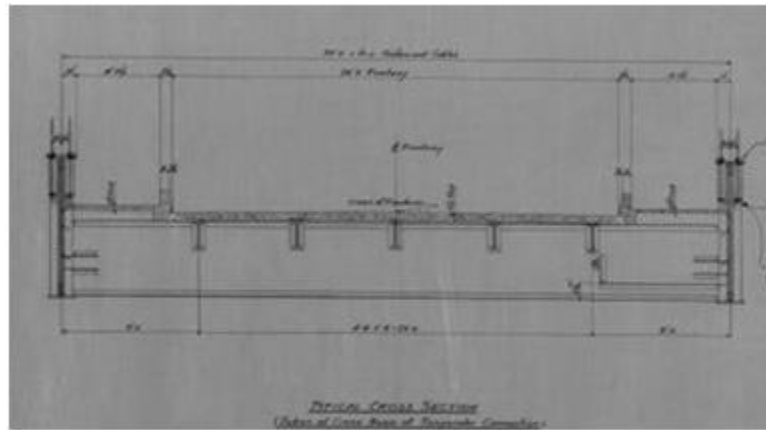
When it was completed and opened to the public in July 1940, the Tacoma Narrows Bridge had the third longest main span in the world. This suspension bridge is in Washington State on the west coast of America. Previous bridge designs with these very long spans had an open lattice type truss beneath the road deck level. The Tacoma Narrows Bridge was the first one of its type to have deep plate girders under the deck level (Washington State Department of Transportation, 2005). The cross section is shown in Fig 2.3.3.a.

Fig 2.3.3.a Typical section through bridge deck (The Tacoma Narrows Bridge Blueprints, 2016)  
(note the deep plate girder on either side)

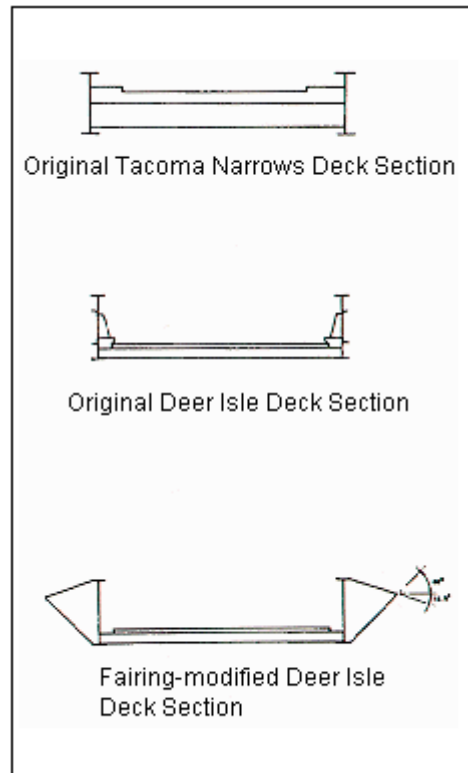
Fig 2.3.3.b Aerodynamic modifications to Deer Island Bridge (Federal Highway Administration, 1996)

Bridge. Fairings were added to the bridge to provide a more acceptable aerodynamic cross section (Federal Highway Administration, 1996). Refer to Fig 2.3.3.b below.

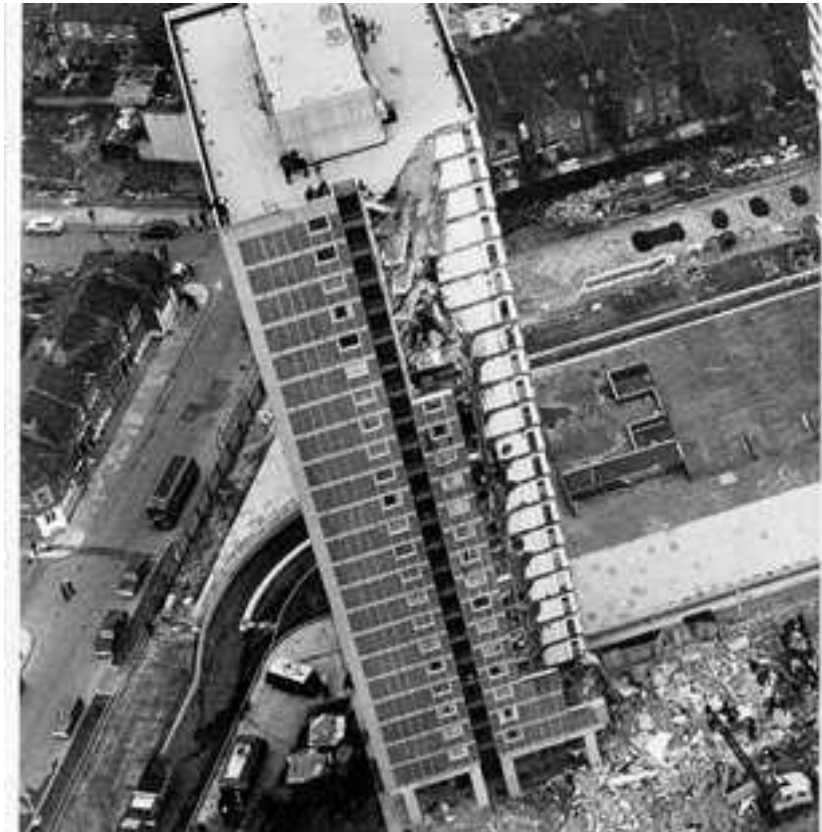
The explosion took place at around 05.45 and four people were killed. If the explosion had taken place a little later when a number of the kitchens in the corner of the building were occupied, then the death toll would probably have been higher. A view of the failed structure is shown in Fig 2.3.4.a below.

Fig 2.3.4.a Ronan Point (Historic England, 2016)

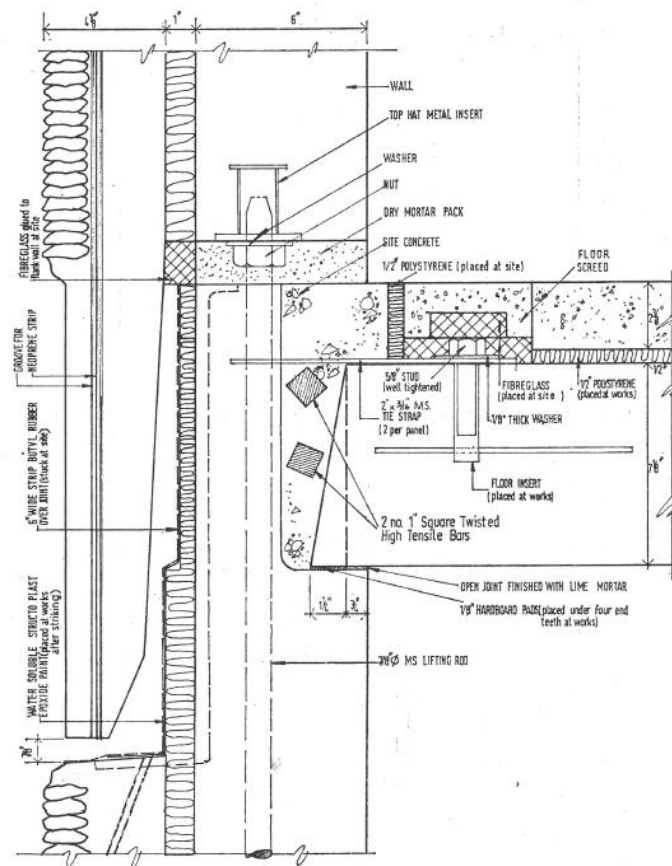
Fig 2.3.4.b Detail D showing the joint between the floor slab and the flank wall (HMSO, 1968).

It should be noted that there is only a 2 inch (50 mm) bearing of the concrete floor slab onto the load-bearing concrete element on which it sits. Although not clear in Detail D, the tie strap has an oval hole which has the advantage of easier construction but a potential flaw. The oval hole allows movement of the supporting wall before the restraining effect of the tie comes into play. The progressive collapse which completely demolished one corner of the building was made possible by what is now recognised as an inadequate tying arrangement.

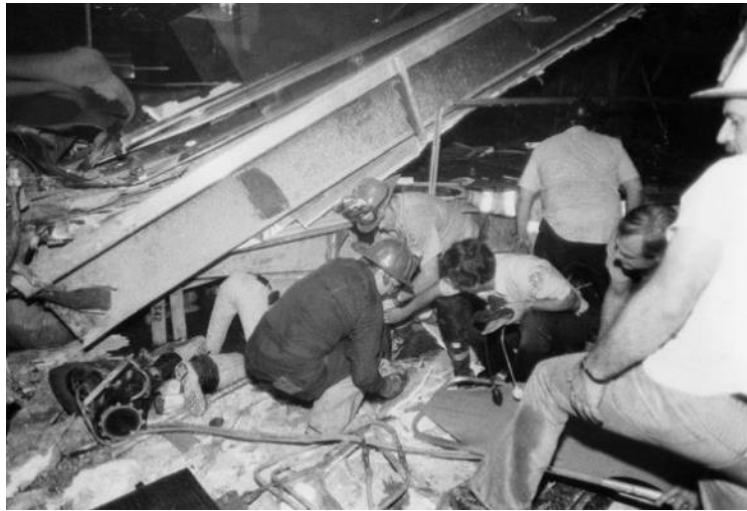
(note the weld connecting the toes of the channels has failed)

Fig 2.3.6.c Rescue efforts (Kansas City Star, 1981)

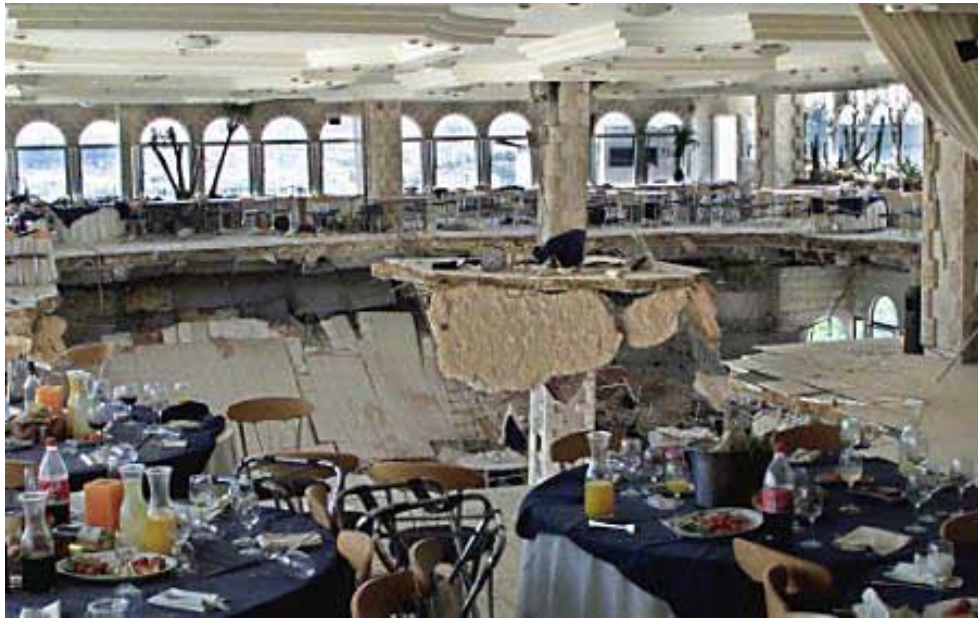
- After the partition removal, the floor in question was seen to have a noticeable sag. Strangely, a heavy concrete screed was added to the floor to give a flat upper surface.
- The spans of the floor were long. Such spans are sensitive to dynamic loads such as dancing.

Fig 2.7.3.a Versailles Wedding Hall (Zailer Committee Report, 2002)  
(note the long spans and punching shear at column)

The Zailer Report investigated the circumstances of the failure and made a number of recommendations. These included that there should be a comprehensive and user friendly building code and that the number of government departments having an interest in building work should have their roles and responsibilities concisely defined.

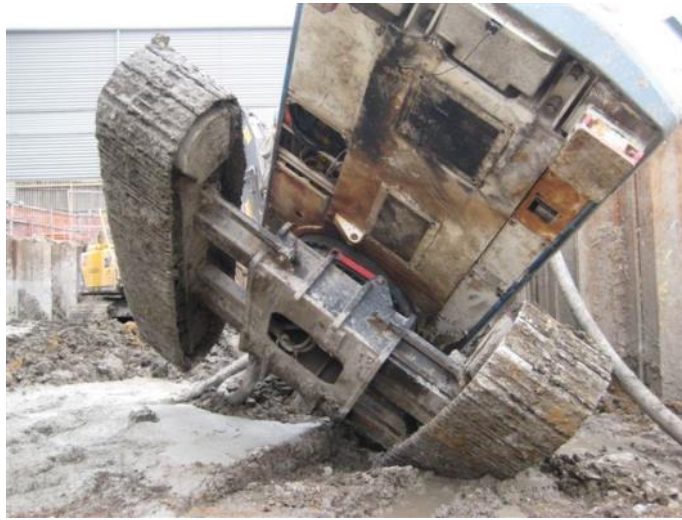
Piled foundations are required in areas of ground with poor structural properties. Piling rigs can weigh up to 200 tons and have a high centre of gravity. Although piling rigs are track mounted to spread the weight of the rig onto the ground, there are numerous cases of piling rig collapses due to inadequate working platforms. The consequences of poor ground can be seen in Fig 2.3.8.a.

Fig 2.3.8.a Piling rig overturning (Construction Enquirer, 2015).

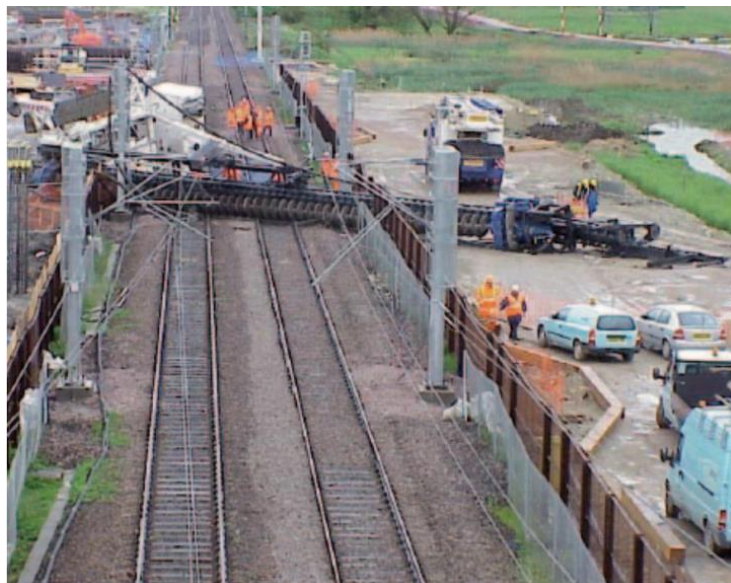
One potentially extremely serious incident occurred on a site immediately adjacent to an electrified rail line in the UK (refer to Fig 2.3.8.b). The ground conditions were very poor and a working platform of stone and a geotextile membrane had been installed. To remove an obstruction, a trench had been dug and the geotextile had been damaged. The trench was then poorly backfilled. When the rig crossed the trench, ground settlement took place and the rig collapsed across the railway line. The 25 kV overhead electric cables were brought down. A passenger train had travelled along the tracks just 2 minutes before the collapse. The subsequent inquiry (HSE, 2004) was told that the site managers were not aware of the critical importance of the backfilling.

Fig 2.3.8.b A continuous flight auger piling rig collapses across a railway line. (HSB Engineering Insurance, 2014).

The trade group representing the piling contractors, The Federation of Piling Specialists now have what is called a Working Platform Certificate. The main thrust of the certificate is to give

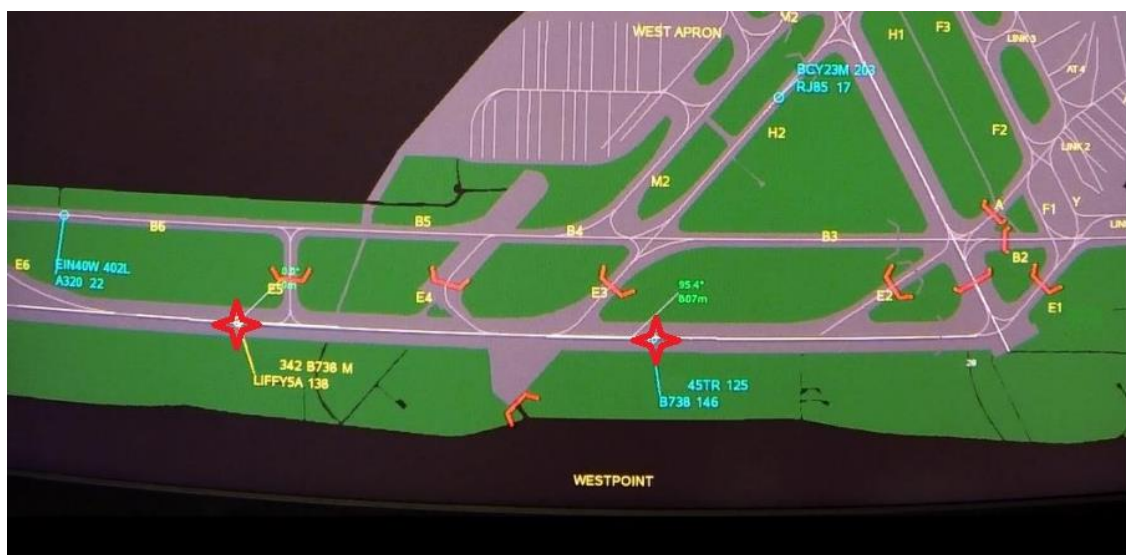
An arriving aircraft was cleared to land on the same runway as the departing aircraft. The two aircraft came within 807 m of each other on the main runway (refer to Fig 2.4.3.a).

Fig 2.4.3.a Plan of runway (AAIU, 2015)

(Note the position of the two red stars representing the aircraft in their closest proximity.)

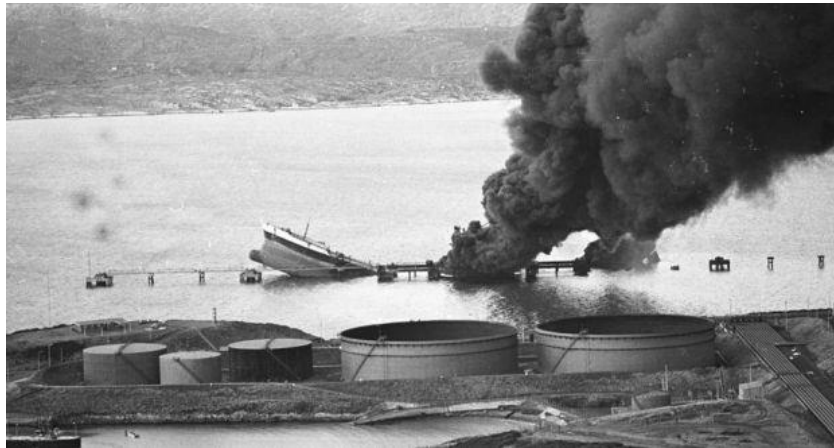
The MV Betelgeuse was a large crude oil carrier. It arrived at the Whiddy Island Terminal, Bantry, Co. Kerry in January 1979 carrying around 115,000 tonnes of crude oil. Early in the morning of January 8<sup>th</sup>, a massive fire accompanied by a number of explosions killed all the crew and a number of others – 50 in all – refer to Fig 2.4.4.a below.

Fig 2.4.4.a The Whiddy Island oil terminal disaster. (Irish Times, 2014)

The Tribunal made no less than 45 recommendations. These included revisions to Statutory Regulations covering the operation of oil facilities. The report was critical of the number of Government Agencies who have legal responsibilities regarding supervision and inspection of oil jetties. Specific recommendations in the report cover areas including the provision of Loadicator equipment, lifeboats, wave-height recorders, anemometers, logbooks, length of shifts, loudspeakers, fire mains, etc.

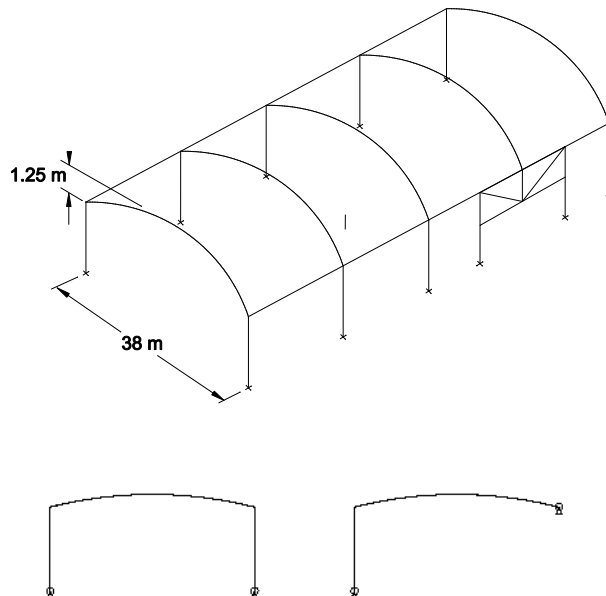
The structural designer designed 2 frames – one was the normal portal frame and the other was the frame whose column was interrupted by the door. The different structural arrangement was recognised in the design. The standard rafter was 1200 x 267 / 267 x 196.8 CUB and the rafter in line with the door was 1200 x 305 / 305 x 289.1 CUB. The non-standard rafter was nearly 50% heavier.

Fig 3.5.1.c. Structural frame showing standard frame and frame at door.

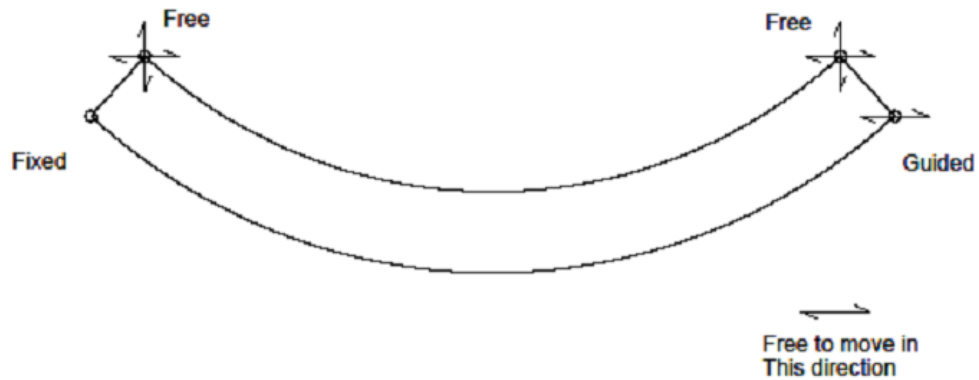
A large cable stay bridge has a significant curve in plan. This is a high profile structure and further details might identify it. The plan view and bearing details as designed are shown below – Figs 3.5.2. a, b, and c.

Fig 3.5.2.a Plan showing the arrangement of bearings.

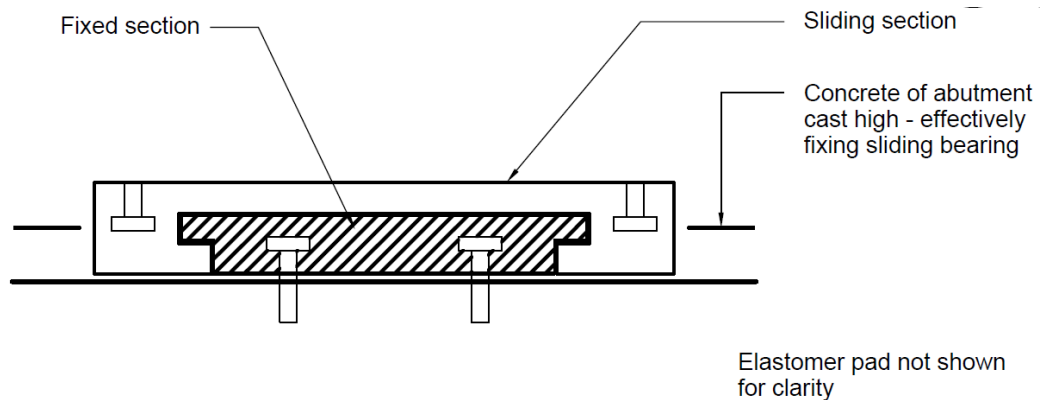
Fig 3.5.2.b. Diagrammatic section through guided bearing.

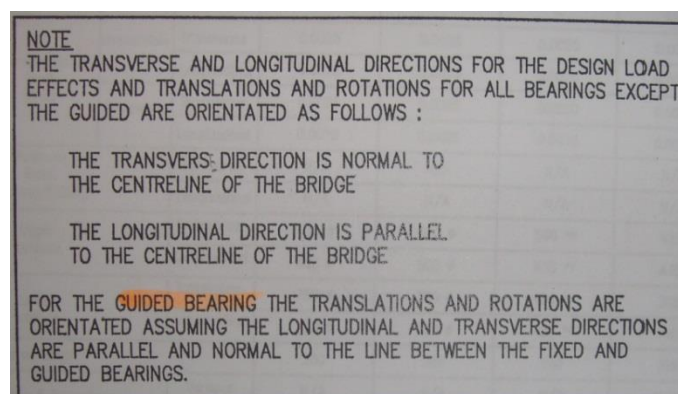
The design drawing for the bridge had the following note – Fig 3.5.2.c.

Fig 3.5.2.c. Note on designer's drawing (Confidential Source, 2015).

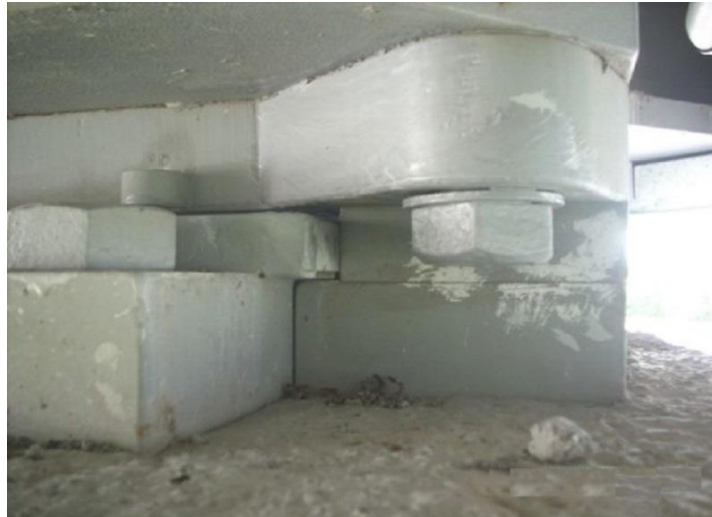
Fig 3.5.2.d. View of sliding bearing (Confidential Source, 2015).

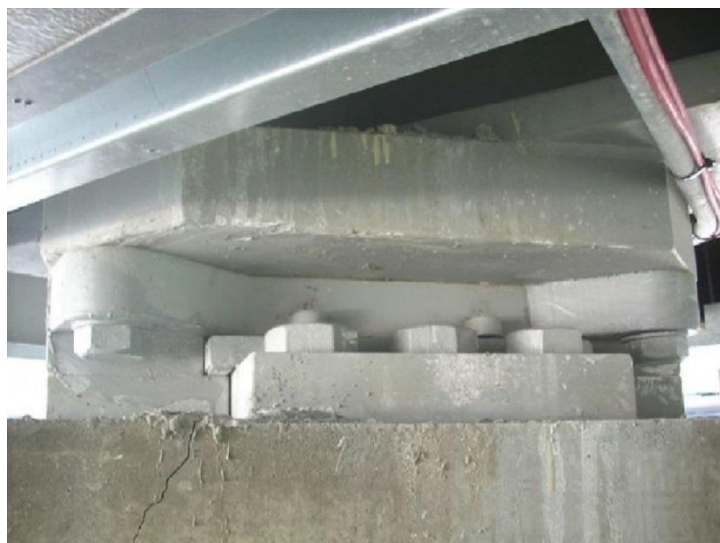
There was, however, a second and unrelated matter regarding the bridge. Measurements were taken of the tension in the cable stays. An analysis of the forces in the cables and the dead weight of the structure revealed a problem - the numbers failed to balance. On-site investigations revealed that the concrete of the abutment was cast higher than indicated on the design drawings. This had the effect of making the guided bearing into a fixed bearing. The bridge had a fixed bearing at both ends of the bridge. Refer to 3.5.2.e for an image of the bearing as constructed.

When the restraining force of the support which was previously modelled as a sliding bearing was taken into account, the cable calculations now made sense. There was a significant force into the abutment. There was cracking at the top of the abutment – see Fig 3.5.2.e below.

Fig 3.5.2.e. Alternative view of sliding bearing (Confidential Source, 2015).

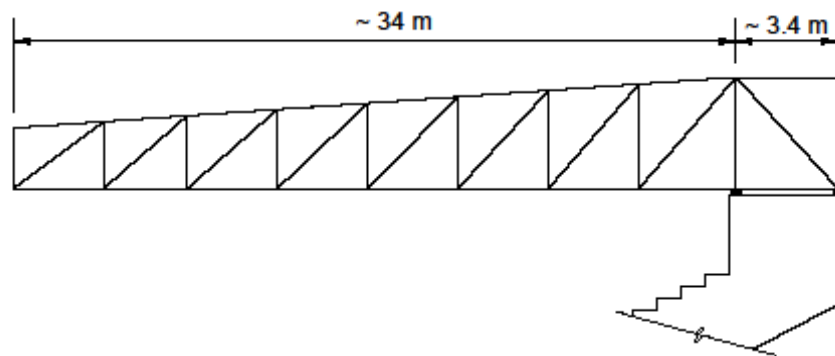
The back support of the truss was a structural pin joint with a horizontal bolt. The front support was adjustable so that during erection all the trusses could be lined and levelled. The precast concrete had 32 mm dia reinforcement.

The drawings showed the front support for shims and a jack as being set back from the front face of the concrete. Refer to Fig 3.5.5.b below.

Fig 3.5.5.a. Section through the cantilever truss.

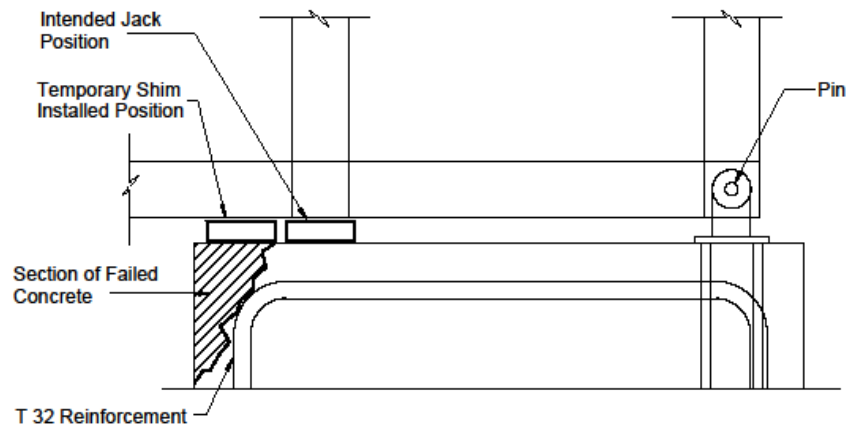
Fig 3.5.5.b. Detail at the support end of the cantilever truss.

The 32 mm reinforcement has an internal radius of 112 mm. This leaves the top corner of the concrete unreinforced.

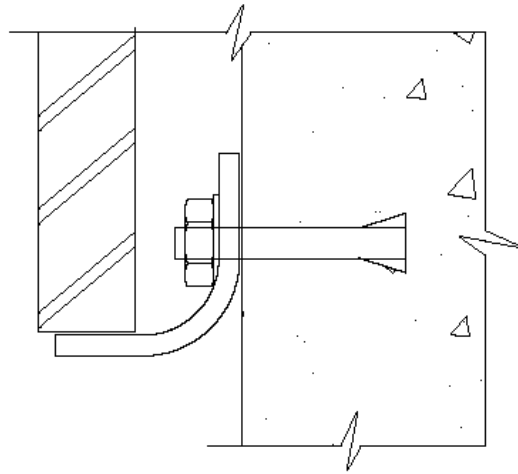
The design drawings showed a rolled steel angle with a thickness of 12 mm. The contractor had difficulty in sourcing the angle and ordered a bent flat refer to Fig 3.5.6.a below.

The flat was bent with a large radius bend. As the bricklayer was laying the bricks, the bolt pulled out.

Fig 3.5.6.a. Shelf angle with bent flat rather than rolled steel angle.

(note the distance between the bolt centreline and the point of rotation of the shelf angle is approaching zero)

The lever arm for the bolt is effectively zero. Therefore the pull out force in the bolt is very large. The bolt behaved exactly as theory would suggest – it pulled out as the wall was being constructed. It is easy to see how a contractor would fail to appreciate the significance of the substitution of a rolled steel angle with a bent flat. It is not the fact that a bent flat was used, it was because the lever arm was approaching zero.

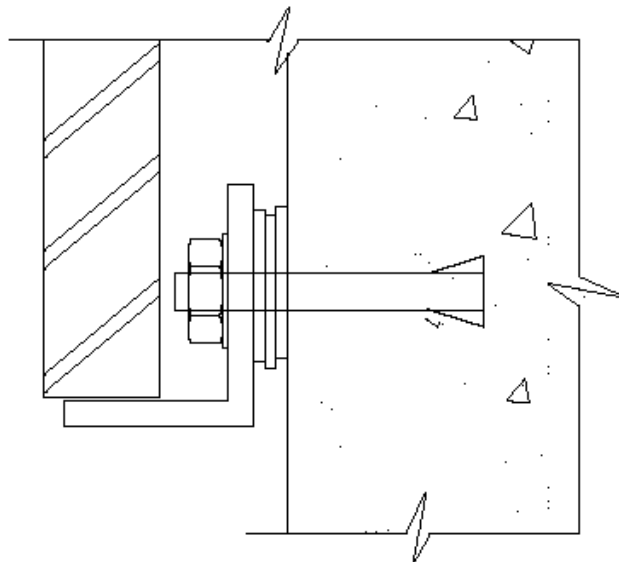
Fig 3.5.6.b. Shelf angle with washers inserted to correct for construction tolerances.

On this particular project, the shelf angle was to be fixed to the insitu concrete frame. The tolerances for the concrete exceeded the normal values. The contractor sought to correct this by adding what was described as “a handful of washers”.

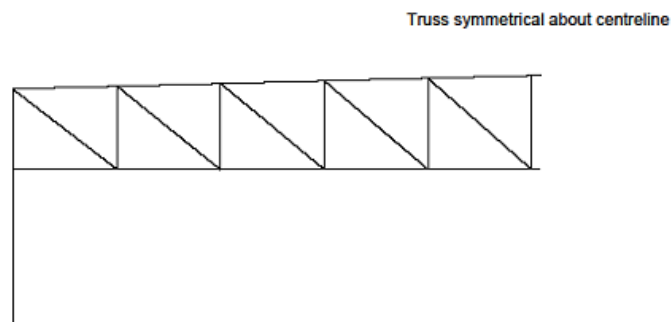
Fig 3.5.7.a. The truss arrangement as shown on the structural engineer's drawing.

In this actual case the error was spotted during construction and the trusses modified with both serious cost and programme implications.

The structural engineer failed to show his intent by way of clear and unambiguous drawings.

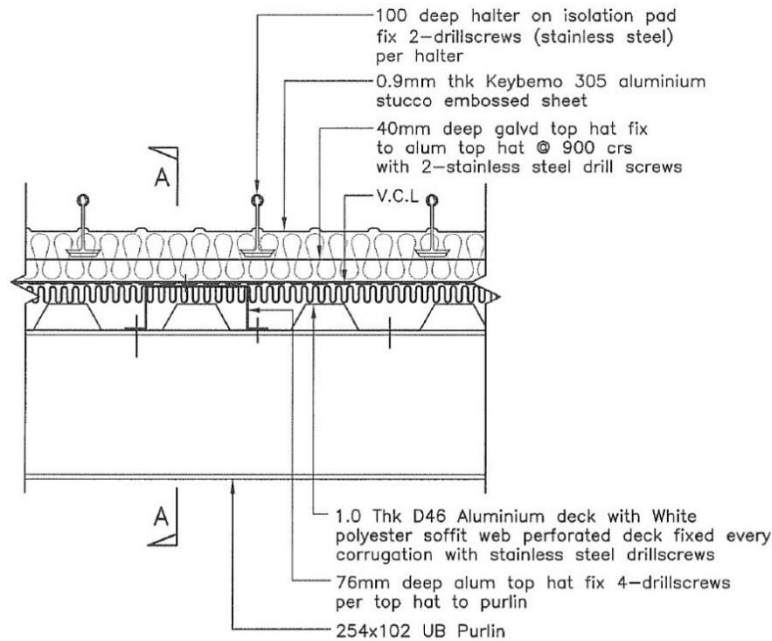
Fig 3.5.8.b. Typical as-built section through the roof (Confidential Source, 2015).

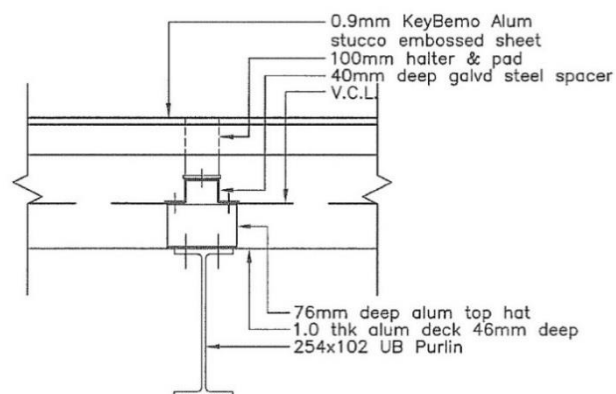
Fig 3.5.8.c. Section A-A through as-built roof (i.e. at 90 degrees to last section).

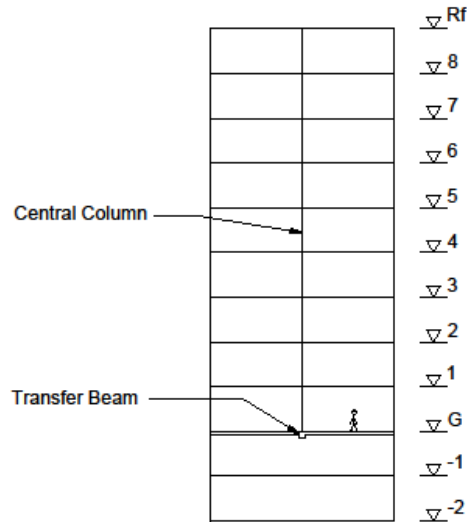
Fig 3.5.11.a. Diagrammatic section through building.

During the later stages of construction significant cracking of the transfer beam was noticed.

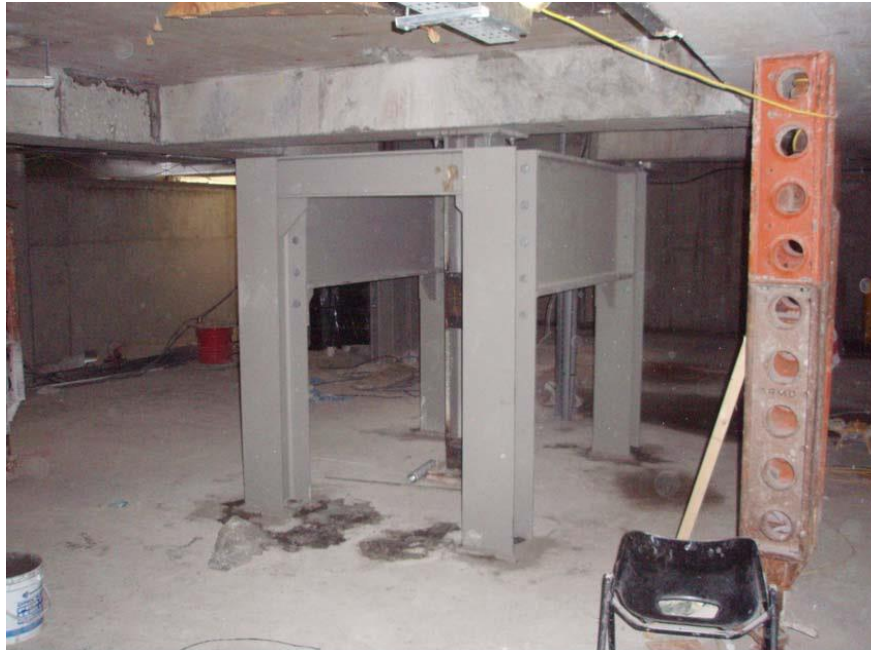
Fig 3.5.11.g. View at upper basement level showing emergency prop and temporary props (Confidential Source, 2015).

(Note transfer beam and the depth of the transfer beam.)

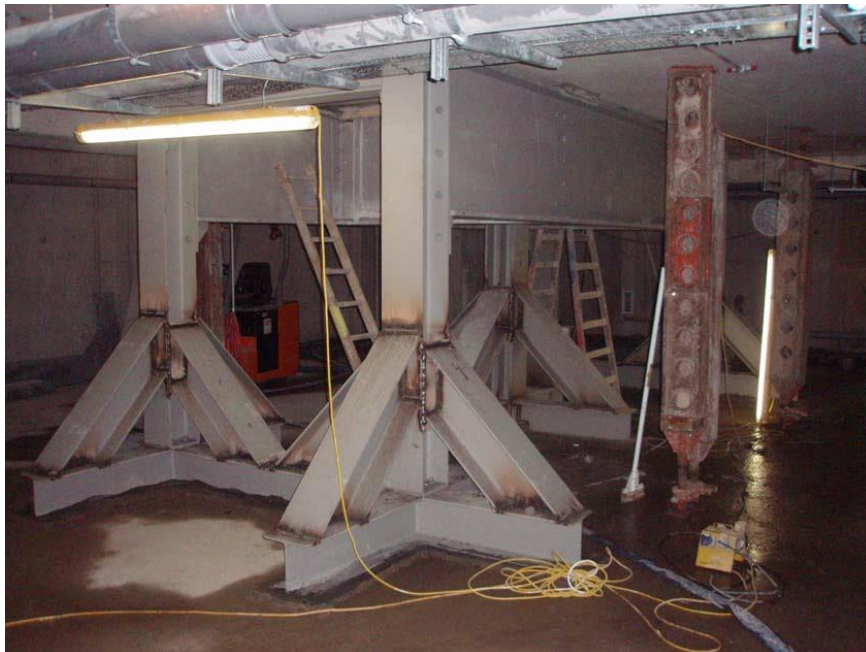
Fig 3.5.11.h. View at lower basement showing temporary propping (Confidential Source, 2015).

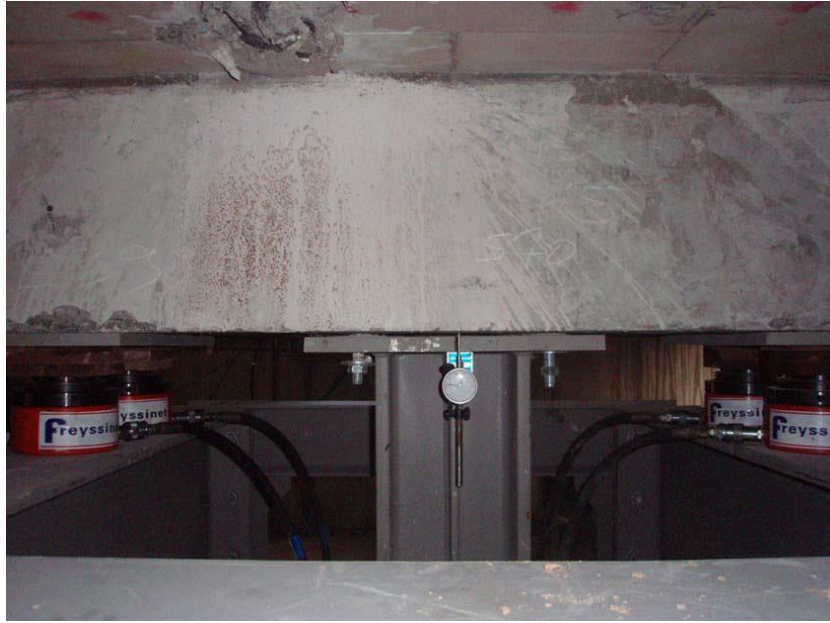
Fig 3.5.11.i. Jacks ready to take load with deflection gauge installed  
(Confidential Source, 2015).

The transfer beam was to be jacked up by 2.5 mm.

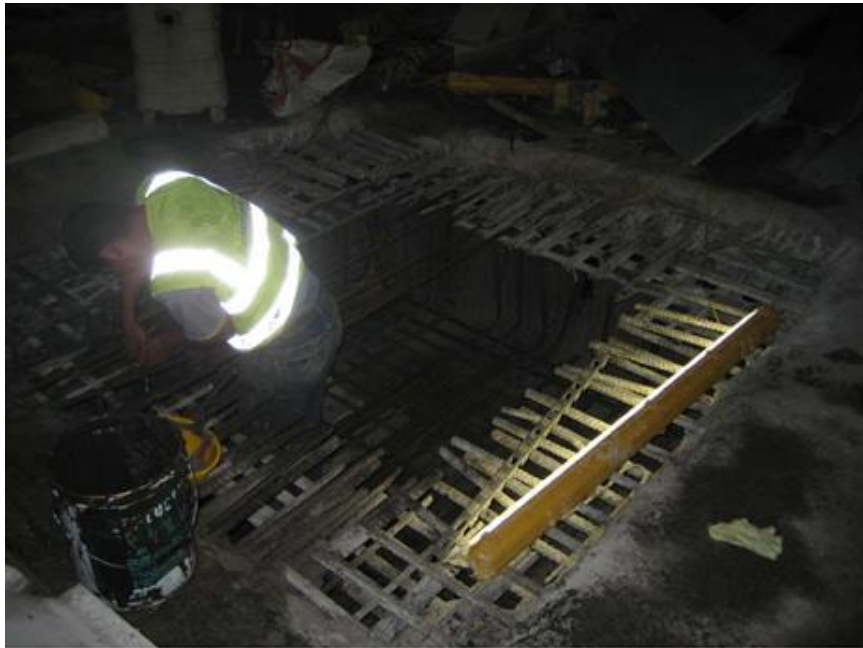
Fig 3.5.11.j. Slab in lower basement with slab thickening prepared (Confidential Source, 2015).

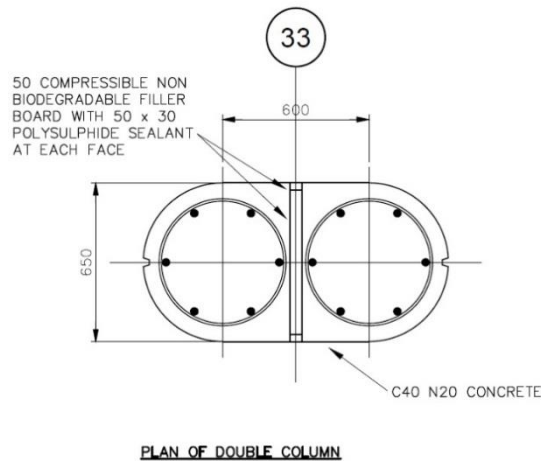
As outlined above, the designer's intent is shown in Fig 3.5.12.c below. The designer gives no indication as to how the joints should be constructed. It would be normally be assumed that the contractor would form the flat section of the column using normal shuttering.

Fig 3.5.12.c. Detail taken from structural drawing showing joint. (Confidential Source, 2015).

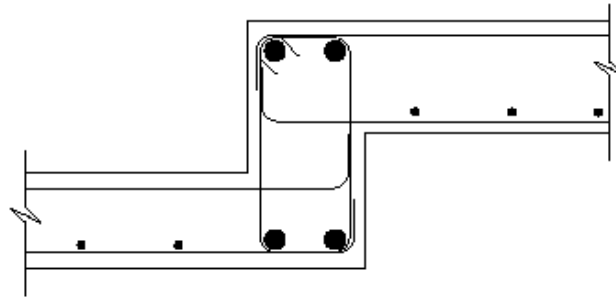
A study quickly showed that this beam was not spanning between supports. It was described as “a beam from nowhere to nowhere”. The slab was spanning in a perpendicular direction to the “beam” at the change in slab level. A cross section is shown in Fig 3.5.13.a below.

Fig 3.5.13.a. Section through beam at step in level. (Confidential Source, 2015).

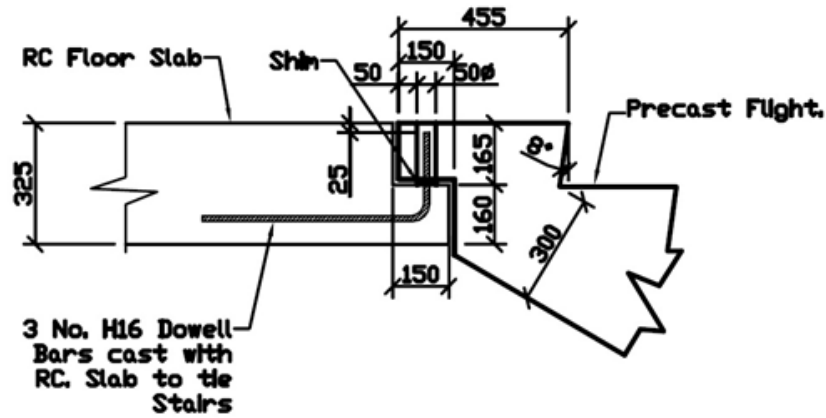
Fig 3.5.14.b. Detail at halving joint. (Confidential Source, 2015).

(Note: this the actual detail from the precast sub-contractor's drawing)

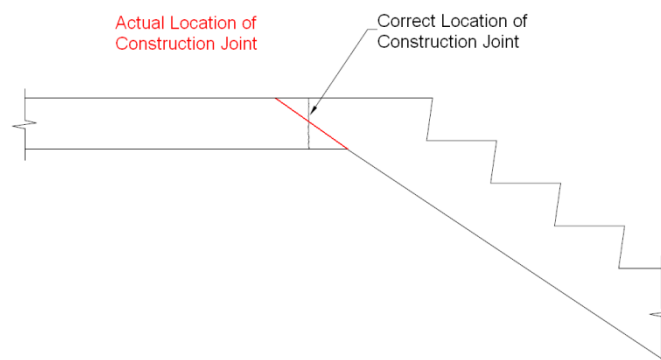
Another issue relates to the construction joint. The stairs were poured in two pours. The lower flight of the stairs was first cast in the yard face down. The concrete used was a self-compacting mix ie with a high slump. As shown in Fig 3.5.14.g below, the construction joint followed the line of the soffit of the flight and therefore was not at right angles to the plane of the bending moment. The high slump concrete would leave a smooth finish – not a rough one to receive the next pour of concrete.

The compression block of the concrete therefore had an inclined slip plane across it. There were however, two rows of reinforcement crossing the plane.

Fig 3.5.14.g. Location of construction joint.

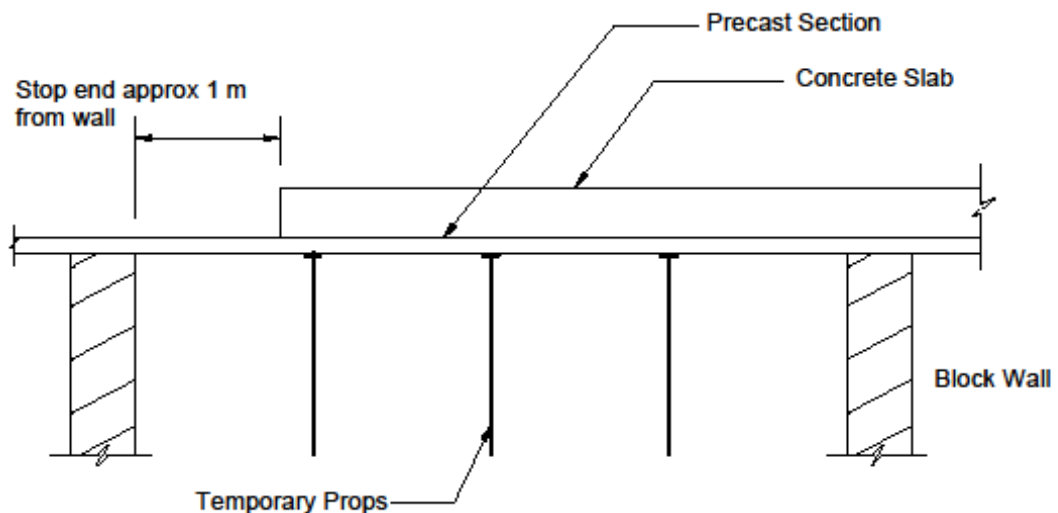
It was the intention of both the contractor and structural engineer that the day works joint would be at the centreline of the block wall. However, the amount of concrete delivered on that day was a little short and a stop end was put in at about one metre from the wall.

The following day, a worker removed some of the temporary props to the slab. There was a sudden shear failure of the thin, pre-cast section of the slab. The slab fell onto the floor below. One man was killed and another received life altering injuries.

Fig 3.5.15.a. Section showing slab and temporary props.

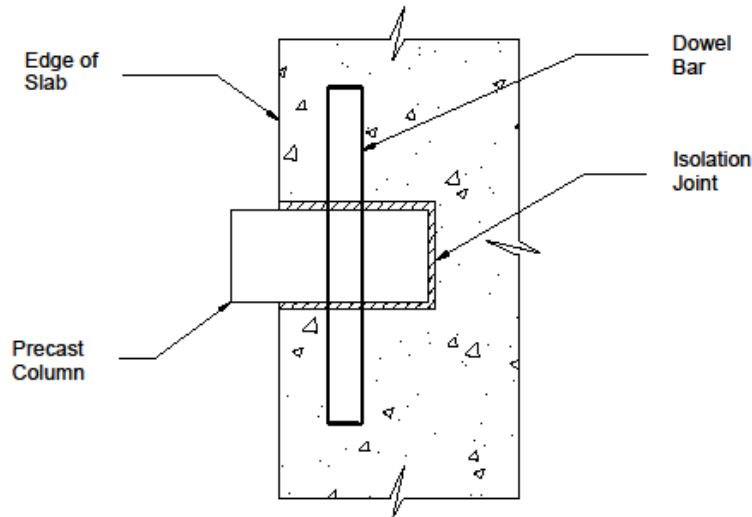
The columns, as constructed, could carry the axial load but if the moment had been added, then the columns would have had inadequate main steel.

The solution was to design the connection as a pin so that the moment was reduced to zero. This was achieved by re-designing the connection with a large dowel pin which was on the centreline of the column as shown in Fig 3.5.16.a below.

Fig 3.5.16.a. Diagrammatic plan of dowel connection. (Confidential Source, 2015).

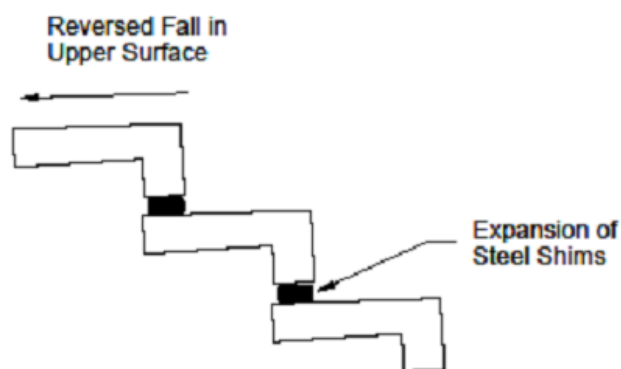
The steps were exposed to rain and over a period of years, the shims rusted. This oxidation caused an expansion. The as-constructed gap between units was originally of the order of 6 mm, but some of the gaps after expansion were measured to be as large as 25 mm. This is shown diagrammatically in Fig 3.5.17.b below.

The units tipped back as shown below and considerable amount of rainwater was falling into the occupied areas below the stand.

Fig 3.5.17.b Cross-section through precast concrete steps after expansion of steel shims.

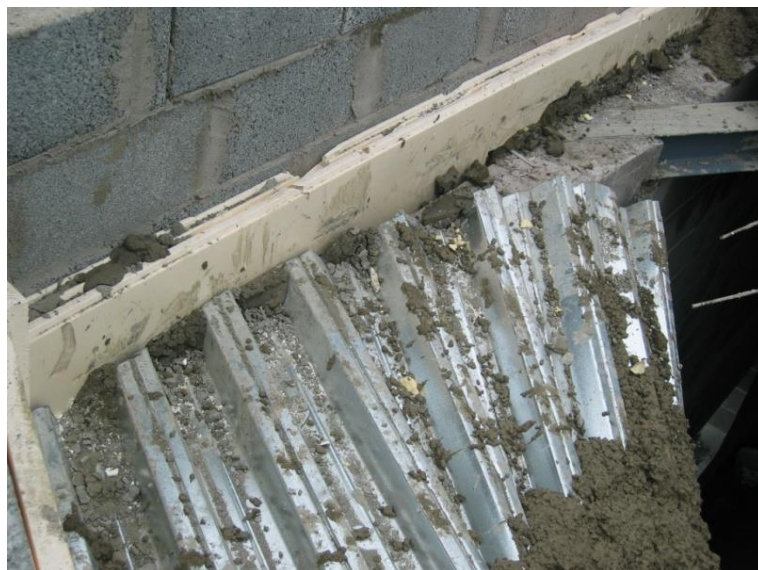
As a separate issue, photos taken immediately after the collapse indicate that the construction at the external wall was incorrect as the cavity was not properly maintained (Fig 3.5.20.b).

Fig 3.5.20.b. Photograph showing absence of cavity at external wall. (Confidential Source, 2015).

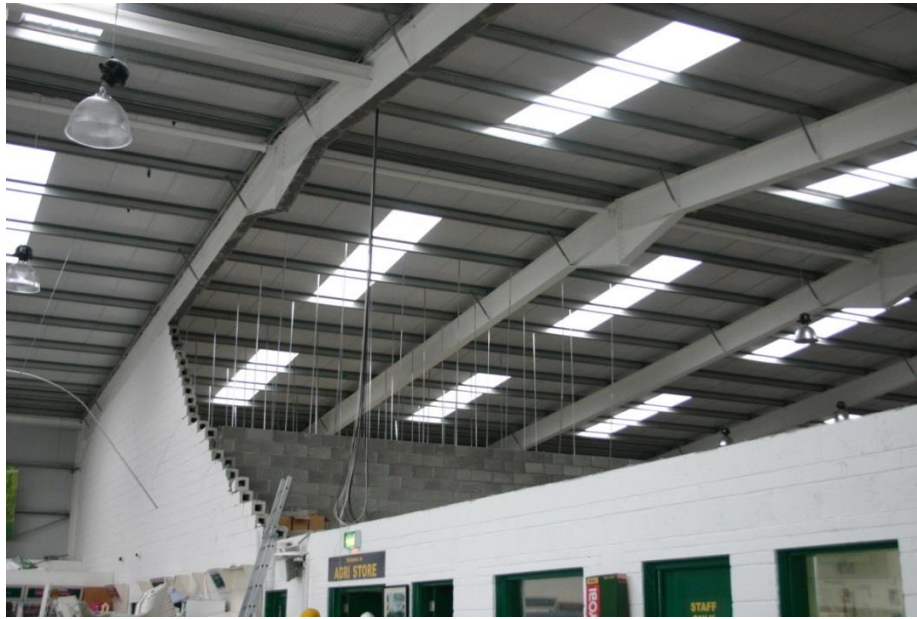
Fig 3.5.22.b. Alternative internal view. (Confidential Source, 2015).

Note the restraining wall at the section of wall which did not collapse

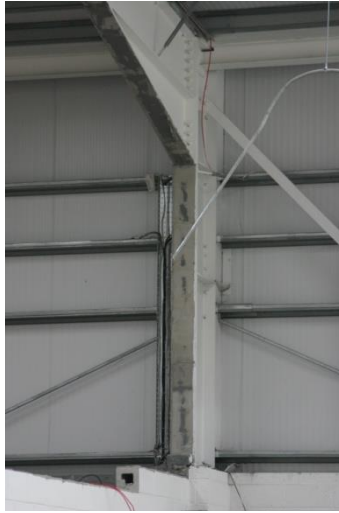
Fig 3.5.22.c. Portal column. (Confidential Source, 2015).

(note the absence of evidence of ties)

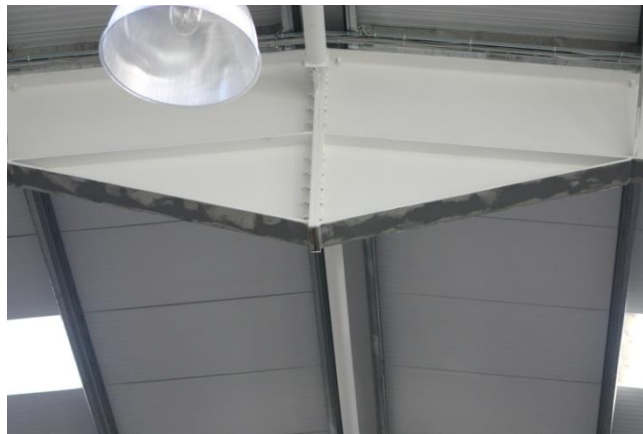
Fig 3.5.22.d. Portal ridge. (Confidential Source, 2015).

(again note the absence of ties)

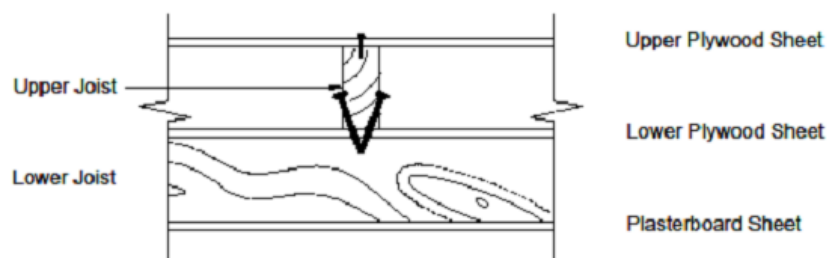
The roof consisted of a steel frame with some blockwork walls with timber joists spanning between the steel and masonry. Plywood sheets were nailed to the timber joists. Unusually, a second layer of timber joists were nailed to the lower timber layer and a second layer of plywood fixed to the upper joists.

The reason for this second layer of joist and plywood is not known. It may be that the second layer was added to provide falls in a required direction (refer to Fig 3.5.24.a).

Fig 3.5.24.a. Cross-section through the roof
