# **A Review of Structural Failures in Ireland**

Trinity College Dublin  
Department of Civil, Structural and Environmental  
Engineering

A Thesis submitted for the degree of Master of Science  
by

Ian James Duckenfield

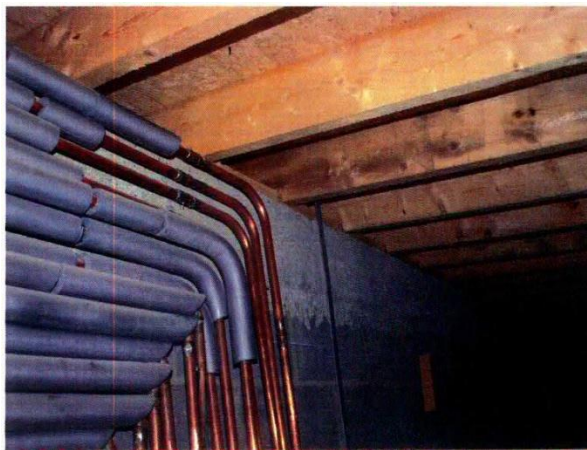
Fig 3.5.26.b: View of an undamaged roof in the same development similar to the failed roof.

Additionally, in places the wall plate was seen to be central on the wall rather than having the inside face of the timber flush with the inside face of the blockwork. This as-built condition is not a good detail because, when the wall plate is subject to an uplift force the 90° bend in the strap can straighten out allowing the wall plate to lift off the wall and possibly allowing wind to get under the roof structure.

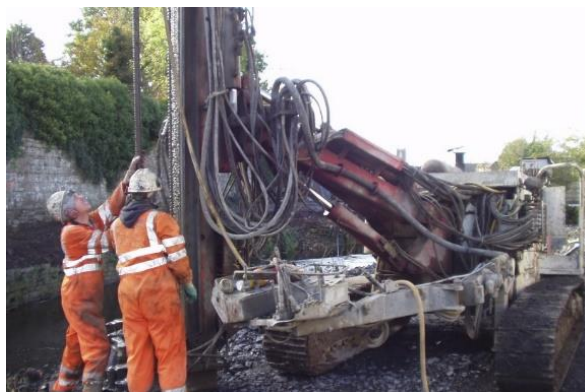
The piles were mini-piles – hollow steel of diameter 80 mm. Each pile had holes along its length. After the piles were formed to their final depth, grout was injected under pressure into the pile. This grout passed through the holes and improved the load bearing properties of the ground. Refer to Fig 3.5.28.a below.

The design required that the piles were rock socketed into the rock. The original plan was to carry out static load tests on the piles. The static load testing was deleted and dynamic tests were substituted. This dynamic testing used dynamic methods connected to a laptop. The exact nature of the dynamic testing is not known.

Fig 3.5.28.a. Mini-pile rig in use. (Confidential Source, 2015).

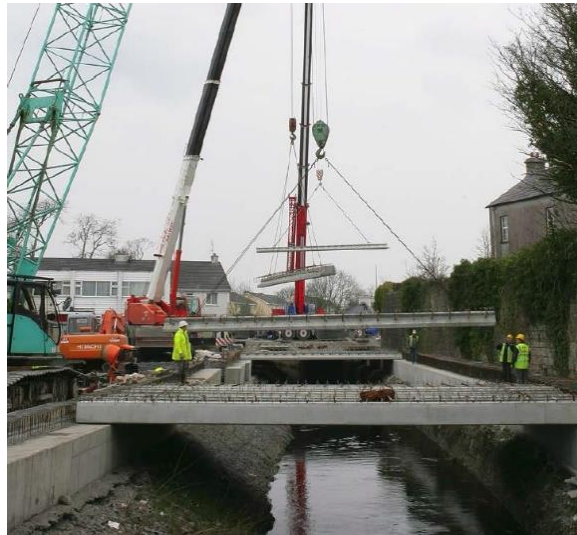
Fig 3.5.28.b. Lifting precast beams. (Confidential Source, 2015).

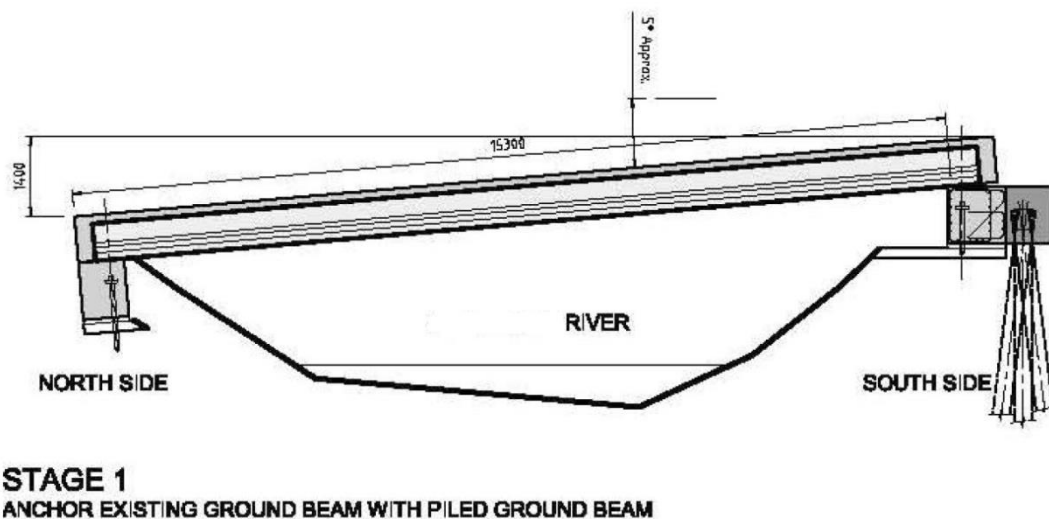
The piles are slender and require a rock socket to form a moment connection at the base of the pile. The slenderness ratio of the pile is sensitive to the fixity condition at the base of the pile.

Fig 3.5.28.e. New raking piles are installed at the south abutment. (Confidential Source, 2015).

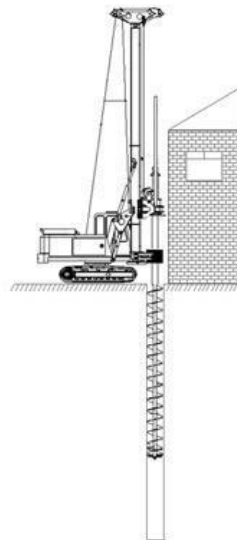
The CFA rig was piling close to the existing building and the auger engaged with a thick electrical cable. The cable was not live but it was still connected to heavy switchgear inside the building. The path of the cable was along a high level pipe rack which ran along a corridor at high level in a zig zag configuration. As the cable straightened severe damage was done to the services on the pipe rack. Some of these were high purity lines which had been fully commissioned and were part of the essential process lines for the facility.

The site was not cleared of services even though the site had been declared as free of live services.

Fig 3.5.29.a. Diagrammatic representation showing rig close to the building.

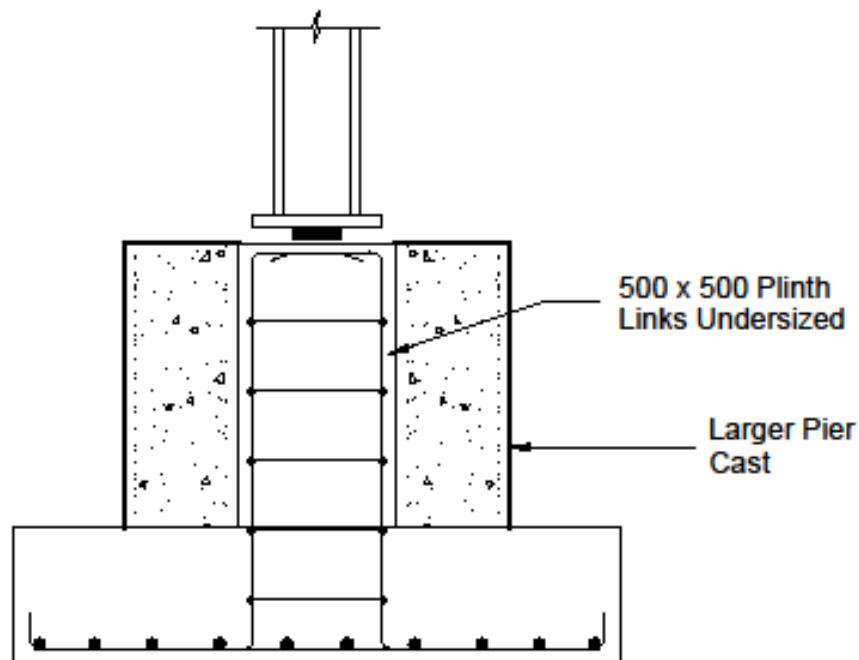
During construction of the frame, it was noticed that the piers were showing signs of serious distress. There was cracking indicating a bursting failure of the pier.

Fig 3.5.30.a. Section showing the foundation detail.

- jack up the structure with pre-determined load
- remove the hardcore around each pier
- remove the concrete of the pier
- re-cast the pier using heavier link steel and a permanent steel shuttering - see Fig 3.5.30.a.
- remove the jacks

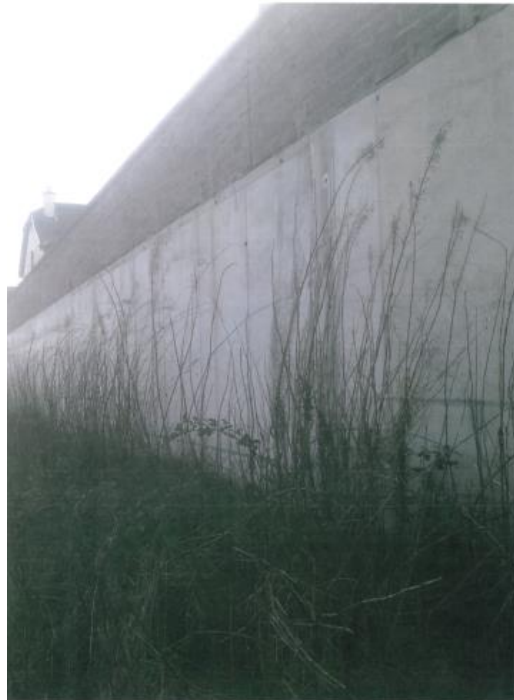
A housing development was on raised ground. The raised section was around 5 m over the original ground level in the relevant area. The reason for this is not known but it is unusual and expensive (refer to Fig 3.5.32.a below).

Fig 3.5.32.a. View of retaining wall (note house in the distance). (Confidential Source, 2015).

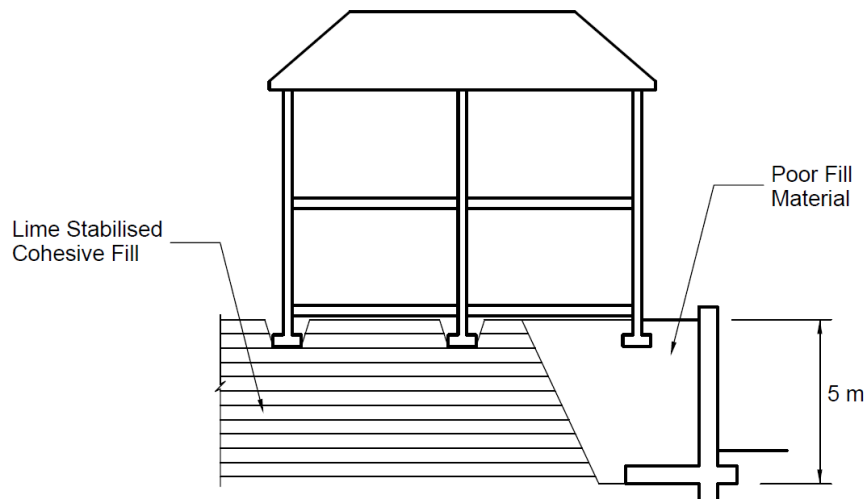
In one area a SPT test was carried out and the sample tube fell around 5 m under its own weight. The N value was therefore zero! This indicates ground which has no structural strength.

Fig 3.5.32.d. Section through house and retaining wall.

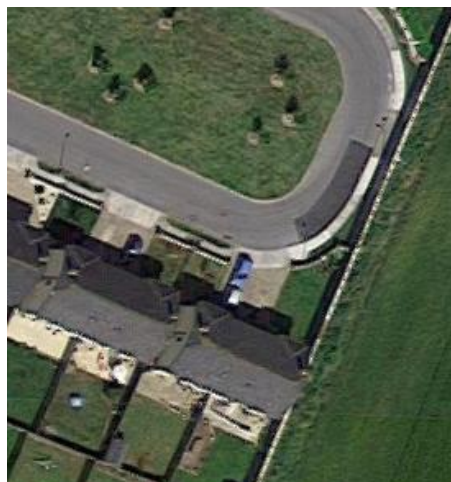
An aerial photo gives a clue regarding a repair to the road – see Fig 3.5.32.e below.

Fig 3.5.32.e. Aerial view. (Confidential Source, 2015).
