O'Kelly B.C., Ward P.N. and Raybould M.J. 2008. Slope stabilization of an embankment on the West Coast Main Line, UK. *Proceedings, First International Conference on Transportation Geotechnics, 25th–27th August, Nottingham, UK*. Vol. 1, pp. 335 – 341.

## Slope stabilization of an embankment on the West Coast Main Line, UK

**ABSTRACT:** A site inspection of an embankment on the West Coast Main Line (UK) revealed a general deterioration of the embankment, significant movement of the trackside services and waterlogging and bulging along the embankment toe. The medium-height embankment, with side slopes at about 30 degrees to the horizontal, was constructed on natural sidelong ground and the site had been an area of previous instability (former ash and slag tip). Site investigation, ground monitoring and analytical modelling indicated that the embankment was at limiting equilibrium and that recent progressive movement was occurring along a rotational slip surface located within the embankment core (ash and slag materials overlying reworked glacial till). The upgrade works comprised the installation of a row of stabilizing piles along the mid-height of the embankment side slope (facil

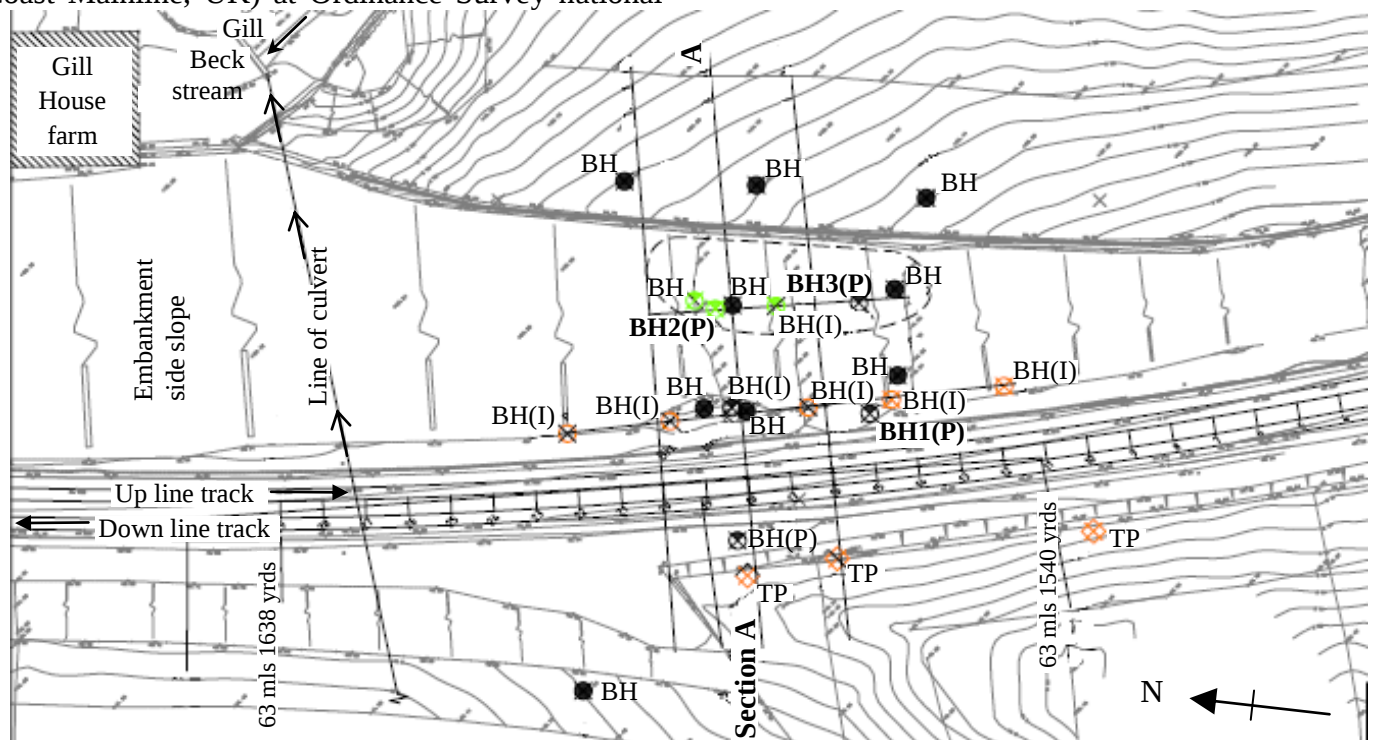
Figure 1. Site location plan. Note: BH, borehole; TP, trial pit; (I), includes inclinometer; (P), includes piezometer.

Two previous slope failures were known to have occurred on the Up-line side, adjacent to the site area behind Gill House farm (Figure 1).

The river Petterill is located about 200 m to the northeast of the site. Gill Beck, one of its tributaries, is culverted beneath the north end of the site area and exits at the embankment toe on the Up-line side, just south of Gill House farm (Figure 1).

The piezometer and inclinometer instruments were located along the Up-cess and at the mid-height of the embankment slope within the length of the toe bulge area. The response zone (sand cell) of the three piezometers at borehole locations BH1(P), BH2(P) and BH3(P) (Figure 1) were over the full depth of the embankment fill material and the instruments were periodically monitored between April 2001 and May 2002.
