Later medieval cross-cultural interactions: the settlement evidence in the baronies of Overk, county Kilkenny and Clanmahon, county Cavan

By Linda Shine

Volume II: Gazetteer of sites surveyed

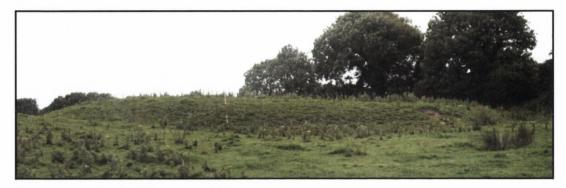
visit. The interior is level and no trace of the bank or berm on the edge of the platform reported in the SMR field report was observed.

Fig. G.2: Aghacreevy platform ringfort from the SW.

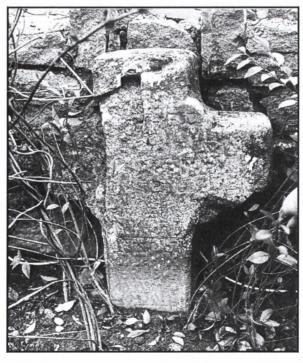
Fig. G.3: Aghnaskeagh cross (after O'Donovan 1995, 212).

The wayside cross is located in a modern landscaped garden, and is located between a stone wall and a hedge making it almost difficult to find and impossible to record. The *Archaeological inventory of county Cavan* (O'Donovan 1995, 212) describes it as a 'badly weathered wayside cross (H *c*.1m) with right arm broken off'. Davies (1948b, 97) records that it is an unperforated ringed cross and that there are raised letters inscribed on it which he read as the name Newall and the date 1626.

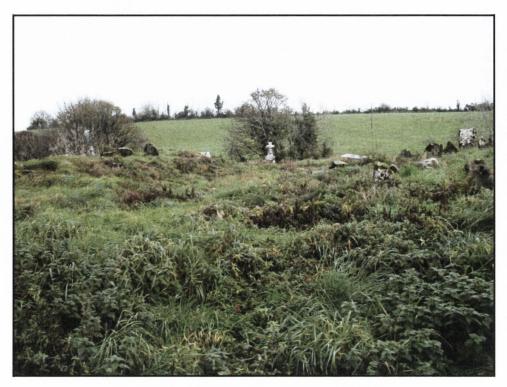
The church in Ballintemple is a nineteenth century Church of Ireland church dedicated to St. Patrick. The church is surrounded by a modern rectangular graveyard. There are the remains of an older graveyard on the opposite side of the road. Although no medieval grave slabs have been located within the older graveyard, the overgrown nature of the graveyard means that grave slabs could have become completely overgrown. There is a large sub-rectangular depression (*c*.6m N-S) in the graveyard opposite the gate and stile that provides access to the site from the road. There are concentrations of gravestones to the north and south of this depression. The River Erne forms the eastern boundary of the site, and this creates an irregular plan for the graveyard. The southern boundary of the site is formed by a stonewall, while a bungalow, built adjacent to the road, appears to have encroached on the NW corner of the graveyard. The River Erne would originally have formed the northern boundary of the site. There are three small grass covered mounds in the NE corner of the graveyard and stone foundations were noted in one. It is probable that these are overgrown grave plots.

Fig. G.4: Site of Ballintemple church from the SW.

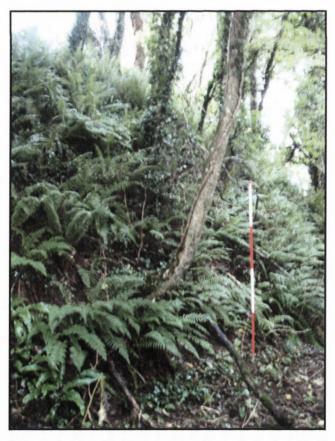
Fig. G.7: The west side of the fosse of the ringwork castle at Ballintemple.

The platform is 4.25m H on the W side, with 0.75m of that height made up of the bank on the edge of the platform. It is significantly lower on the E side, 2.9m H, with 1.2m of that height being made up of the bank. The interior of the site had been cleared of vegetation in the weeks before this site visit. The interior has a saucer shape, due to the slumping of the surrounding bank. There are a number of trees in the centre of the interior of the site, which is otherwise featureless. The site slopes gently from NE-SW.

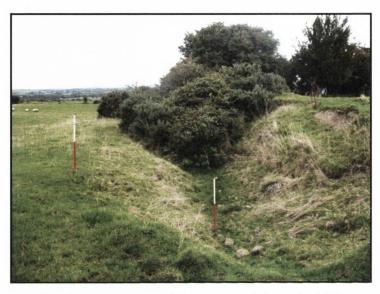
have been the location of the original entrance to the site. There is another gap located at the east corner of moated site, but his appears to be a modern addition and tractor tracks in the areas suggests that the farmer uses it for access. There are a number of conglomerate boulders in the moated site, and in the adjacent field there is a line of them along one side of it.

Fig. G.10: Fosse around Bawn moated site at the NW.

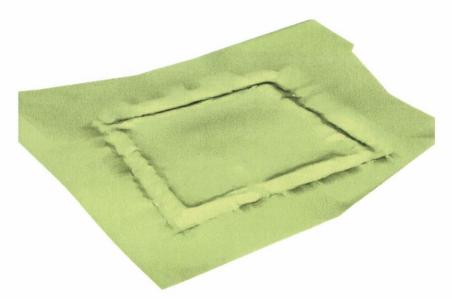
Fig. G.11: 3D terrain model of the moated site at Bawn from the northwest (after O'Conor 2008).

The Ordnance Survey namebooks translate the name Bawn, Badhbhdhún, as a castle bawn. There is no townland called Bawn on the *Maps of the Escheated Counties of Ulster* instead there is a townland called Drumlumman in its location, which contains a church. This would suggest that the townland name Bawn is comparatively recent. Bawn appears to have been within an area of unforfeited lands on the *Down Survey* map of the barony of Clanmahon and is therefore not depicted or labelled. The *Ordnance Survey* First Edition six-inch map of this area depicts the site as a rectangular area enclosed by a bank. The second edition map depicts the site as a rectangular area enclosed by a bank and external fosse. On the south and west sides there is a field boundary outside the fosse and on the east and north sides there is another bank outside the fosse. The surrounding area has been sub-divided with field boundaries and a laneway runs along the S side of the site connecting the nucleation of buildings NE of the site with the roadway to the west.

Davies surveyed the site in 1946 and a copy of this report is contained in the NMI monument files for county Cavan and he also included Bawn in his 1948 article on the Castles of county Cavan (Davies 1948a, 109-110). Davies noted the absence of the remains of buildings within the bawn. He argued that the deterioration of the southwest

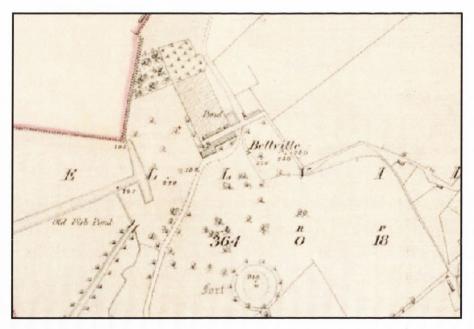
Fig. G.12: Bellville House as depicted on the *Ordnance Survey* First Edition six-inch map.

The *Ordnance Survey* First Edition six-inch map does not depict a rectangular earthwork projecting west from the Bellville House. The map does depict numerous rectilinear estate features such as ponds, fishponds and geometric gardens. The second edition does not depict any rectangular earthwork at the west side of Bellville House and by this date many of the estate features appear to have been removed.

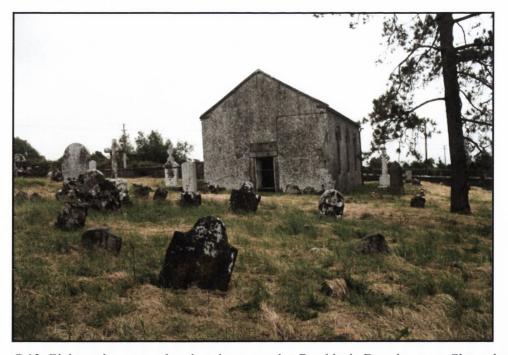
The site is currently occupied by the remains of an eighteenth century Church of Ireland church. It is located at the east end of a graveyard, which contains graveslabs dating from the eighteenth century. There is a curving field boundary north of the site that suggests this may have been the site of an earlier church, but only a short section of this curved boundary survives.

Fig. G.13: Eighteenth century church and graveyard at Bracklagh, Drumlumman, Clanmahon.

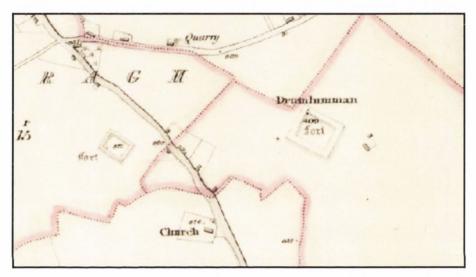
Fig. G.16: Carrickabane moated site (labelled Drumlumman) as depicted on the *Ordnance Survey* First Edition six-inch map.

The *Ordnance Survey* namebooks gives the name of the townland as Carrickbawn, *Carraic Bán* and translates it as White Rock. It also notes the presence of 'a large square fort at the N side of the townland called 'Drumlumman Fort'. This corresponds with the location of Carrickabane moated site.

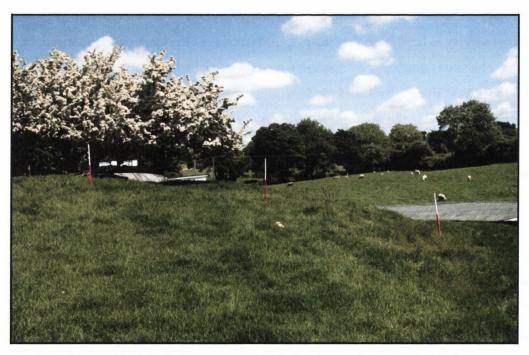
The platform in the centre is probably a natural mound that was scarped during the construction of the ringfort. The diameter of the platform is quite small (14.80m), but given the distance over which it slopes (7.30m) and the width of the fosse (9.70) it is possible that it once larger. Ploughing and land clearance may have been responsible for the erosion of the platform and surrounding bank on the west side, giving them their gently undulating appearance. There are a number of features on the platform. A depression on the west side of the platform was pointed out by the landowner as being the reputed site of a 'tunnel' and this is probably the 'souterrain possible' referred to in the RMP. At the north side of the platform there is a large stone slab beside which a small tree (possible whitethorn) is growing.

Fig. G.18: Clonbockoge platform ringfort, the south side of the platform.

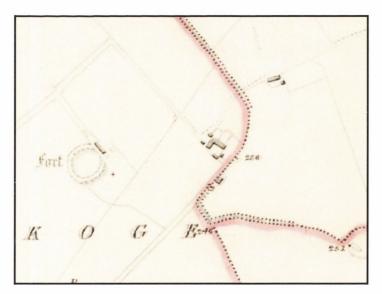
Fig.G.19: Clonbockoge platform ringfort as depicted on the *Ordnance Survey* First Edition sixinch map.

No documentary references or antiquarian accounts of this site were uncovered during this research. The *Maps of the Escheated Counties of Ulster* map of the barony of Clanmahon includes the townland of 'Clonbackogie' but does not include any man made features within it. The *Ordnance Survey* First Edition six-inch map depicts this site as a circular area enclosed by a bank. It also indicates that by the 1840s the NW side of the ringfort had already been impacted by the construction of a house, which was accessed by a laneway that runs from NE-SW. By the time the second edition has been compiled further buildings had been constructed at the NW side of the site further impacting the site which is depicted as a circular area enclosed by a field boundary which slopes downwards on its eastern and western sides.

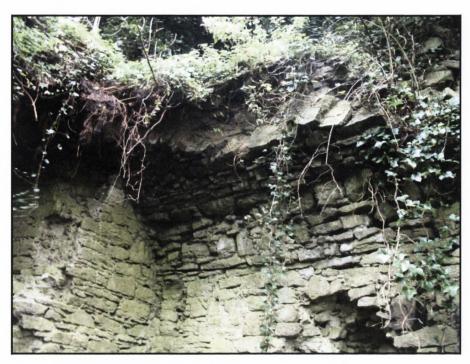
The castle is a tower house, at least 3 storeys in height with a pronounced base batter. The tower house is in a poor state of repair and local people report that it has deteriorated rapidly in recent years since ivy that grew on the castle was cut. The NW and SW walls survive almost to their full height. The east corner of the tower house has been almost completely destroyed, leaving only sections of the NE and SE walls extant.

Fig. G.20: Collapsing barrel vault and NW wall of Crover Castle.

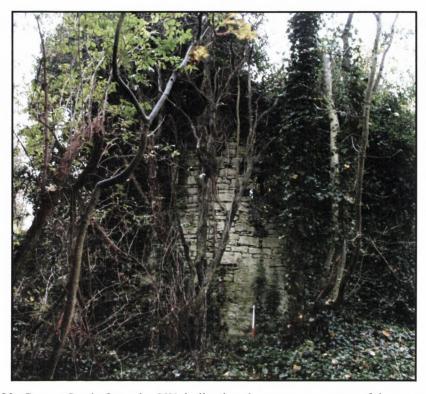
Fig. G.23: Crover Castle from the SW, indicating the overgrown state of the tower house.

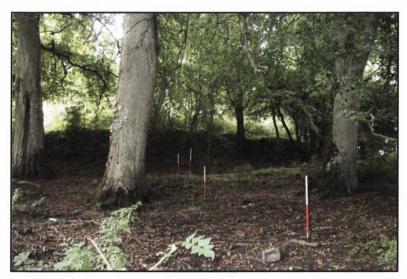
Fig. G.25: South side of Crover platform ringfort showing the platform, bank and fosses.

The site consists of a circular platform, enclosed by two banks with internal fosses and an inner bank or berm around the edge of the platform. This is a large and impressive site, with internal dimensions of 29m N-S and 24m E-W. The edges of the interior of the site are badly overgrown and there is some tree growth in the interior. The berm

along the edge of the platform is 0.30m to 0.50m high above the interior of the platform. The platform and the berm are 1.80m to 2.10m above the bottom of the innermost fosse. The only obvious gap in this berm, although

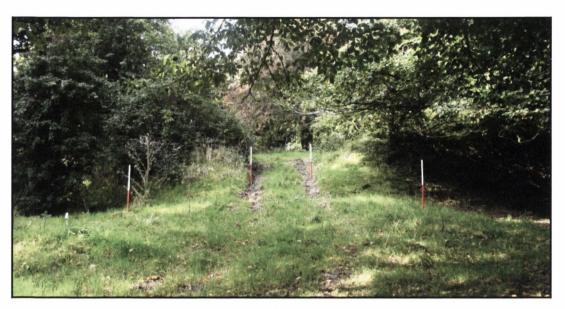
A ramped entrance to the site is located at the SE, and the entrance way is 2.50m in width through the innermost bank or berm, and 6m in width through the inner bank. There is a causeway across the inner fosse. The entrance faces a stream that runs along the edge of the field and a bank runs along the west side of the stream for most of the length of the ringfort. A stone wall runs from this bank to the ringfort at the north of the entrance way. The outer bank and fosse are absent for a considerable distance on this side of the ringfort.

Fig. G.27: Causewayed entrance to the platform ringfort at the SE of the site.

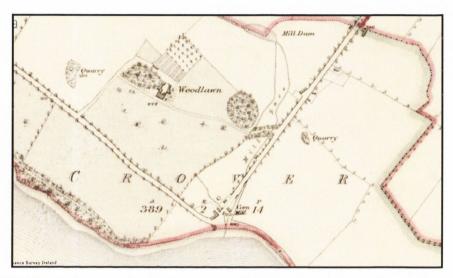
Fig. G.28: The platform ringfort in Crover as depicted on the *Ordnance Survey* First Edition six-inch map.

*Ulster* map of the barony of Clanmahon appears to omit the townland of Crover. The *Ordnance Survey* First Edition six-inch map shows the platform ringfort located beside the avenue to Woodlawn House. There is a millrace to the east of the site that is depicted as a tree covered, multi-vallate enclosure.

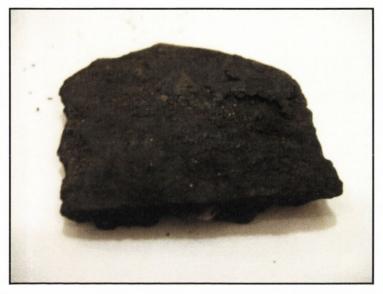
Fig. G.29: Pottery from Dillagh Crannóg (NMI reg. no. 1980:110).

The NMI topographical files for Dillagh townland record that this crannog was discovered when Dillagh Lake was drained in the 1980s. The lake was quite small, c.20 acres in extent and was surrounded by extensive marshland. The crannóg was located 10m from the original shoreline and was 18m to 20m in diameter. When the site was inspected shortly after the lake was drained, spreads of ashes, which maybe the remains of hearths were noted. Most of the stakes and piles at the centre of the island are of softwoods, alder, birch and ash; only a few planks of oak were identified. A number of finds were collected from the surface of the crannóg during the inspection of this monument in 1982; the remains of two wooden staves, probably originally part of a barrel; two leather fragments; a wooden point; and six sherds of crannóg ware pottery (NMI reg. nos 1982:107 to 1983:111). Crannóg ware is generally dated to the later medieval period and there is nothing in the rest of the assemblage that would contradict this date. The sherds of crannóg ware described in the National Museum of Ireland Topographical files as 'coarse black fired ware with very large quartz grits, one sherd is from a vessel with straight sides and a plain vertical rounded rim' (NMI Reg. No.1982:110). This would suggest that the crannóg was used during the later medieval period but it is unclear whether this was a permanent or temporary occupation of an

existing crannóg. This file also indicates that the pieces of leather might be fragments of a shoe and that one of the finds from the crannog was a wooden weaving spindle.

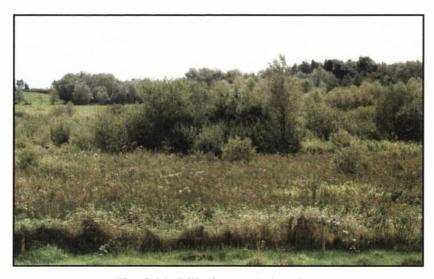
Fig. G.30: Dillagh crannóg location.

The landowner indicated that the lake had been drained accidentally during work to the river that fed the lake. It was part of a scheme to improve the drainage of the surrounding area. The landowner showed us to the crannóg, it has been untouched since 1982 and is consequently quite overgrow with trees and bushes. It was impossible to get accurate measurements of the site and so instead we will rely on the measurements obtained during the examination of the site in 1982.

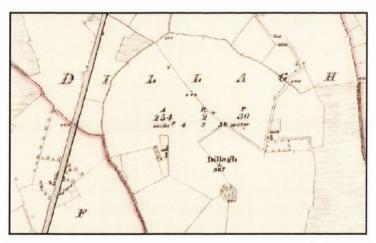
Fig.G.32: The ringfort in Dillagh and the circular field pattern as depicted on the *Ordnance Survey* First Edition six-inch map.

No documentary references to this site were uncovered during this research. Davies described the site, probably in the 1940s when he did his research in Cavan, and the fosse was more evident at that date. The fosse was 6 feet (c.1.82m) wide, with a maximum depth of 3 feet (c.1m). The bank was 7 to 4.5 feet (c.2.1m to c.1.4m) in height from the bottom of the fosse and was 'level with the centre all round'. The ramparts are very overgrown, which makes it impossible to get further measurements. The centre slopes gently S., and was formerly planted. The fort is circular, int. diam. 35 yds' (32m) (NMI monument file for Dillagh townland, county Cavan).

The *Down Survey* map of the barony of Clanmahon includes the townland of Dillagh but does not depict any features within it. The *Maps of the Escheated Counties of Ulster* for the barony of Clanmahon includes the townland of Dillagh and Dillagh Lake, but also does not depict any features within it. The first and second editions of the *Ordnance Survey* six-inch map of the area depict the site as a platform, with trees

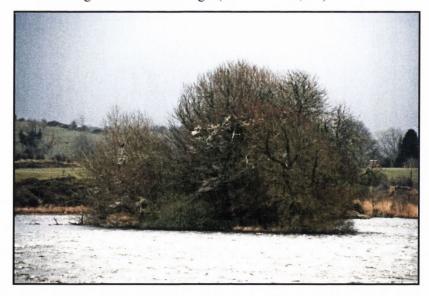
Fig. G.33: Drumcarban crannóg (courtesy of the Photographic Unit, DOEHLG).

This crannóg was not visited during this study, so we must rely on the account of the site compiled by Davies in the 1940s. The NMI monument files include a description of the site by Davies, 'The island is circular, 25 yards (c.23m) across and about 1.5 feet (c.0.45m) above water level. It is much overgrown. It is surrounded by a kerb of large stones one foot (c.0.3m) high and on one shore is visible a small area of platform of square juxtaposed logs. No other wood structure is visible, but this lake has not been affected by recent drainage like Lough Oughter'. He also reports a local tradition that there was a stone causeway running across the lake from the island NE to the lakeshore but he considered it to be unlikely due to the depth of the lake. Davies also noted a stone kerb at a crannóg on Farnham Lough (Davies 1942, 19).

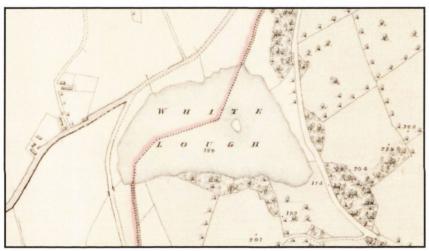
Fig. G.34: Drumcarban crannóg in White Lough Extract as depicted on the *Ordnance Survey* First Edition six-inch map.

The *Ordnance survey* namebook give the name of the townland as Drumcárbán, *Druim Cearbáin* that was translated as Cearban's ridge of long hill. The *Maps of the Escheated Counties of Ulster* includes the townland of 'Dromcarban', with trees and a hill marked on the map, but no other features were included. The *Ordnance Survey* First Edition six-inch map shows the crannóg in White Lough, but it is not labelled.

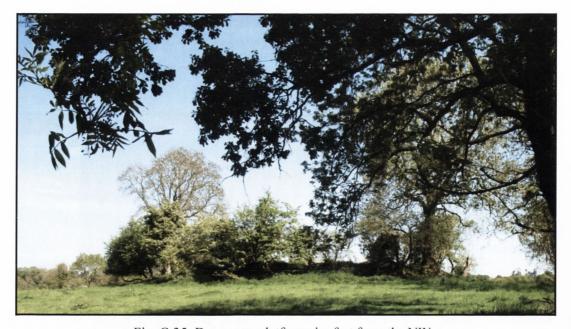
This site consists of an unenclosed platform and any banks and fosses that may have existed are no longer visible. There is a trace of a possible bank on the N side of the site. The platform (34.3m diam. top of platform, 1.15m H. at N, 1.55m H. at S) has no obvious internal features other than the traces of a very slight berm or lip along its edge.

Fig. G.35: Drumeeny platform ringfort from the NW.

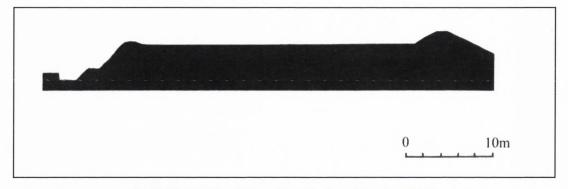
Fig. G.37: Profile of Drumlion Platform Ringfort E-W.

This site consists of a circular platform (int. diam. 31.5m E-W) with a bank or berm around its edge and a fosse at its foot. From the NE to the SE there is a step or terrace on the side of the platform, it is 1.3m above the base of the fosse and is 1.3m in width. Above this terrace the platform is 3m in height. On the W side where this terrace is not present, the platform is 3.3m H above external ground level. The *Archaeological Inventory of county Cavan* indicates that the fosse has been partially recut (O'Donovan 1995, 84) and it is possible that this terrace may be the result of recutting of the fosse or later changes to the site. The fosse is 2m wide on the W and a field boundary has been constructed on its edge. On the E a laneway has been constructed along the base of the platform and while there are traces of the fosse it is impossible to ascertain its original dimensions.

The bank or berm on top of the fosse varies in internal height between 0.25m (E) and 1.35m (W) and is 1.2m in width. The bank and the fosse are overgrown with trees, which include hawthorn trees. The interior of the site is overgrown with nettles and brambles, but generally appears to be quite flat. Two gaps in the bank were observed, one to the SW and another to the SE. The gap on the SE is very overgrown making it impossible to obtain accurate measurements; it appears to have a ramped causewayed entrance. The gap to the NW is marked by a 2m gap in the bank, and there is no causeway at this point. At this point the platform is 1.7m in height above external ground level.

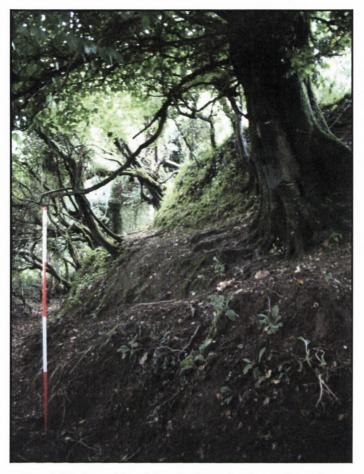
Fig. G.38: East side of the platform ringfort at Drumlion.

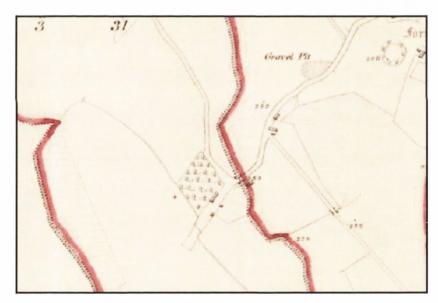
Fig. G.39: Location of Dundavan castle as depicted on the *Ordnance Survey* First Edition sixinch map.

where the O'Reilly families had lived in Dundavan in 1826. In his 1947 article entitled 'The castles of county Cavan' Davies (1947a, 97) stated that 'two houses were indicated to me as O'Reilly residences in 1826 but the antiquity of neither is convincing'. One of these possible locations is the location of the castle site on the RMP map. This stone built house with outbuildings was ruined when Davies visited the site. The other possible location was Brady's public house, a larger than average cottage. As there were no above ground remains of a castle at either site, Davies felt that any identification of the site of this castle was uncertain. The *Down Survey* and *Maps of the Escheated Counties of Ulster* maps of the barony of Clanmahon do not depict a building in this townland. The *Ordnance Survey* First Edition six-inch map depicts the site as a substantial building and two outbuildings with a tree plantation immediately to the north of them. The tree plantation has been removed before the compilation of the second edition but the substantial building continues to be depicted.

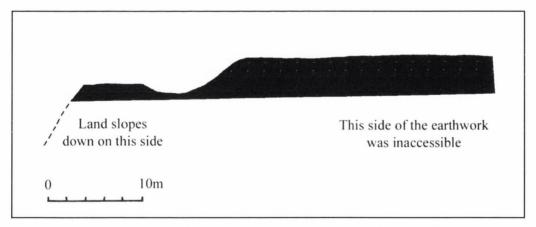
The site consists of a central platform surrounded by a bank and internal fosse. The bank does not surround the entire platform and it is best preserved on the western side. On the northern side the bank is incorporated into a field wall, which is largely composed of stone. The fosse is very wide at this point and a tractor appears to have driven along it regularly in recent times. The fosse on the western side is only 2.75m wide. The bank is missing at the SE where the boundaries of an irregularly shaped field have truncated it.

Fig. G.40: Profile of Dungummin Upper platform ringfort W-E.

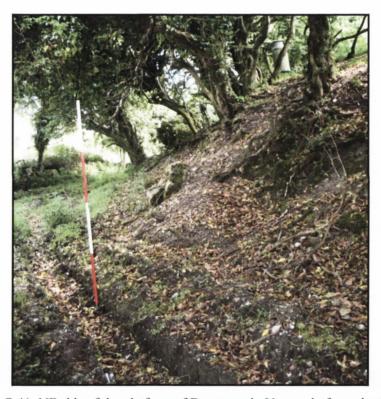
The platform is very overgrown and it was not possible to measure it. The inventory reports that the summit of the site measures c.39.5m NE-SW and c.28m NW-SE. The overgrown nature of the summit makes it impossible to examine its surface or identify any internal features. The tower, recorded in previous reports on the sites was identified at the SW of the platform, but the area was so overgrown that only one side of the tower could be observed. Previous reports have described this structure as a folly of later eighteenth, early nineteenth century construction.

Fig. G.41: NE side of the platform of Dungummin Upper platform ringfort.

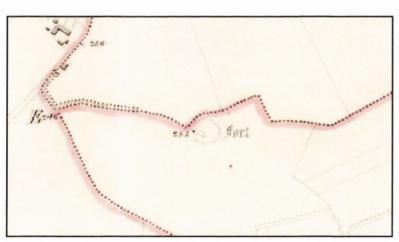
Fig. G.42: The platform ringfort in Dungummin Upper as depicted on the *Ordnance Survey* First Edition six-inch map.

There are no documentary references to Anglo-Norman activity at the site and there is no church in the immediate surroundings. No structures are depicted in this townland on either the *Maps of the Escheated Counties of Ulster* or the *Down Survey* map of the barony of Clanmahon. The *Ordnance Survey* First Edition six-inch map depicts this

site as a sub-circular platform, enclosed by a single line of hachures and located immediately adjacent to the townland boundary between the townlands of Dungummin Upper and Dungummin Lower. A rectangular

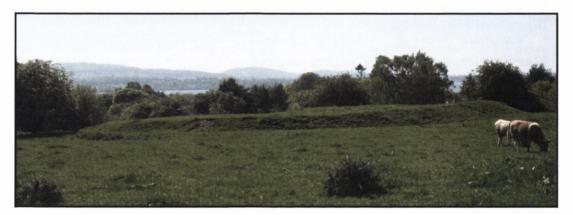
The platform is 1.75m - 2m in height. The enclosing bank is very degraded and is at its highest to the east where the level of the surrounding land drops. At the north side of the site the bank and fosse are low relief and wide and appear to have been

degraded. The bank is c.7m in width and the fosse is c.4m in width at this point. This low, broad profile suggests that the bank and fosse have been significantly modified perhaps through ploughing or land clearance. This bank is described in the SMR files as a counterscarp bank.

Fig. G.43: Fortland I platform ringfort from the N.

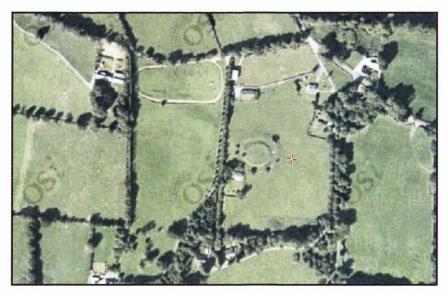
Fig. G.45: Fortland I platform ringfort as shown on the *Ordnance Survey Ireland Map Viewer* ortho-photograph (2005).

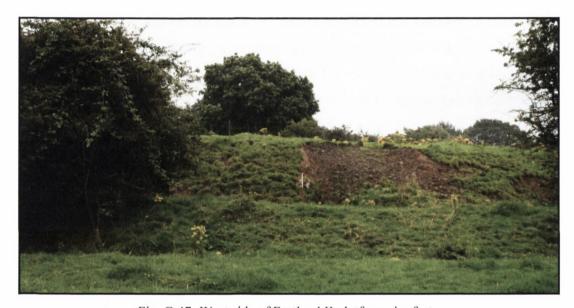
The outer fosse is c.0.2m deep and is largely infilled. It survives best on the western side of the site. The interior of the site is largely clear but there are a number of trees planted around the perimeter of the site and within the fosse. There are the possible remains of an entrance at the SE, where there is a 3.7m gap in the berm and a 5.4m gap in the outer bank and a ramped causewayed entrance between them.

Fig. G.47: West side of Fortland II platform ringfort.

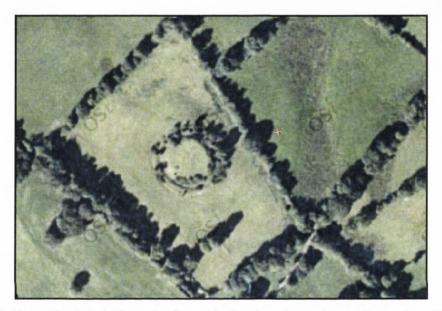
Fig. G.48: Fortland II platform ringfort as depicted on the *Ordnance Survey Map Viewer* ortho-photograph (2005).

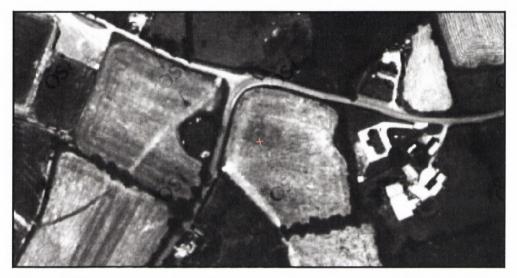
this site as a circular enclosed area, using its standard convention for depicting ringforts. At this date the road has already truncated the site. The second edition depicts the site as a circular enclosure truncated by the road, no hachures are used in its depiction. The *Ordnance Survey Map Viewer* shows the area of the ringfort, standing out against the rest of the field, which is cultivated, while the ringfort had not been cultivated. This would suggest that it has been levelled since 1995.

Fig. G.52: Garrymore ringfort as shown on the *Ordnance Survey* Map Viewer orthophotograph (1995).

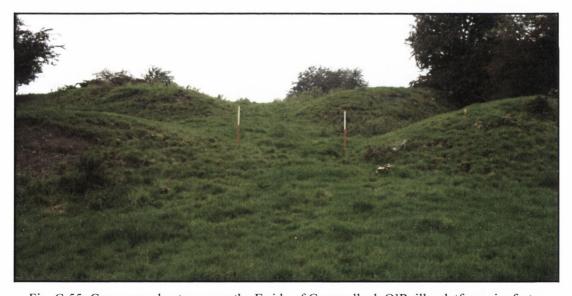
A causewayed entrance feature is located on the east side of the platform and is 4m in width. The inner fosse is largely in-filled and at this point is 3.5m in width. The bank measures 0.8m - 1.15m in height internally. There is a quantity of stone in the western area of the bank and fosse. The outer bank has a very low profile to the east and southeast, with a slight fosse between it and the inner bank. The outer bank and inner fosse are more pronounced at the S and SW and are absent on the west side, where the land drops down sharply from the inner bank.

Fig. G.55: Causewayed entrance on the E side of Garrysallagh O'Reilly platform ringfort.

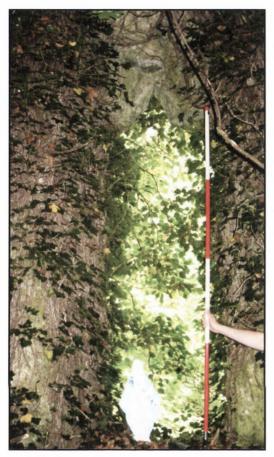
The east window of the church has been badly damaged and the only remaining cut stone is located at the head of the window. The east window in 2.80m in height and 0.95m wide while the embrasure in which it is contained is 1.3m wide. The SMR reports that this window had a ogee-head, while the Archaeological inventory for county Cavan (O'Donovan 1995, 200) relies on Davies (1948b, 81) description of the window, 'at the top is a pointed cusped lintel arch, 8in. wide, unglazed and with slightly concave chamfer on outer edge'. The window head is in poor condition in the interior of the church and it is difficult to view it from the exterior due to the overgrown nature of the site. Davies (1948b, 81) has suggested that this window head might have been inserted from an older church. Although the church is in a ruinous and overgrown state it is clearly still frequented for devotional reasons. There is a

statue of the Virgin Mary resting on the sill of the east window and other statues and medals throughout the church.

Fig. G.58: East window (int.) in Kill Church.

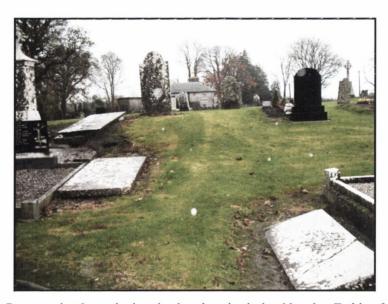
Fig. G.61: Graveyard at Lavagh church, showing rise in land level at E side of graveyard.

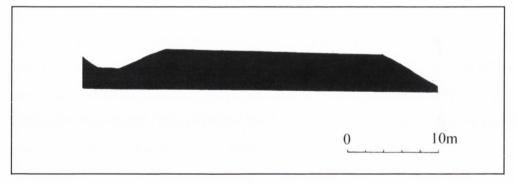
This site is a classic pudding bowl shaped motte, and there are traces of a surrounding fosse on the north side of the site. A laneway runs around the S and W sides of the motte and a landscaped garden has been created at its eastern side. The motte varies in height between 3.10m (N) and 2.10m (S) and the summit is 23.6m N-S and 27.7m E-W. On the N side of the motte a flat-bottomed fosse can still be observed (W. 2.4m, depth below external ground level 1.1m). The fosse and the sides of the motte are overgrown with trees and bracken. There is a stone revetment on the inner face of the bank at the NE, and it is probable that it is associated with the stone shed located north and above it. It is clearly a later feature and probably associated with the estate type landscape depicted on the *Ordnance Survey* First Edition six-inch map of the area.

Fig. G.64: Profile of Lavagh motte N-S.

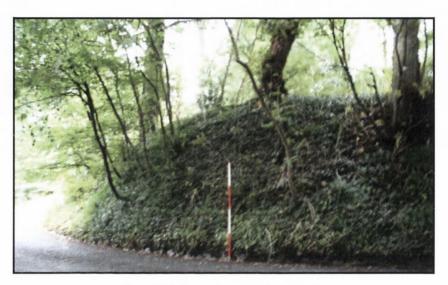
There is a small depression in the centre of the summit of the motte, with dimensions of 1.8m N-S and 1.1m E-W. It may be the result of the felling or collapse of a tree. The eastern side of the motte has been landscaped into a terraced garden.

Fig. G.65: Lavagh motte from the S.

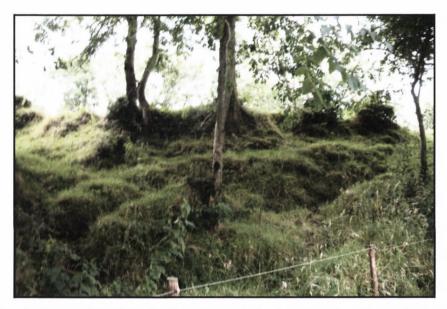
landscape and is lower than the natural ground level on both sides. The ringfort is c.2m higher than the laneway and this is due to the natural fall in ground level due to the ridge on which the site is located and the construction of the laneway. It does not appear to be the result of a deliberate attempt to raise the level of the ringfort. This slope down to the lane includes a terrace like feature that runs along the route of the laneway and is likely to be a product of the lanes construction. There is no sign of the bank at the NW side of the site and the edge of the site is marked by trees that form the field boundary.

Fig. G.68: East side of the ringfort at Legaweel, taken from the adjacent laneway.

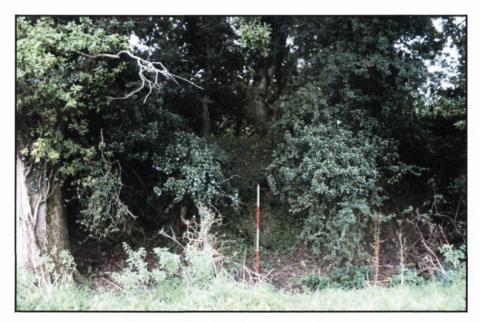
Helen Lanigan Wood indicates that the original entrance was probably at the E, where there is a gap in both banks and the slight remains of a causeway across the fosse. Lanigan Wood also records the presence of a second gap in the inner bank or berm at the SE, but with no corresponding gap in the outer bank. Despite this fact the *Archaeological inventory of county Cavan* concludes that the gap in the SE also apparently represents an original entrance. Lanigan Wood describes the interior of the site as fairly level, with a slight slope to ESE.

Fig. G.73: The NE side of Lismore platform ringfort.

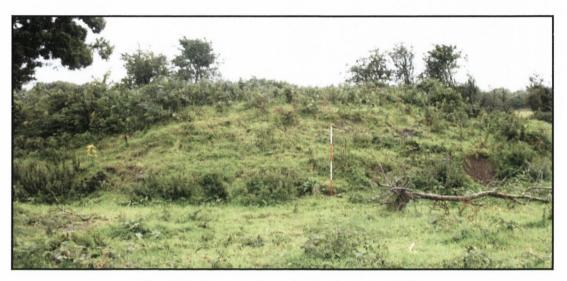
This mound is 1.95m H at the SSW and 2.45m H at the NNE and there is no indication of a bank or berm along the edge of the site. There is a sub-circular depression (diam. 6.2m, depth 0.2m) on the summit of the motte at the SE of uncertain function. The site is covered in bracken and an ash tree grows against the E side of the mound.

Fig. G.78: Moat platform ringfort from the NNW.

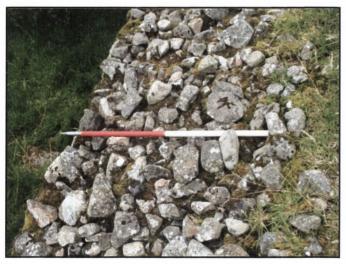
This site consists of a sub-circular area (diam. 39.75m) enclosed for at least two-thirds of its circumference by a dry-stone wall 1.45m in width and 1.05m in height. The wall is absent from the SSW to the NNW, where a laneway has been constructed along the side of the site. Sheds have been constructed close to the site and to it NW. The interior of the site has been built up to a higher level than the surrounding wall. A profile was compiled from NNE-SSW to illustrate the intact wall and the shape of the site where this is absent. Starting from the NNE, there is the stone wall 1.65m H and 1.45m W

Fig. G.79: The enclosing wall at Moydristan Cashel

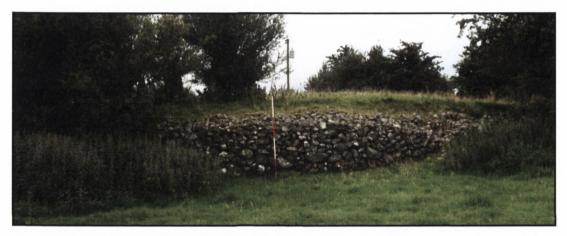
Fig. G.81: Moydristan Cashel from the NE.

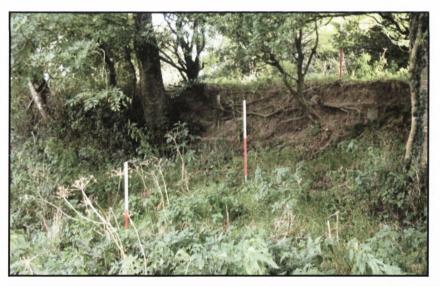
The original entranceway is not recognisable but this may be due to the overgrown state of the site. An SMR site report dating to 1970 reports the presence of a rock outcrop in the higher area of the interior, but there was no sign of this when the site was visited. The site does not appear to have been overgrown when the site was visited at this date, which may account for this difference.

Fig. G.84: NW side of the platform of Moynagh Lower platform ringfort.

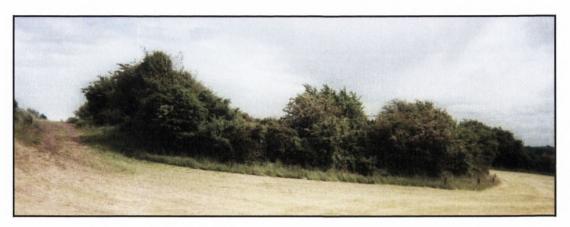
The bank appears to have been removed from the north side of the site and it is probable that it was removed during ploughing in the area. The surrounding fields are very flat and featureless. There is a possible entrance feature on the south side of the site, where there is a gap in the enclosing bank and an access way to the platform. The site is too damaged to be able to establish with any certainty whether this is an original feature. The bank on the south side has a very high stone content.

Fig. G.86: Moynagh Upper platform ringfort from the N.

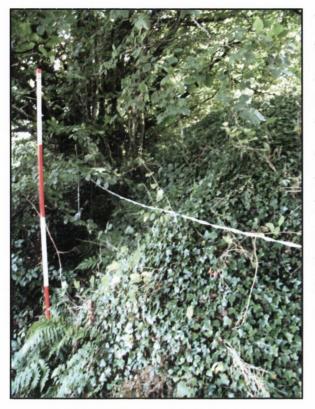
Fig. G.90: NW side of Omard platform ringfort.

There are two gaps in the bank, one to the NW and one to the NE. The gap to the NW is 1.4m wide internally and 1.9m wide externally. There is little evidence for a causeway and it does not appear to be the original entrance. The gap in the NE is largely overgrown, making it impossible to obtain accurate measurements (c.3m wide from SMR field report dated 1986) or establish whether or not there is a causeway.

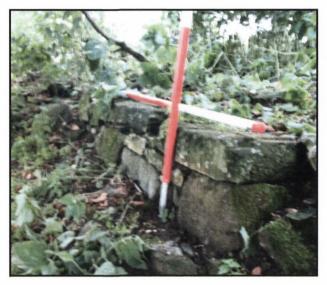
Fig. G.92: NW corner of the stone foundations on top of Racraveen motte.

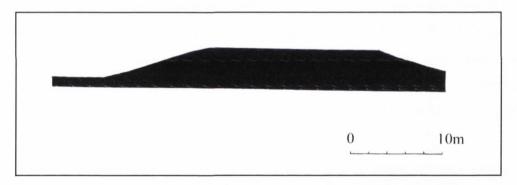
Fig. G.93: Profile of Racraveen motte N-S.

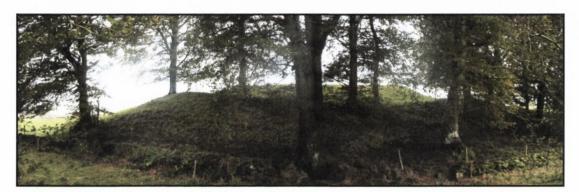
The surrounding bank varies in height, it is lower at the western side, but the land falls away quite sharply on this side and therefore there might have been less need for a bank here. Alternatively it might have degraded over time. There is some evidence for stone in the bank, and the walls of the surrounding fields are of dry-stone construction. Similarly the bank is entirely absent at the north side, where there is a sharp drop in the ground level. The bank is quite substantial to the northeast and east. At the east side the bank is 2m wide and the fosse is 5m wide.

Fig. G.96: Raheever platform ringfort from the NNW.

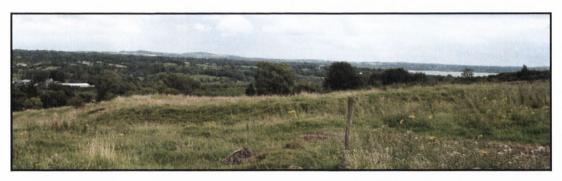
Fig. G.99: Tawlaght ringfort from the SW.

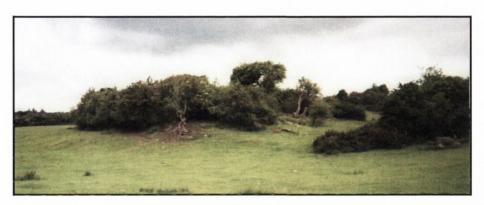
Fig. G.101: Tullygullin enclosure from the S.

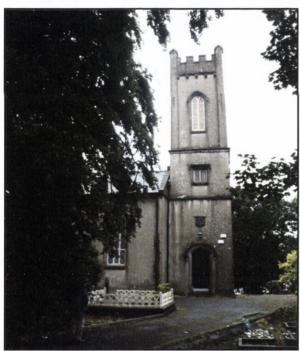
Fig. G.103: The nineteenth century church of Ireland church in Abbeylands.

A disused Church of Ireland church now occupies the site and a date stone above its doorway records the year 1821 and the name of the churchwardens Eaton Edwards and Robert Briscoe. Carrigan (1905, IV 208) suggests that the remains of the abbey may have been removed during the clearing of the site for the construction of this church. The eighteenth century gravestones in the graveyard would indicate that it was in use prior to 1820. The graveyard is surrounded by a stone wall that appears to be contemporary with the church.

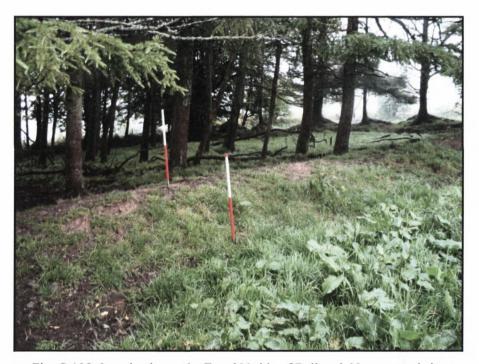
Fig. G.108: Low banks on the E and N side of Ballygub New moated site

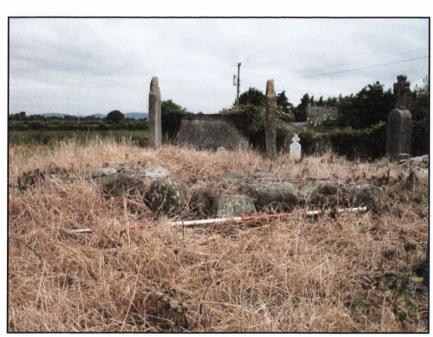
The graveyard is sub-rectangular in plan and can be divided into a northern and a southern section. The southern section has a higher ground level. The southeast corner of the graveyard is the highest part of the graveyard and it contains the footings of two parallel sections of stone wall. The north wall footing is 5.50m in length and 0.80m in

Fig. G.117: Stone footings of the south wall of Ballytarsney Church.

width, while the southern wall footing is 3.60m in length and 0.90m in width. The distance between the two walls is only 4.60m, meaning that if these walls represent the remains of a church it was a

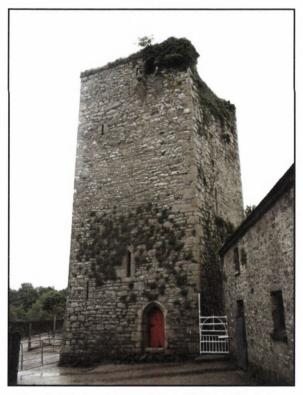
Fig. G.122: Brownsford tower house, from the NW.

This is a well-preserved five-storey tower house, with a base batter and a wall-walk level. It is vaulted above the first floor and the internal dimensions at this level are 4.20m (E-W) x 5.80m (N-S). The tower house is orientated NNW-SSE, but for the purposes of this report it will be assumed to be orientated N-S. The tower house is accessed via a door in the north wall, with intra-mural staircase in the thickness of this wall. This staircase provides access to the first floor, from where it continues up

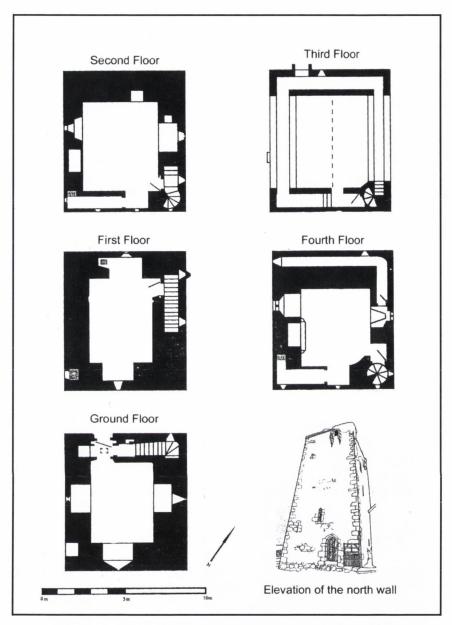
Fig. G.123: Plan of Brownsford Castle (after McCarthy 2007).

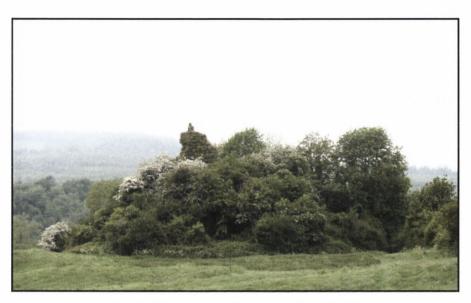
There is a fosse at the base of the motte, which is now only visible on the northern side, but Orpen reported in the early twentieth century that it was visible on all sides particularly 'on the land side' (Orpen 1909, 323). O'Conor reports that this fosse is 4.5m wide from the base of the motte to the exterior lip of the fosse. It is 1.2m in depth

beneath the external ground level and a modern drystone wall revets its edge (O'Conor 1993, 492).

Fig. G.130: Motte in Clonamery from the W.

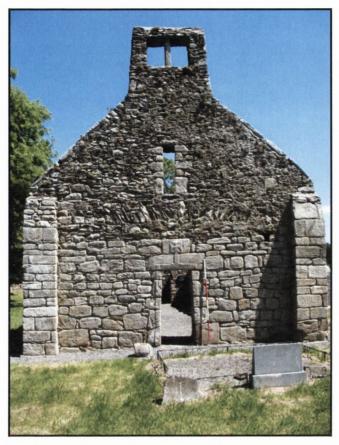
Fig. G.132: Exterior west wall of Clonamery church featuring bell-cote and Maltese cross above the doorway.

There is a lintelled doorway at the west end of the church, this would have been the entrance to the original single-celled church. The exterior of this door is beautifully decorated with a Maltese cross carved above the lintel. The north and south walls extend slightly beyond the west gable, and these projections are called antae, the function of these antae was to support the ends of the roof. Above the lintel and the carving there is a relieving arch, and above that again a single light rectangular headed window set within a narrow embrasure. Finally, the west gable is surmounted by a bell-cote. The masonry above the doorway and its carved lintel appears to be part of a later period of construction.

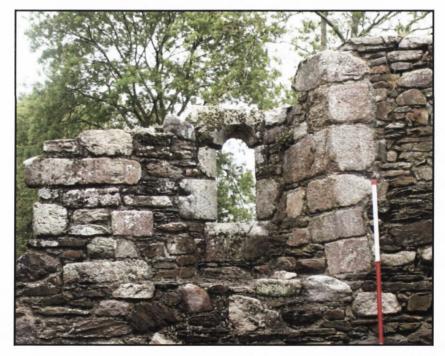
The west wall of the chancel contains the chancel arch and no other features of note. The south wall of the chancel contains a round-headed doorway set within an embrasure and east of the doorway is a rectangular single-light window set within an embrasure. The east wall of the chancel contains a simple single-light round-headed window set within an embrasure. The north wall of the chancel is badly damaged, and the west end of it is missing completely and the east end only survives to a height of 0.78m. The sacristy was added to the north side of the chancel. The break in the line of the north wall of the chancel and the south wall of the sacristy may indicate the position of a doorway into the sacristy from the chancel. The north and west walls of the sacristy are featureless, while the east wall contains a rectangular headed single-light window.

Fig. G.133: Interior of east window in Clonamery church.

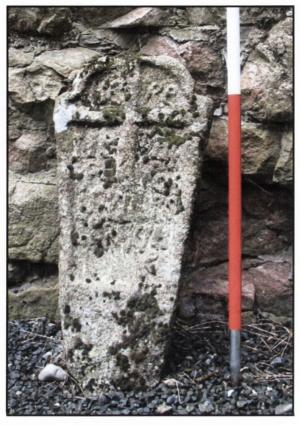
There are a number of cross-slabs in the nave, one of which is an unusual Christian pillar stone with crosses carved in relief. There are a further three cross slabs at the west end of the nave. These are simple stone slabs with a cross carved in high relief. There are a number of memorials on the internal walls of the church and there is

Fig. G.134: Cross-slab in the church in Clonamery.

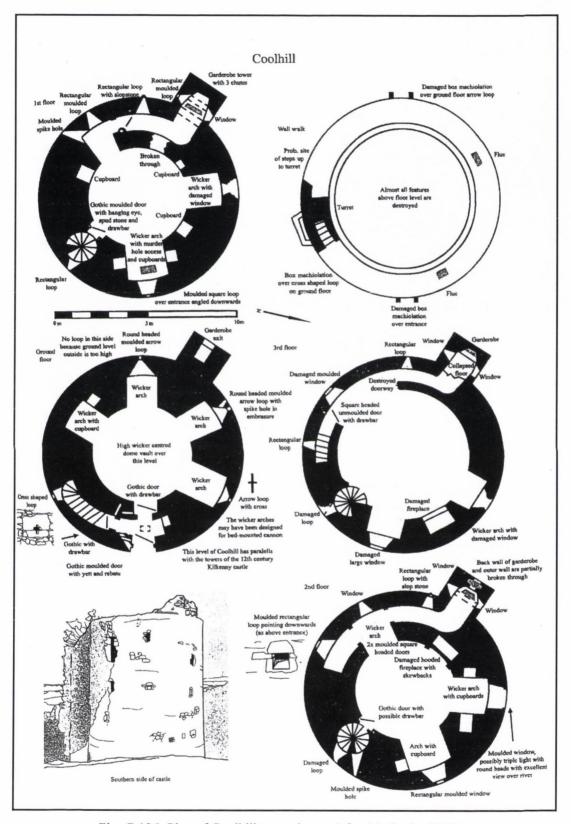
Fig. G.136: Plan of Coolhill tower house (after McCarthy 2007).

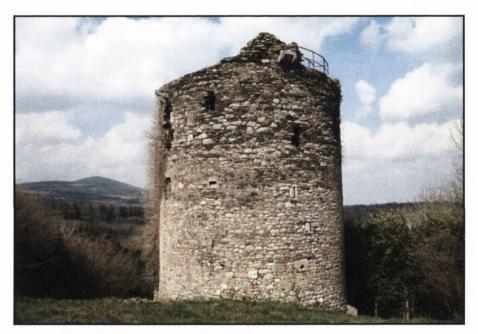
Fig. G.136: Coolhill Castle from the SW.

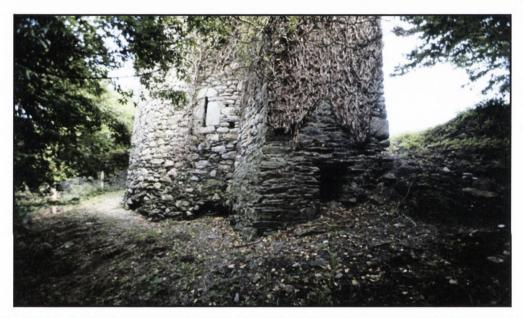
Fig. G.139: Garderobe tower on the NW side of Coolhill castle (courtesy of the Photographic Unit, DOEHLG).

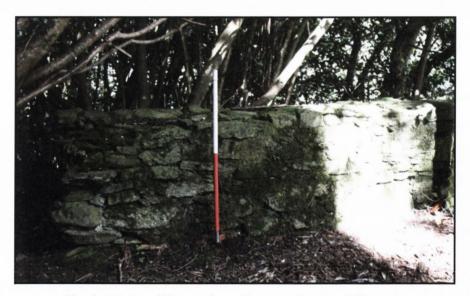
Fig. G.140: Possible remains of bawn wall at Coolhill castle.

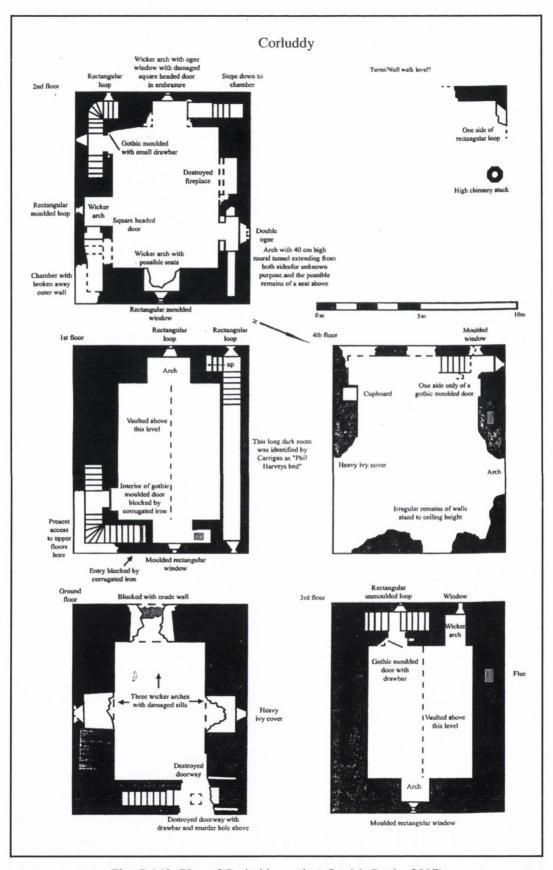
Fig. G.142: Plan of Corluddy castle (after McCarthy 2007).

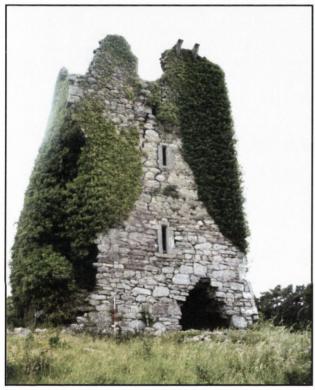
The first floor would have been supported by a wall plate, which rested on corbels on the north and south walls and was inserted into sockets in the corners of the east and west walls. There is a pointed vault above the first floor. There are rectangular single-light windows in square embrasures in the east and west walls at this level. The window embrasure in the east wall has access at its north side to the top of the murder hole.

Fig. G.143: Corluddy tower house from the east.

The second floor sits on top of the first vault and is accessed via a set of intramural steps. The intra-mural staircase runs within the thickness of the east, south and west walls, moving clockwise around the castle as it travels up its height. The north wall contains an intra-mural staircase between the level of the first and second floors.

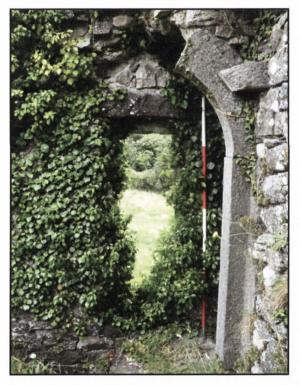
Fig. G.144: Entrance to the fourth floor of Corluddy tower house.

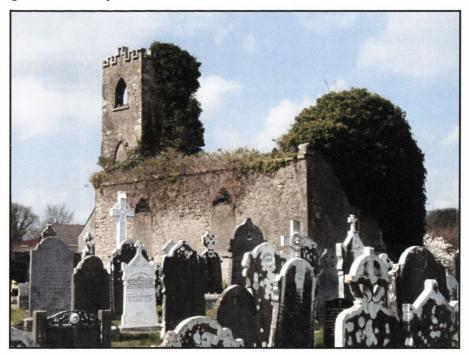
The church site (KK033-032---) is occupied by the remains of a nineteenth century Church of Ireland church which Carrigan (2005, IV 124) records was constructed c.1800 on the site of an ancient parish church. There are no visible remains of the earlier parish church on this site, and the earliest graveslabs noted during the site visit were eighteenth century in date.

Fig. G.148: Disused nineteenth century Church of Ireland church in Farrantemple townland, in the hamlet of The Rower.

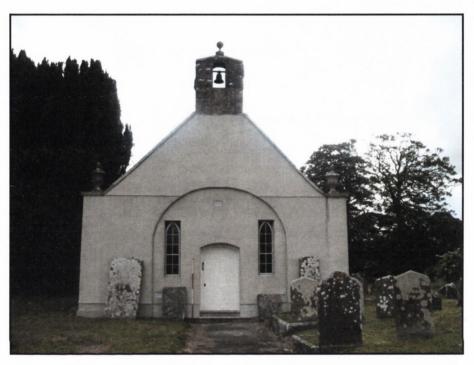
The chancel was converted into a mortuary chapel and mausoleum for the Earls of Bessborough, who had an estate in nearby Piltown. The church would therefore originally have extended almost to the gate of the churchyard and this is reflected in the *Ordnance Survey* First Edition six-inch map. There is a vault under the east end of the church, and it can be accessed via an entrance in the floor of the mortuary chapel. The only visible features of an antiquity are a stone head above the east window on the

external wall surface and the fragments of at least two altar tombs. The stone head above the east window appears to be a female head, but it is badly damaged. Carrigan (1905 IV, 216) noted a stone effigy of the Blessed Virgin fixed to the wall over the east window, and it is possible that this stone head might be part of this effigy.

Fig. G.150: The chancel of Fiddown church, now used as a mausoleum chapel.

The east and west walls extend beyond the sidewalls, and may represent the walls of the earlier church. The interior of the church appears to be well maintained, while the graveyard, especially to the rear of the church is very overgrown. Most of the legible headstones in the graveyard are eighteenth and nineteenth century in date. Fragments of altar tombs rest against the west end of the church. The lichen growth on these fragments has made them illegible, so we must rely on earlier descriptions of them. One of these fragments is the lid of an altar tomb and a portion of the Latin inscription in raised gothic lettering was visible in a broad border running down one side and one end of the slab. Carrigan notes a plain latin cross down the centre surmounted by an IHS monogram. The inscription reads 'Haec sunt monumenta D Fulci Den Filii secundi D Den et Catherinae Geraldinae conjugis quorum animae in pace requiescant 1618' (SMR report). A granite font was formerly in the graveyard but it was removed in the last century to the old chapel in Piltown. It has an oval shaped bowl and

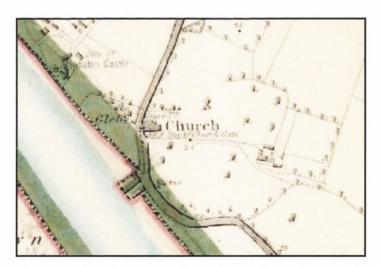
Fig. G.151: Fiddown church as depicted on the Ordnance Survey First Edition six-inch map.

The *Down Survey* map for the barony of Iverk does not depict a church in the townland of 'Fiddowne'. Two structures are depicted within the townland, but neither appears to be a church. An area of glebe land is marked with a cross to the east of the settlement at Fiddown. The *Ordnance Survey* First Edition six-inch map includes the church and graveyard, and the curve in the road which runs to its south may preserve the line of a circular enclosure around the site. The plan of the church depicted on this map indicates that the church had not yet been reduced in size to the current mortuary chapel, but its depiction on the second edition map indicates that by 1901 the plan of the church had been reduced in size significantly, which would correlate with the information provided by Carrigan.

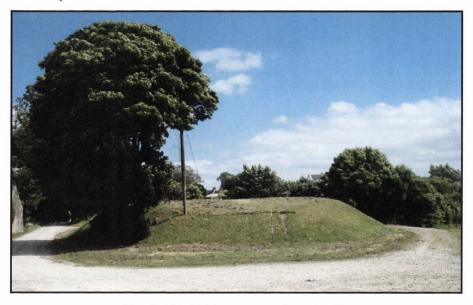
Fig. G.152: Fiddown motte from the W.

This motte appears to have been modified to a large extent and it is now has an irregular in plan. The motte is 20.60m in length (E-W) and 7.40m to 26.10m in width (N-S), its narrows at its northern end. The motte is c.2.50m in height and is quite steep sided, except to the NE where the slope is more gentle and where it appears that machines access the site for grass cutting. The site is surrounded by modern roadways on three sides (N, S and W) and there is no evidence for a bank or fosse surrounding the site. The top of the motte is flat and featureless.

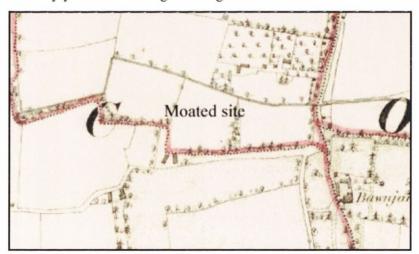
Fig. G.156: The moated site in Garranbehy Big as depicted on the *Ordnance Survey* First Edition six-inch map.

The *Down Survey* map of the barony of Ida shows four small buildings, possibly cabins in the townland of 'Garanbeghy'. The *Ordnance Survey* First Edition six-inch map depicts two houses in the area the SMR indicates as the location of the moated site. The area identified as the possible moated site is depicted in the same way as the field boundaries in this area.

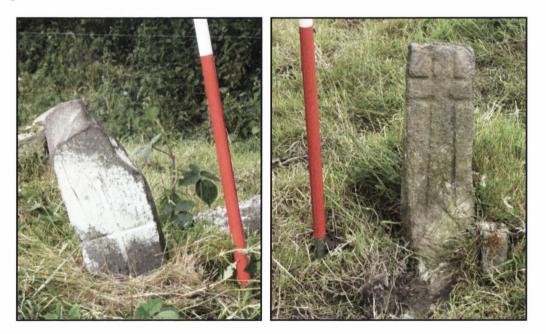
Figs. G.157 and G.158: Cross-slabs in the graveyard at Glenballyvally church site.
