Later medieval cross-cultural interactions: the settlement evidence in the baronies of Overk, county Kilkenny and Clanmahon, county Cavan

By Linda Shine

Volume II: Gazetteer of sites surveyed

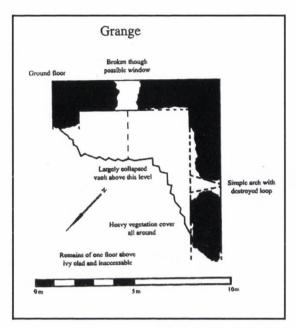
Fig. G.160: Plan of Grange tower house (after McCarthy 2007).

This is a poorly preserved tower house (int. dims. 5m NE-SW by 7.75m SE-NW), with only two surviving walls (SE and SW), and a very short length of a third wall (NE) all of which are overgrown with ivy. The walls, which are constructed of randomly coursed limestone rubble and a gritty lime mortar, are 1.55m thick. There are the remains of a pointed barrel vault above the ground floor and part of the first floor above the vault survives. The height of the vault (*c*.4m) and the presence of joist holes in the SW wall, suggest that there would have been a loft under the vault. The SW wall also contains the remains of a window at ground floor level (H. 0.9m, W. 0.25m), there is no surviving cut stone in this single-light rectangular window with a widely splayed embrasure and flat lintelled head. There is a small rectangular ope set into a splayed, round-headed embrasure, east of the centre of the SE wall (H. 1.55m, min W. 0.3m). There is a lintel stone and a relieving arch above this window.

The remains of at least two possible windows can be observed through the ivy at first floor level (above the vault) of the SW wall. The window at the west end of the SW wall is very overgrown and appears to be broken out with no surviving cut stone. The second possible window is located S of the centre of the SW wall. The remains of an arch above this ope were noted, but it was great obscured by ivy.

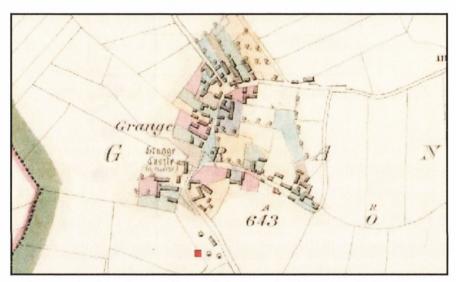
Fig. G.161: The site of Grange castle as depicted on the *Ordnance Survey* First Edition sixinch map.

The *Down Survey* map for the barony of Iverk depicts a church surrounded by a number of small structures, possibly houses, in the townland of 'Grange'. No castle is depicted within the townland. The *Ordnance Survey* First Edition six-inch map marks the castle site at the SW edge of the settlement of Grange and labels it 'Grange Castle (in ruins)'

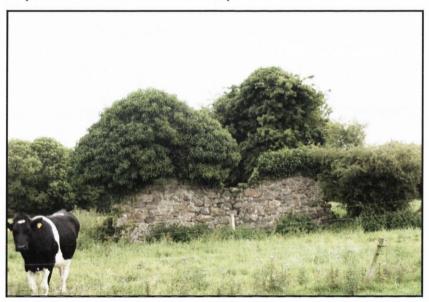
Fig. G.162: Killaspick Church in Grange townland.

The church is in ruins and very little of the original church survives (12m E-W by 6m N-S). It is located in the centre of a large field, but is separated from it by a barbed wire fence designed to keep the cattle grazing in the field away from the church remains. At the time of the field inspection there was a bull in the field, so it was only possible to conduct a quick survey of the church while the landowner was present. All dimensions quoted are taken from the field report in the SMR file.

Only the west gable survives to any height (3.4m H.) and it is heavily overgrown with ivy. There are the remains of a window ope at the centre of this wall, which indicates

the former position of the window, but there is no surviving cut-stone and the head of this ope has been removed. The other walls only survive to foundation level. At the east end of the area enclosed by barbed wire is a large eighteenth century headstone with a wall behind it, which was probably erected to support this graveslab. It may indicate the location of the original east wall, but this is not an original section of wall. The graveslab is decorated with the arms of the Bowers family of Waterford and bears the date 1716.

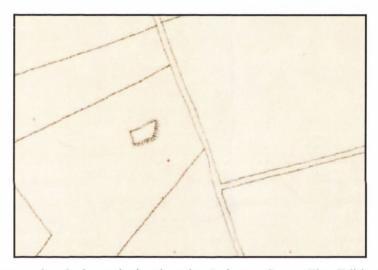
Fig. G.164: Grange church site as depicted on the *Ordnance Survey* First Edition six-inch map.

The *Down Survey* map for the barony of Ida includes the townland of Grange, but does not depict any structures within it. The *Ordnance Survey* First Edition six-inch map includes the rectangular platform, but des not label the site and the platform is not marked on the *Ordnance Survey* twenty-five inch map.

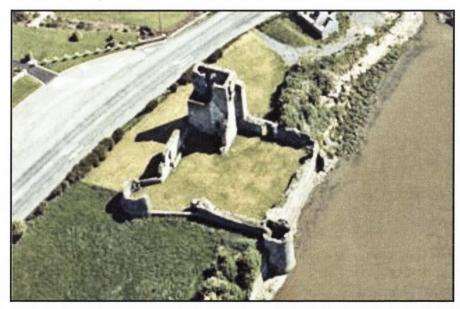
Fig. G.165: Aerial photograph of the Granny castle complex (courtesy of the Photographic Unit, DOEHLG).

The castle essentially consists of an enclosure, with a tower and hall at the NE corner and the remains of a possible windmill protruding from the NW corner. The south side of the castle is dominated by a series of three stone towers, connected by stone walls, constructed along the bank of the River Suir. Two of the towers are located on the corners of the enclosure and are connected by a thick curtain wall (2.25m), while the third tower is located west of the main enclosure, connected to it by a substantially thinner wall. A simple gateway with draw-bar holes in the E wall, appears to be the original entrance way to the castle complex.

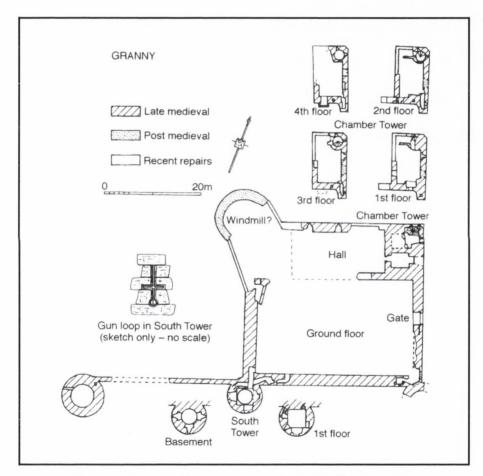
Fig. G.166: Plan of Granny castle (after McNeill 1997, 186).

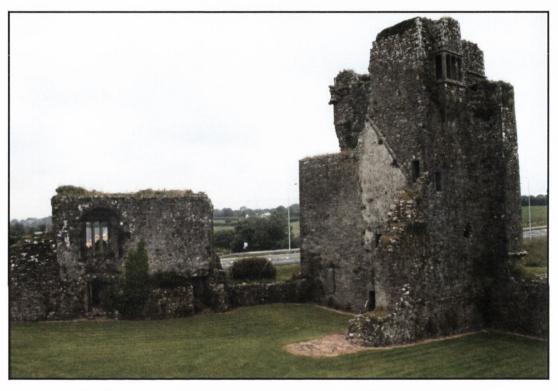
Fig. G.167: Accommodation tower and hall building in Granny Castle complex.

The S wall of the tower is located within the enclosure and the lower storeys of this wall are quite featureless. There is a string course 2m above ground level, possibly connected with the vault above the ground floor. The SE corner of the tower projects to accommodate the garderobe chute. The junction between this projection and the

south wall is curved. There is a large window or square headed doorway at the W end at second floor level. It has similar dimensions to an ope at this level in the adjoining west wall. There is a large oriel window with five oval headed moulded windows at fourth floor level. Leask (1941, 106) has argued that this oriel is a seventeenth century addition but McNeill (1997, 185) has stated that the evidence for this is no longer visible.

A hall was attached to the W. side of this tower, the gable coping for this hall can be seen on the W gable of the tower and the remains of sections of the N and S walls of the hall survive. There is a doorway with a simple round arch in this wall of the tower house. This doorway would have been accessed from inside the hall building and it is probable that the only access to the tower was through the hall. There is another doorway almost directly above this, which would have provided access to the first floor level. The ground floor, which has a vaulted roof, is divided into two separate chambers: one is accessed via the ground floor doorway and one is accessed via a staircase from the first floor. There is another large ope on the south side of this wall at the level of the roof of the hall. While it is much smaller than the other doorways in

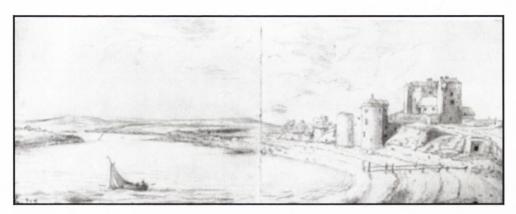
Fig. G.173: 'Castle Granne 1 mile from Waterford 1699' by Francis Place, held at the Victoria and Albert Museum, London.

By comparing this drawing to Francis Place's drawing of the castle would suggest that this is a depiction of Granny Castle. Francis Places late seventeenth century drawing of the castle indicate that it was a substantial complex of which the surviving residential tower and tower on the riverfront were a small part. This depiction indicates that the hall building was a two-storey structure and that where the remains of the windmill are now located was once occupied by a round corner tower and another tower, similar to the surviving residential block. Edwards (2000, 69) has argued that Granny Castle was 'a focal point in the feudal power of the earldom' and Place's depiction would suggest that this was both the home of an important individual and an important administrative centre. The *Down Survey* map would suggest that there was a settlement nucleation at Granny in the seventeenth century and the 1415 extent of the manor, could indicate that this settlement nucleation was in existence since before that date.

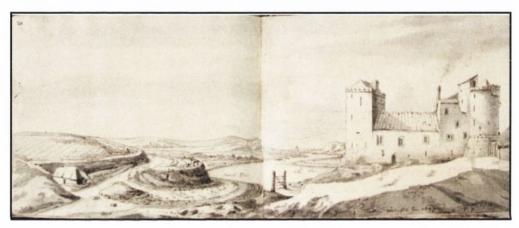
Fig. G.174: Francis Place's drawing of Granny Castle 1699, held in the Victoria and Albert Museum, London.

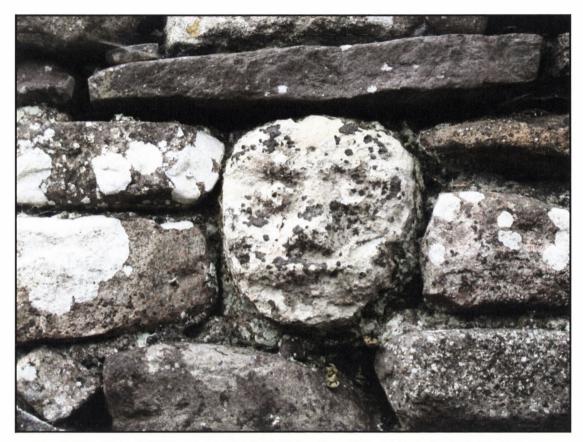
Fig. G.176: Stone head located in the farmyard wall at Kilcraggan, Ballytarsney, county Kilkenny.

The only other feature of archaeological note at the site is a stone head that has been built into the wall of the farmyard. It is probable that this stone head came from a church or other religious building. Carrigan (2005, IV 154) translates the townland name as the church of the rocky land, which he argued indicated that there was a church stood in the 'Crochteen' at Mr O'Halloran's house. A fragment of a wayside cross was moved from Kilcraggan to Thinvane House, near Carrick-on-Suir by the Briscoes several year before Carrigan visited the site (Carrigan 2005, IV 155). The cross fragment was decorated with a heraldic shield of the Leonard family and an inscription which included the date 1622. These accounts have led to the suggestion that there were ecclesiastical structures on the site.

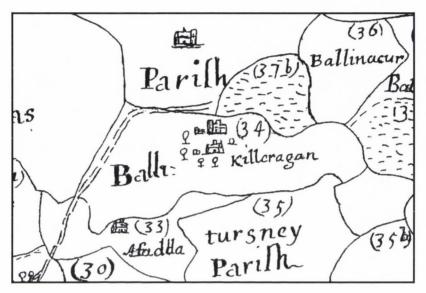
Fig. G.177: The townland of Kilcraggan as depicted on the *Down Survey* map of the barony of Iverk.

The inclusion of the castle site and the possible adjacent ecclesiastical site in the SMR appears to be based on Carrigan's account, which is outlined above and the *Down Survey* barony map. The *Down Survey* barony map includes two large buildings, perhaps a castle and a church, as well as two small cabins in the townland of Kilcraggan. These buildings appear to be surrounded by trees. The 1653 survey of the lands granted to the countess of Ormond includes an old ruined castle and some thatched cabins in the valuation of Ballytarsney (Manning 1999, 52). This castle could

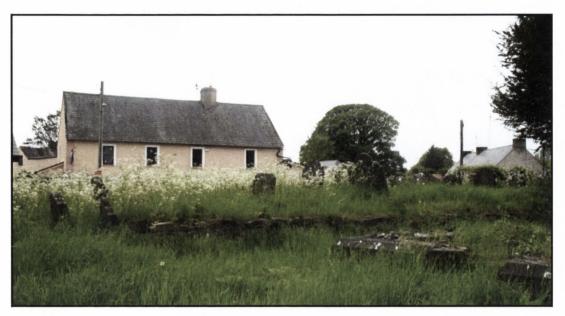
Fig. G.179: The graveyard at Kilmacow church site.

The site of the church is now an overgrown graveyard and there are few traces of the church. The south end of the graveyard is raised above the level of the rest of the graveyard, and this area contains the vast majority of the gravestones. There are stone walls against the north and west sides of this raised area. Many of these graveslabs date to the eighteenth century, including the early to mid-eighteenth century (1721, 1732 and 1744). There is a gateway in the west end of the south wall and close to this on the raised area there is a small square stone structure with approximate dimensions of 4m x 4m. There is an arch in this structure that runs east to west. The function of this structure isn't immediately obviously and Barry has suggested that it could be a mausoleum or an ice-house (Terry Barry, pers. comm.).

The graveyard contains the remains of a vault and an inscription on its north side states that it is the family vault of the Greenes of Greenville. This structure may be the possible tower foundations referred to in the SMR file for the site and of which I can find no other trace. It is possible that the vault could have been inserted into the former church. There is now no trace of the grave slab, a rubbing of which was made by John Hogan and donated to the *Kilkenny and South-East of Ireland Archaeological Society* (later the *Royal Society of Antiquaries*) in 1864-6. An account of the donation was included in the journal and it indicated that it was a coffin-shaped tombstone on which an interlace cross was inscribed along with the following dedication; 'thys done be edmonde butler and bi katrin b hys wyf anno d m ccccc lii' (1552) (Anon 1864, 114). Carrigan gives a slightly different account of the inscription, but the pertinent facts are the same, the inscription is to Edmonde Butler and his wife in the year 1552 (anno dn' mccccclii).

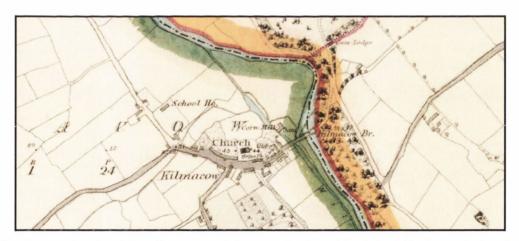
Fig. G.181: The church in Kilmacow and the curve in the road south of the site as depicted on the *Ordnance Survey* First Edition six-inch map.

appears to be a portal tomb and could be the Leacht of Kilmacow. A bridge over the river Blackwater is depicted adjacent to this nucleation and a fording point on the river could have been the impetus for the establishment of a settlement at this location. The *Ordnance Survey* First Edition six-inch map for the barony of Iverk depicts the church within a rectangular graveyard, with a curved street pattern to its south. In the first edition six-inch map the church is simply labelled church, but it is labelled 'St. Mochua's Church' on the twenty-five-inch map.

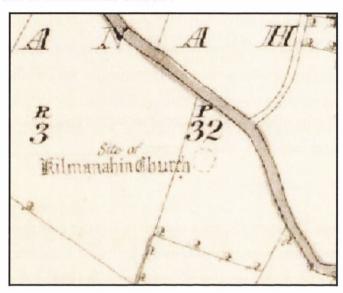
The *Down Survey* map of the barony of Iverk does not depict any structures within the townland of 'Killmanagh-heene'. The site of Kilmanahin church is marked on the *Ordnance Survey* First Edition six-inch map as a circular area enclosed by broken line, and is labelled 'site of Kilmanahin Church'.

Fig. G.182: Kilmanahin church site as depicted on the *Ordnance Survey* First Edition six-inch map.

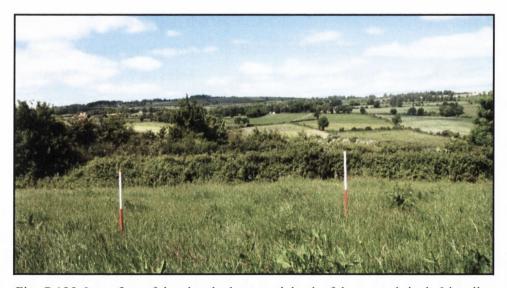
The site consists of a roughly rectangular area enclosed by a field banks on the north and east sides and broad low banks on the south and west sides. The bank on the south and west are very low relief and difficult to identify when the site was visited as the field was under long grass. The field banks were very overgrown and it was difficult to estimate their dimensions, they were certainly more than 1m in height. The best evidence available for the original form of this site is its depiction on the *Ordnance Survey* First Edition six-inch map of the area (reproduced on the following page).

Fig. G.185: Inner face of the ploughed out north bank of the moated site in Listerlin.

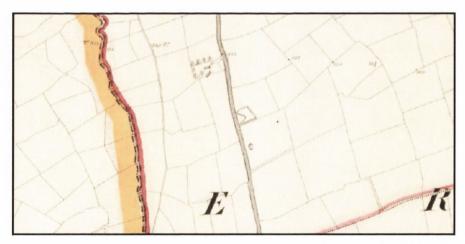
No documentary references or antiquarian accounts of this site were uncovered during the course of this research. The site was not marked on the *Down Survey* map of the barony of Ida. The site was marked on the *Ordnance Survey* First Edition six-inch map of the area but not on subsequent editions leading to the conclusion that the site was levelled between 1839 and 1901 (Barry 1977, 192). A detailed account of the historical references to Listerlin are included in the gazetteer entry about Listerlin motte (KK036-026---).

Fig. G.186: The moated site in Listerlin as depicted on the *Ordnance Survey* First Edition sixinch map.

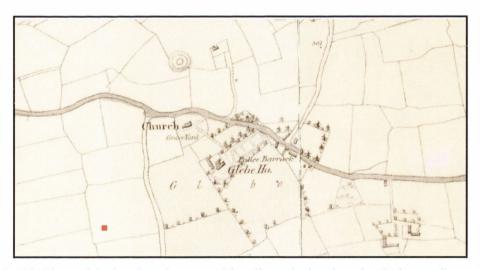
Three cabins are also depicted to the west of the church site. The *Ordnance Survey* First Edition six-inch map depicts the church within a sub-circular graveyard. The graveyard has curving boundaries to the north and east and rectilinear boundaries to the west and south.

Fig. G.189: The parish church and motte at Listerlin as depicted on the *Ordnance Survey* First Edition six-inch map.

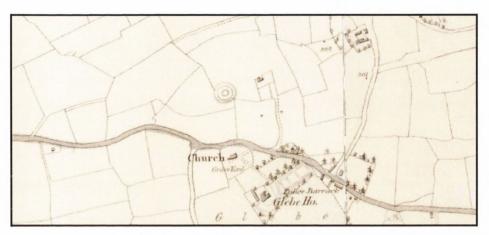
The *Ordnance Survey* First Edition six-inch map depicts the motte in Listerlin with a series of concentric circles of hachures. These hachures show the dished summit of the motte, as well as a fosse around the base of the motte.

Fig. G.192: The motte in Listerlin as depicted on the *Ordnance Survey* First Edition Six Inch map.

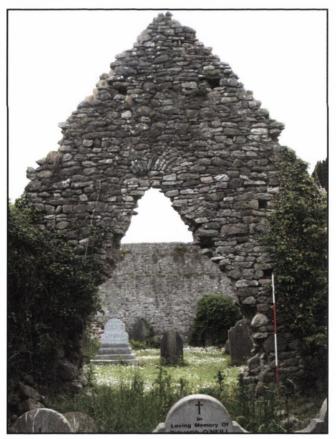
Fig. G.195: West side of chancel arch at Owning Church.

The wall containing the chancel arch forms the west wall of the chancel. However, the cut stones that surrounded the arch are not visible on this side, which appear to be a normal gable wall the bottom central section of which has been removed. A number of putlog holes are visible on this wall. The bottoms of two single-light windows, set within embrasures, are located in the north wall. The south wall contains two windows set within embrasures, a doorway and an aumbry. The original cut stone does not survive on any of the windows in the chancel. The window at the west end of the south wall of the chancel has an unusual cut stone at the top of its inner face. This cut stone was obviously originally from a larger feature as it is larger that the embrasure into which it is inserted. The walls of the church are heavily overgrown making detailed examination of many of its features impossible. The external doorjambs of the doorway have elaborate mouldings, which consist of a large roll at the inner angle of a block of stone. Flanking the roll on either side are small plain rolls. This type of roll moulding is likely to date to the thirteenth century (Forrester 1972, 30). The internal face of the doorway contains a much different style of doorjamb that is later in date. The form of this door surround is similar to the style of the surround for the aumbry and may be of a similar date. It is probable that the roll moulding were reused from a doorway in the original church when the nave was added.

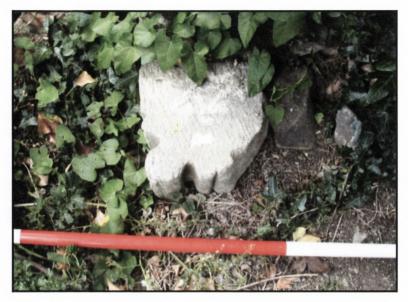
Fig. G.196: Roll moulding from door-jamb in Owning Church.

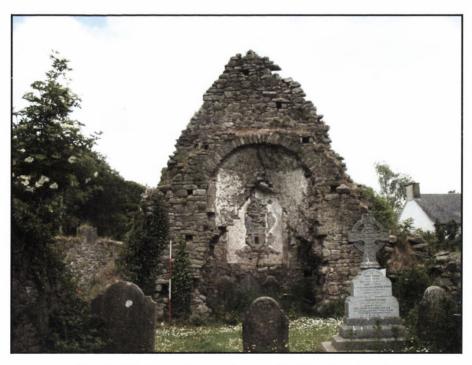
The east wall has been modified over time and it original form is hard to discern. A single light window has been inserted into the centre of the window, and it is possible that the cut stone for this was originally part of one of the other windows of the church. There is also evidence for a large arched window in this east wall, which may originally have held tracery. A large part of the internal face of this wall has been plastered making its analysis difficult.

Fig. G.197: Internal face of east wall of Owning church.

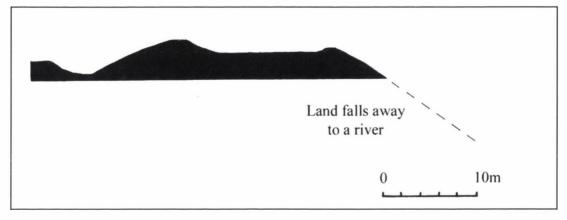
Fig. G.198: Profile of earthwork castle/recycled ringfort in Owning W-E.

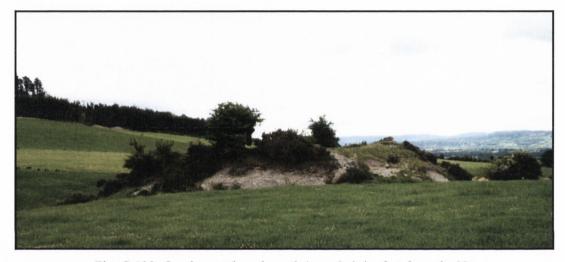
The width of the bank varies greatly from 1m to 1.90m, the widest section is to the east where the bank is in poor condition and has slipped making it lower in height (0.15m int.) and wider. The bank is 0.90m high internally on west side of the platform. The fosse is U-shaped and is 1.35m below external ground level. There is damage to the N side of the platform and this reveals that the motte is composed of a loose, shaley soil with a high stone content. There are a number of flat stone slabs in the side of the platform and the fosse, and there is a sandstone erratic on the NW corner of the motte, indicating that the area was affected by glaciation.

Fig. G.199: Owning earthwork castle/recycled ringfort from the N.

The site consists of a circular platform (11.80m in diameter and 3.60m above the bottom of the fosse) with a bank or berm around its circumference and an external fosse for most of its circumference. The ground slopes down steeply to the stream on the east side and there is no fosse here. To the NE the fosse has been removed, probably through the action of ploughing. There is a possible entrance feature at the north side of the motte, where there is a causeway through the fosse.

The low height of the platform and its location would suggest that this site might be a platform ringfort rather than a motte. The site is located within the townland of Owning, in the parish of Owning, the obvious location for a manorial caput, but the distance between the 'motte' and the church makes its identification as a manorial caput unlikely. Kieran O'Conor (1993) did not include Owning in his list of earthwork castles in Leinster.

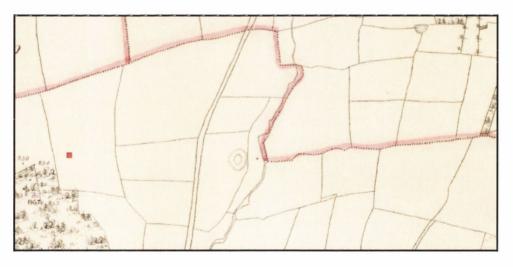
In the *Down Survey* map of the barony of Overk the northern end of the modern townland of Owning is a separate townland called the 'Commons of Owney' and a large house, with a chimney is the only structure depicted in this townland. The *Ordnance Survey* First Edition six-inch map depicts the site with two concentric rings of hachure, with a field boundary, which is no longer extant, running adjacent to its east side.

Fig. G.200: The earthwork in Owning as depicted on the *Ordnance Survey* First Edition sixinch map.

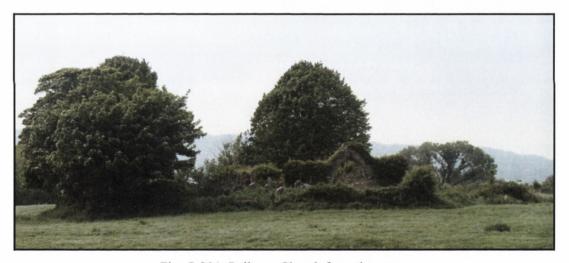
Fig. G.201: Pollrone Church from the west.

The church is a rectangular structure, described in the SMR files as an undifferentiated nave and chancel church. However there is a substantial arch at the east end of the church, which could represent the remains of a chancel arch. The fact that stones jut out from the exterior of this wall would also indicate that the church originally extended further eastwards. The SMR file complied by E. FitzPatrick argues that as the much modified east gable, contains a pointed arch that was the remains of a rough uncut embrasure of the former east window. FitzPatrick noted that there are traces of mortar impressions south of the plank centering on the soffit. The *Ordnance Survey*

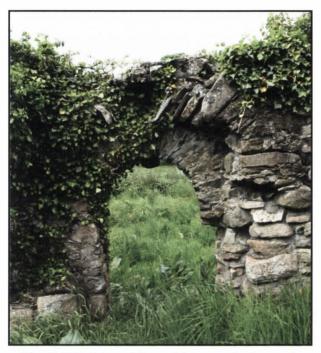
Fig. G.202: Internal face of doorway in the south wall of the church in Pollrone.

Access to the church was through opposing north and south doorways, both of which appear to have been round-headed and set within embrasures. The south doorway is well preserved and the round-head remains in tact. The top of the north doorway is damaged but it is clear that it was originally round headed. Both of the side walls contained a window opening at their east ends and both windows were single

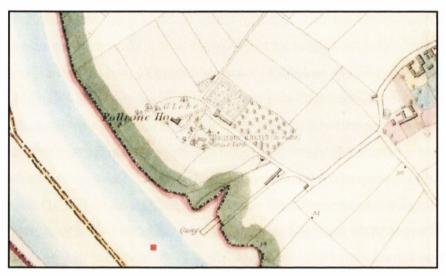
graveyard in Pollrone and labels the church 'Pollrone Church (in ruins)'. Pollrone House, which is located NW of the church appears to be located in Glebe land, and is accompanied by formal, landscaped gardens.

Fig. G.204: Pollrone Church as depicted on the Ordnance Survey First Edition six-inch map.

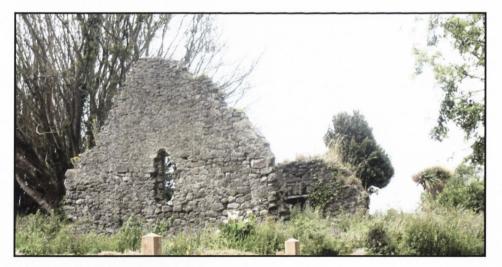
Fig. G.205: Portnascully church from the east.

The church is largely destroyed, with only two upstanding gable walls surviving. Their orientation suggests that they are east and west walls, but there is only 4.5m between them. The east wall contains a round-headed single-light window, 1m below the apex

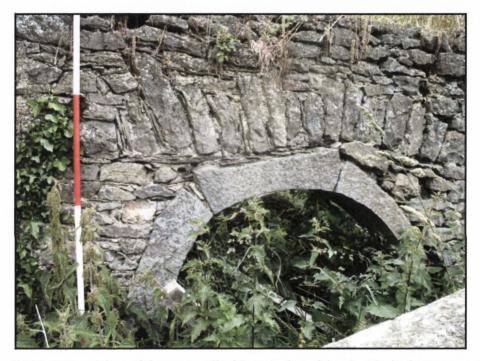
of the gable, the wall thins, creating a ledge, which may have been part of the supports for a rood loft. The west wall appears to have been substantially modified over time. A cut-stone arch appears to have been inserted into this wall, but the relieving arch above it appears to be original. This arch is set into a recess that is 0.50m deep, while the thickness of the wall is 0.75m thick. The recess is 2m in length and 1.25m in height (but there appears to have been substantial build up in the area of the church). The closeness of the east and west walls would suggest that the surviving walls might represent an east wall and a chancel.

Fig. G.206: External face of the west wall of the remains of the church site in Portnascully.

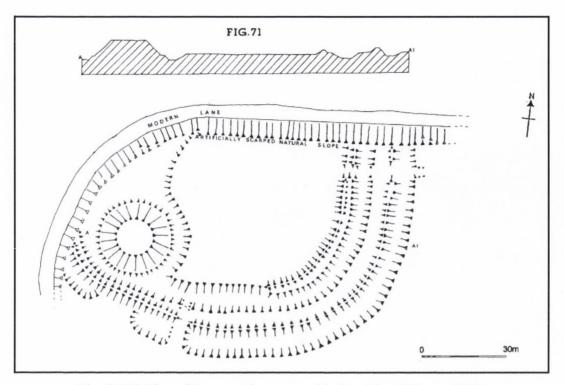
Fig. G.207: Plan of Portnascully motte and bailey (after O'Conor 1993).

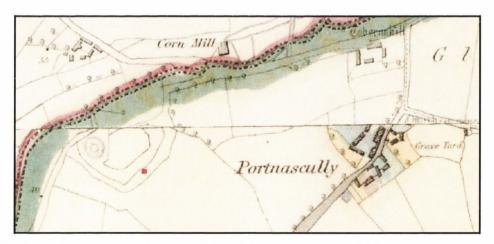
Fig. G.208: The motte and bailey and church in Portnascully as depicted on the *Ordnance Survey* First Edition six-inch map.

The *Down Survey* map of the barony of Overk does not mark the townland of Portnascully, which suggests that the townland was not forfeited under the Cromwellian confiscations. The *Ordnance Survey* First Edition six-inch map shows the motte and the D-shaped bailey, but does not label the site.

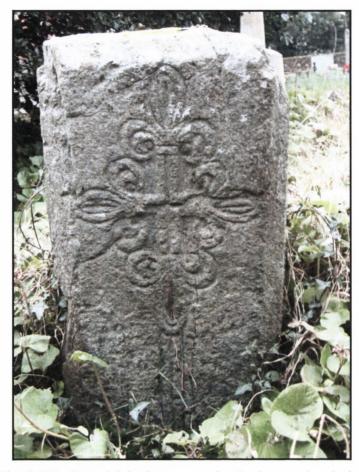
The site of the medieval parish church is now occupied by a graveyard and all that remains of the former church is a medieval graveslab and the fragment of another. The graveslab fragment was found in the south of the graveyard and consists of the bottom of a coffin shaped slab with chamfered edges. It is decorated with the stem of a cross terminating on a fleur-de-lis and can be assigned a thirteenth to fourteenth century date (Ó Drisceoil 1996, 237). The complete graveslab is now set upright in the ground and consists of a coffin-shaped slab with chamfered edges. The face of the slab is decorated with an elaborately carved fleur-de-lis cross from which runs a stem with central ribbing. O'Drisceoil (1996, 238) has assigned this slab a thirteenth to fourteenth century date on the basis of its form and ornamentation. A third graveslab fragment of similar form and decoration was found at the parochial house in Rosbercon during landscaping works there in 1958 (O'Doherty 1982). This site was later the site of a Church of Ireland church and its construction may have been responsible for the total destruction of the medieval church.

Fig. G.209: Graveslab in the graveyard at Rosbercon church site.

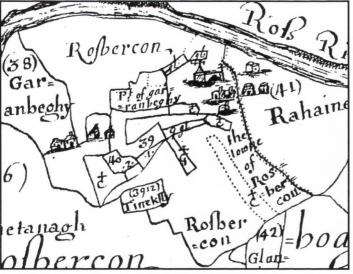
Fig. G.210: Rosbercon townland as depicted on the *Down Survey* map of the barony of Ida.

The *Down Survey* map for the barony of Ida depicts a church and a number of small buildings in the townland of Rosbercon. To the west of this nucleation and further away from the River Suir, 'the towne of Rosbercon' is labelled beside a long narrow area of

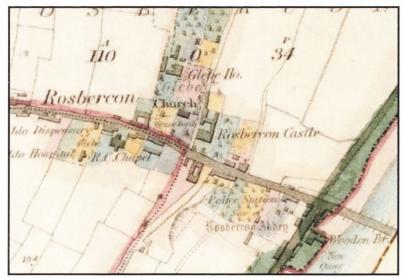
located in this area of Glebe land, beside the town of Rosbercon and its parishioners, but the church is not depicted on this map. The church beside the River Barrow is likely to be the site of the Dominican Friary. The *Ordnance Survey* First Edition sixinch map depicts and labels the church site in Rosbercon, on the north side of the road that connects the town of Rosbercon with the bridge to New Ross. The church is surrounded by a rectangular graveyard. Rosbercon Castle is marked adjacent to the church in Rosbercon, and while this is today the site of a large, relatively modern, house, there is a suggestion that this was the site of a medieval castle in Rosbercon. No castle is, however, depicted on the *Down survey* map in the townland of Rosbercon.

Fig. G.211: The church site in Rosbercon as depicted on the *Ordnance Survey* First Edition six-inch map.

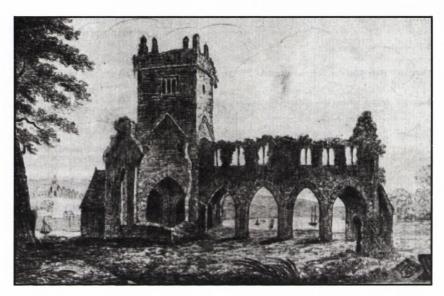
Grace described the friary in Rosbercon in 1823: 'From the lofty tower of the church, supported on four pointed arches, and adorned with pinnacles, an arcade extends formed by the interior south wall of the aisle, containing five Gothic arches of noble dimension, over which are ten windows, each divided by mullions, and terminating with circular tops. Other less interesting remains, together with numerous tombstones, are dispersed about' (Grace 1823). However, Manning has cast serious doubts on the accuracy and reliability of Grace's illustrations (Manning 1997). According to Manning Sheffield Grace had 'an irrepressible urge to show the Grace family as more important than they really were and to misuse and deliberately falsify different types of evidence towards that end' (Manning 1997, 125-126). Where his drawings could be compared to standing buildings they have been proven to be inaccurate and on this

Fig. G.212: Ruins of Rosbercon Abbey from the Memoirs of the Family of Grace 1823 (Carrigan 2005, IV 183).

basis we can give little credence to Sheffield Grace's descriptions. Unfortunately, many later antiquarians, such as Carrigan (2005, 184) reproduced this description in their own work. No accurate account of the architecture and plan of this monastic foundation were uncovered during the course of this research.. The tradition that the Grace family founded this monastery is probably also attributable to the suspect scholarship of Sheffield Grace.

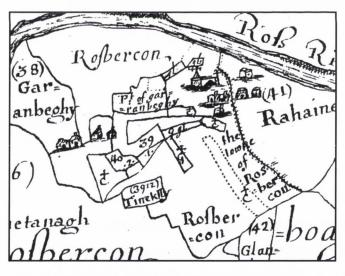
Fig. G.213: The friary in Rosbercon close to the River Barrow as depicted on the *Down Survey* map of the barony of Ida.

The *Down Survey* map of the barony of Ida depicts a church and three smaller buildings close to the west bank of the River Barrow. There are three more small buildings close by, just over the border with the townland of 'Rahaine'. To the west of the church, an area labelled the town of Rosbercon is marked, adjacent to an area of glebe land. A number of other areas of glebe land are also

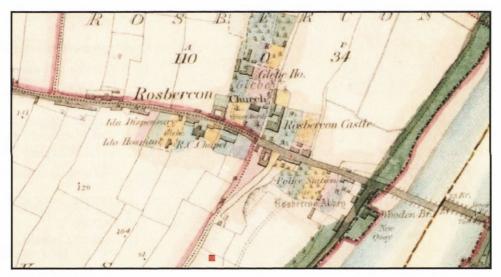
Fig. G.214: The location of the site of Rosbercon Friary as depicted on the *Ordnance Survey* First Edition six-inch map.

included. The *Ordnance Survey* First Edition six-inch map marks the 'site of Rosbercon Abbey' close to the River Barrow and south of the street that connected Rosbercon to the wooden bridge. In the second edition maps however the site of Dominican Friary has been moved to the location of the church, uphill from the River

Barrow and on the north side of the road that connect Rosbercon to the bridge. On this map the site is labelled 'Convent of the Dominicans (site of)'. There is no clear reason why the site of the abbey should have been moved to this location, but Carrigan also records that the churchyard in Rosbercon was the site of the Dominican friary (Carrigan 2005, 184). However, the archaeology ie website marks the friary site at the location provided on the *Ordnance Survey* First Edition six-inch map and McCutcheon (1998, 76) also suggested that the friary location on the first edition map was the correct one. A comparison of the *Ordnance Survey* First Edition six-inch map with the *Down Survey* map suggest that the church marked on the *Down Survey* map was the site of the Dominican Friary rather than the parish church site, which would have been located in the area of Glebe land to the west.

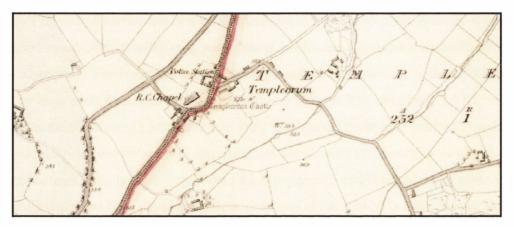
Fig. G.217: Templeorum Castle and Oldcourt Church as depicted on the *Ordnance Survey*First Edition six-inch map.

the area indicates that the modern church in Templeorum, is in fact in the adjoining townland of Oldcourt. The label 'site of Templeorum Castle' is marked on the Templeorum side of the townland boundary, but the site of the castle appears to be marked by a sub-circular area on the Oldcourt side of the townland boundary. On the twenty-five inch Ordnance Survey map the symbol to denote the former site of an antiquity is located in the same location as the sub-circular area on the first edition sixinch map. However, the field in which earthworks have been observed is located on the other side of the road and townland boundary in Templeorum. The field in which

the earthworks are located, is today one large open field, but the *Ordnance Survey* First Edition six-inch map of the area depicts the area as being divided into two separate fields, the eastern one containing a building enclosed by field boundaries, with another enclosed area to the south.

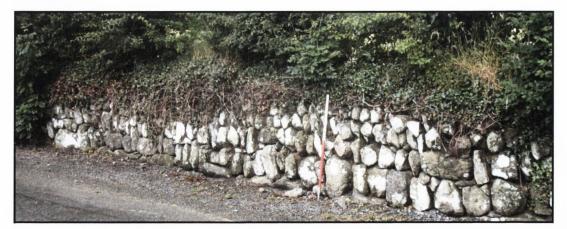
Fig. G.218: Stone wall reportedly built with stone from the castle.

A local man, who lives opposite the site, pointed out the castle site and the field walls close to it are made of large stones that are reputed to have come from the castle. The form of the stone would not dispute this suggestion. The field was under corn when the site was visited but the local man described the site as a square platform, 'the only flat part of the field', and this platform could be seen in the differential corn growth. He also reported that blackened stones were also found in the field during ploughing. A previous report compiled for the SMR file on the site described the platform as being no more than 20m square, delimited by a scarp, most prominent to the E and S. It also reported the presence of a number of irregular earthworks probably contemporary with the castle.
